Technical Memorandum

To: Bob Brannan
From: Jay Lyman
Date: March 3, 1999
Subject: ODOT No. 16962 – I-5 Trade Corridor Study
Existing Geometrics and Identified Deficiencies

*I-5 Trade Corridor Study
Existing Geometrics and Identified Deficiencies*

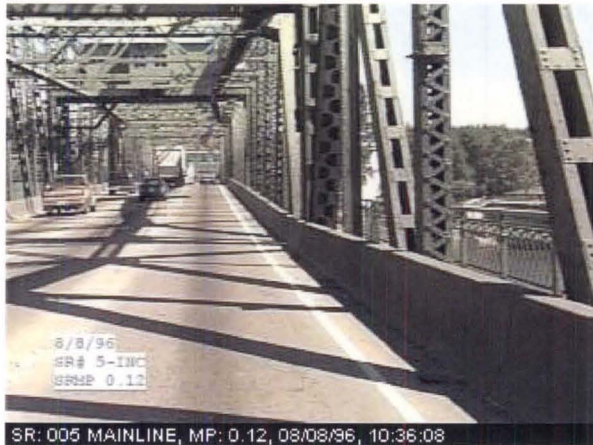
**Columbia River Bridge
(Northbound)**

Most of the deficiencies identified in the table above are substandard shoulder widths. These substandard widths are mostly due to the limited deck widths along bridge structures. Some examples include the Columbia River Bridge (inside and outside shoulder widths vary between zero and one foot), the Salmon Creek Bridge (outside shoulder widths of 2 feet), and the Interstate 205 overpass (outside shoulder widths of 4 feet). These examples are pictured below for both the northbound and southbound directions.

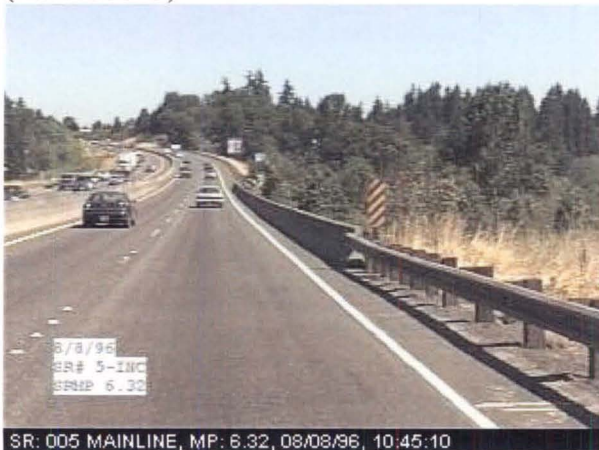
**Salmon Creek Bridge
(Northbound)**

Salmon Creek Bridge (SR 6.30 to SR 6.38)	Both	– Outside shoulder widths of 2 feet.	– Narrow bridge structure.
I-205 Overpass (SR 7.49 to SR 7.54)	Both	– Outside shoulder widths of 4 feet.	– Narrow bridge structure.

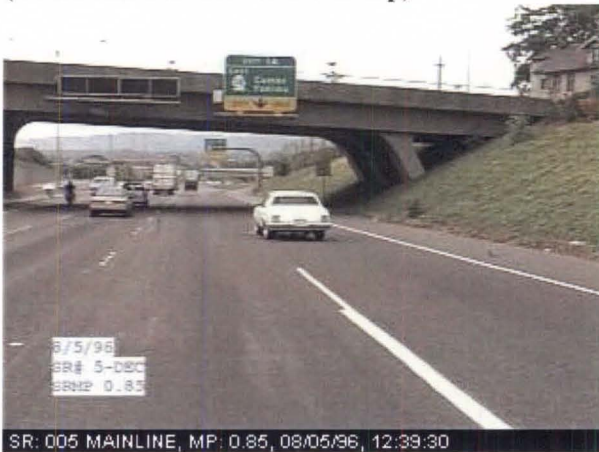
(Mill Plain Boulevard On-Ramp)

Two areas have been noted along I-5 where spacing between ramp terminals is insufficient. The first location is in the state of Oregon along the southbound auxiliary lane located between the Weidler Street on-ramp and the I-84 off-ramp. The weaving area length was measured to be 995 feet. The second location (pictured below) is in the state of Washington along the southbound auxiliary lane located between the Mill Plain Boulevard on-ramp and the SR14 off-ramp. The weaving area length was measured to be 666 feet.

Insufficient Weaving Area In The Southbound Direction Between Mill Plain Boulevard On-Ramp and SR 14 Off-Ramp

In both cases, the measured distances between ramp terminals do not meet the recommended minimum ramp terminal spacing of 2,000 feet for a freeway-to-freeway connection.

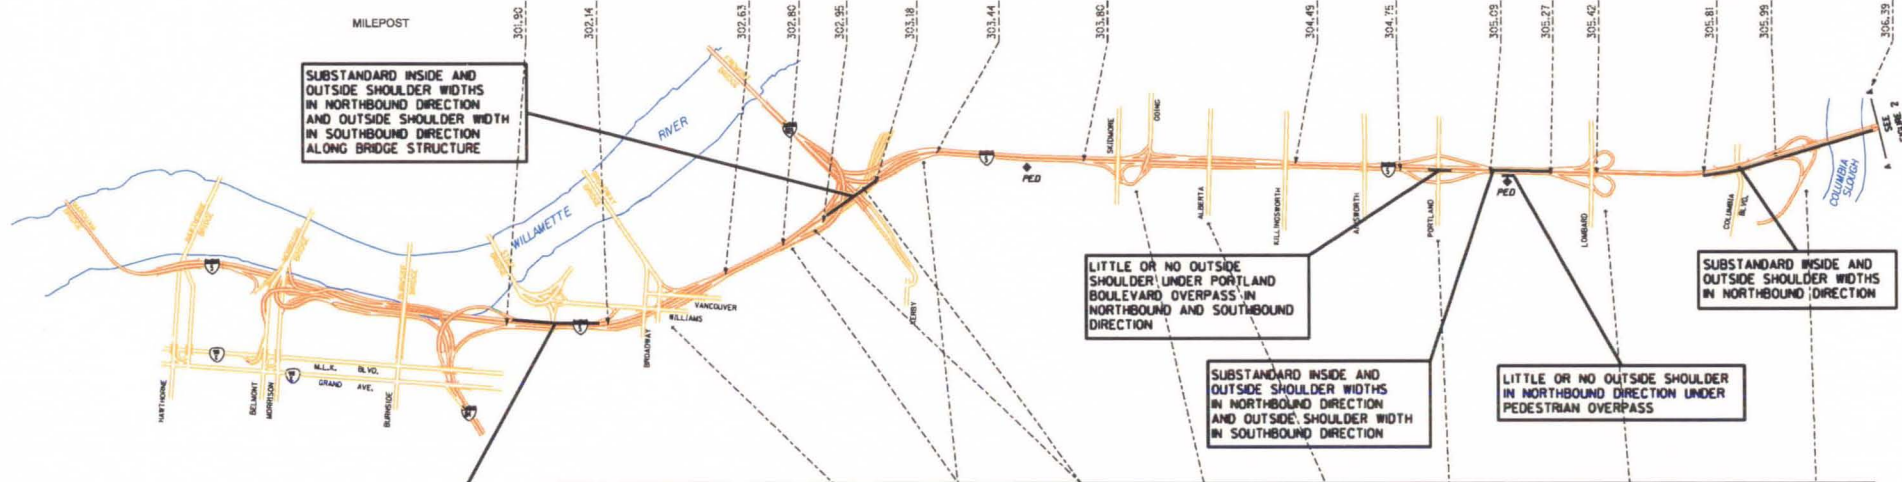
FIGURE 1
Interstate 5
-Existing Geometrics and Identified Deficiencies

Location	Direction	Potential Deficiency(ies)	Constraint(s)
Weidler St. on-ramp to I-84 off-ramp (MP 301.90 to MP 302.14)	SB	– Insufficient ramp terminal spacing of 995 ft.. – Outside shoulder width of 2 feet.	– Short interchange spacing.
Between I-405 on/off-ramps (MP 302.95 to MP 303.18)	NB	– Inside and outside shoulder widths of 3 feet.	– Narrow bridge structure.
	SB	– Outside shoulder width of 2 feet.	– Narrow bridge structure.
Between Portland Blvd. on/off-ramps (MP 304.75 to MP 305.09)	Both	– Outside shoulder widths of only 1 foot.	– Portland Boulevard overpass (both directions). – HOV lane (northbound).
Portland Blvd. on-ramp to Lombard Ave. off-ramp (MP 305.09 to MP 305.27)	NB	– Inside shoulder width of 3 feet and outside shoulder width of 1 foot.	– HOV lane. – Pedestrian overpass.
Columbia Slough Bridge (MP 305.81 to MP 306.47)	NB	– Inside shoulder width of 2 feet and outside shoulder width of 0.5 feet.	– HOV Lane. – Narrow bridge structure.

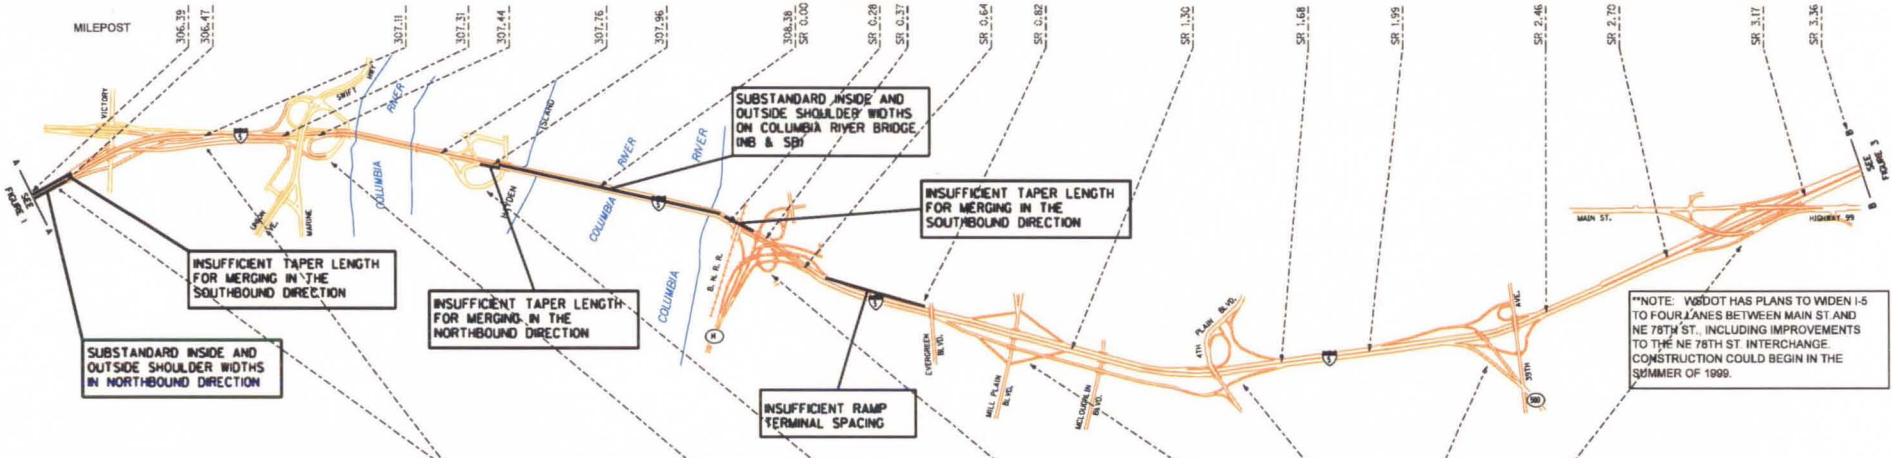
FIGURE 2
Interstate 5
-Existing Geometrics and Identified Deficiencies

Victory Blvd. on-ramp to Columbia Slough Bridge	SB	– Insufficient taper length for merging.	– Short distance between on-ramp and bridge structure.
Jantzen Beach/Hayden Island on-ramp to Columbia River Bridge (MP 307.95 to MP 307.98)	NB	– Insufficient taper length of 158 feet for merging with mainstream traffic lane.	– The proximity of the on-ramp relative to the Columbia River Bridge structure.
Columbia River Bridge (MP 308.38 to SR 0.28)	Both	– Inside and outside shoulder widths of 0- to 1-ft.	– Narrow bridge structure.
SR 14 Westbound on-ramp to Columbia River Bridge (SR 0.36 to SR 0.33)	SB	– Insufficient taper length of 211 feet for merging with mainstream traffic lane.	– The proximity of the on-ramp relative to the Columbia River Bridge structure.
Mill Plain Blvd. on-ramp to SR 14 off-ramp (SR 0.64 to SR 0.82)	SB	– Insufficient ramp terminal spacing of 666 ft..	– Short interchange spacing.
