FITNESS FOR PURPOSE EVALUATION OF THE
COUNTERWEIGHT SHEAVE/TRUNNION ASSEMBLY
FOR
OREGON DEPARTMENT OF TRANSPORTATION

WJE NO. 1997.3010

June 2000

WISS, JANNEY, ELSTNER ASSOCIATES, INC.
330 Pfingsten Road
Northbrook, Illinois 60062-2095
(847) 272-7400

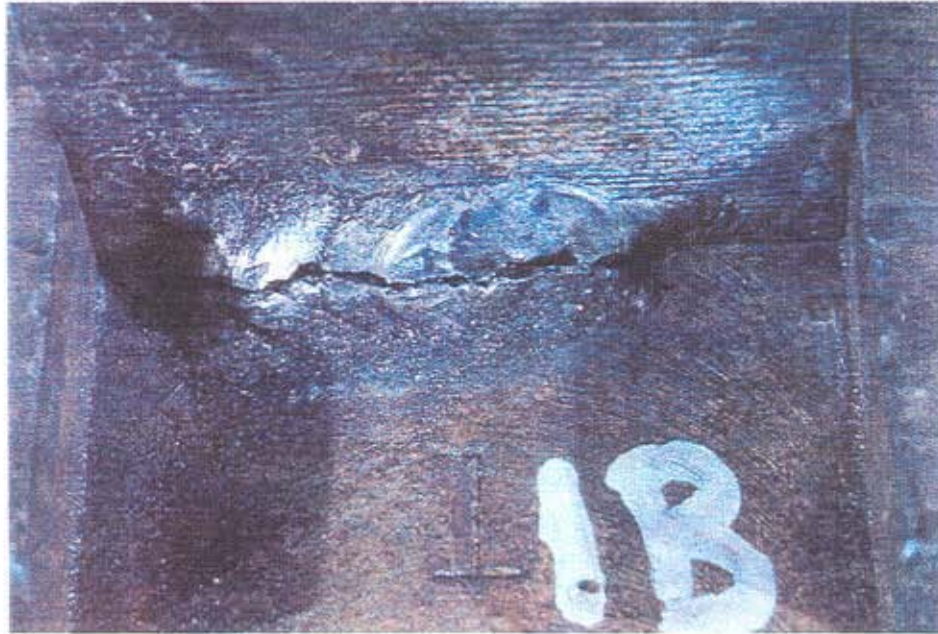
Before attempting to remove the trunnion from the sheave, the six sheave keyway retainer welds (three on each end) were closely examined. Because of the stainless steel weld metal used, dye penetrant was employed to highlight the fillet weld cracks. Weld cracks were observed along the weld tie or through the throat of all six fillet welds. Figure 2.3 shows a cracked key retainer weld at east keyway 1B.

Fig. 2.3 – Cracked key retainer weld at keyway 1B

As noted earlier, the fillet welds at all six keyway retainer welds were cracked. These welds were small and of poor quality possibly developing after welding due to improper preheat and weld shrinkage. A nonmagnetized stainless filler metal of unknown grade was used for these retainer welds. Nondestructive tests using a visible dye liquid penetrant were performed to enhance the inspection and to locate cracks that may not be visually observed. NDE of the welds found no indications of cracking from the weld root or weld toe into the trunnion base metal. A keyway retainer weld crack was selected for additional fractographic evaluation to verify the NDE results.

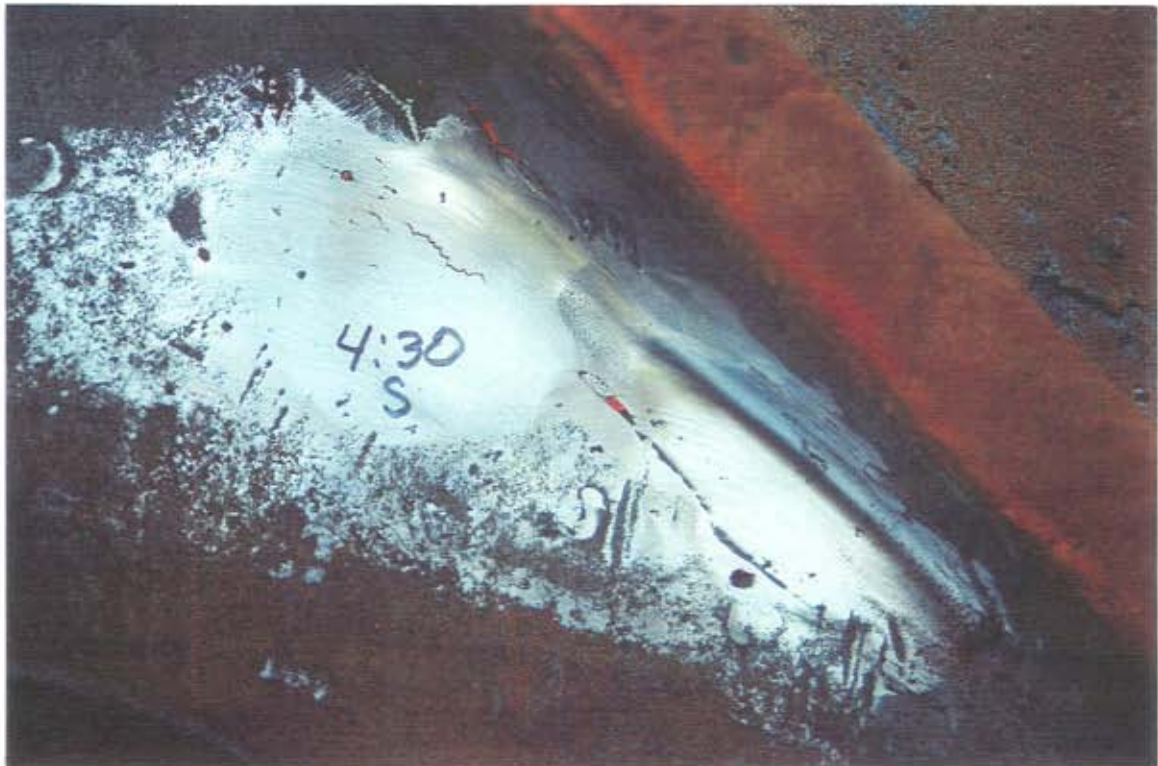
oriented. Two of the deeper cracks located in high stress regions were removed by coring for fractographic examination. Figure 3.2 shows one of these cracks shown highlighted by magnetized particles in the sheave spoke. In addition, two large steel samples were cut from the sheave wheel for material and chemical testing. Figure 3.3 identifies the sheave sample locations.

Fig. 3.2 – Apparent shrinkage crack detected in sheave by MT

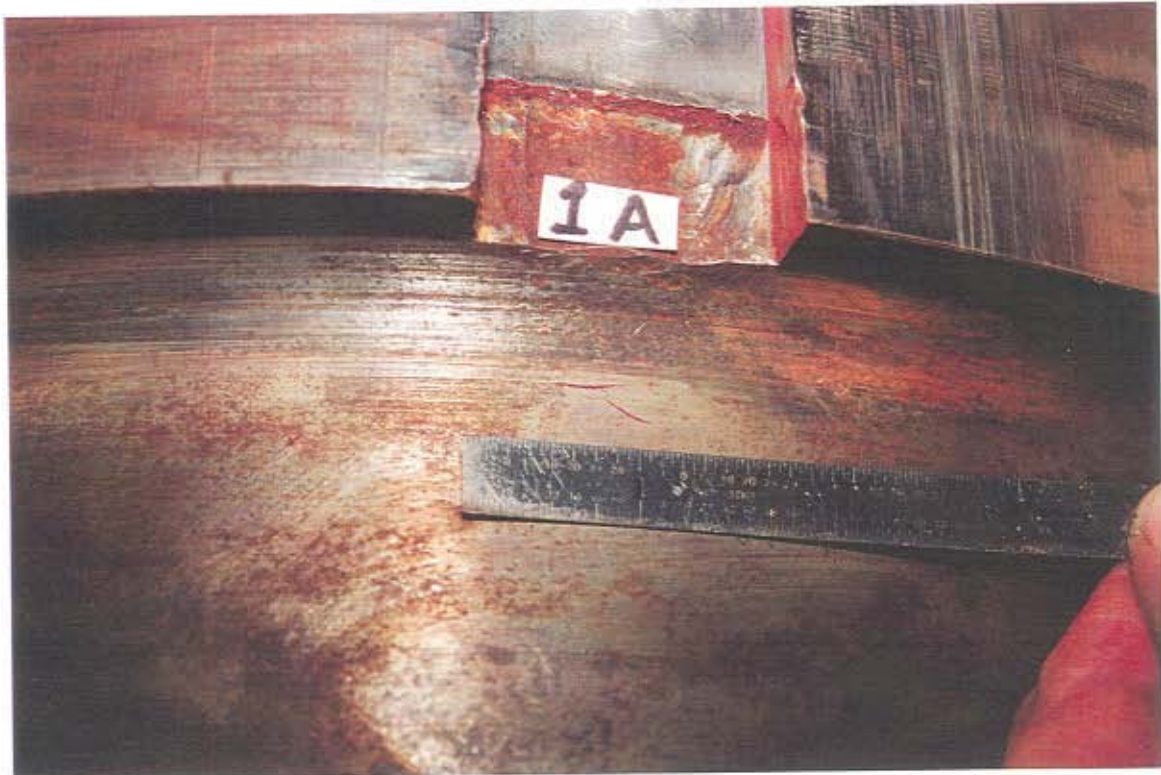
All of the surface or sub-surface discontinuities detected both by MT and UT methods were located near keyways where modifications to fill oilways with weld metal had been performed during the 1960 retrofit work. Surface defects were identified by MT at keyways 1A, 3A, and 1B. Sub-surface crack-

a) Defect 1A. Note random orientation of defects.

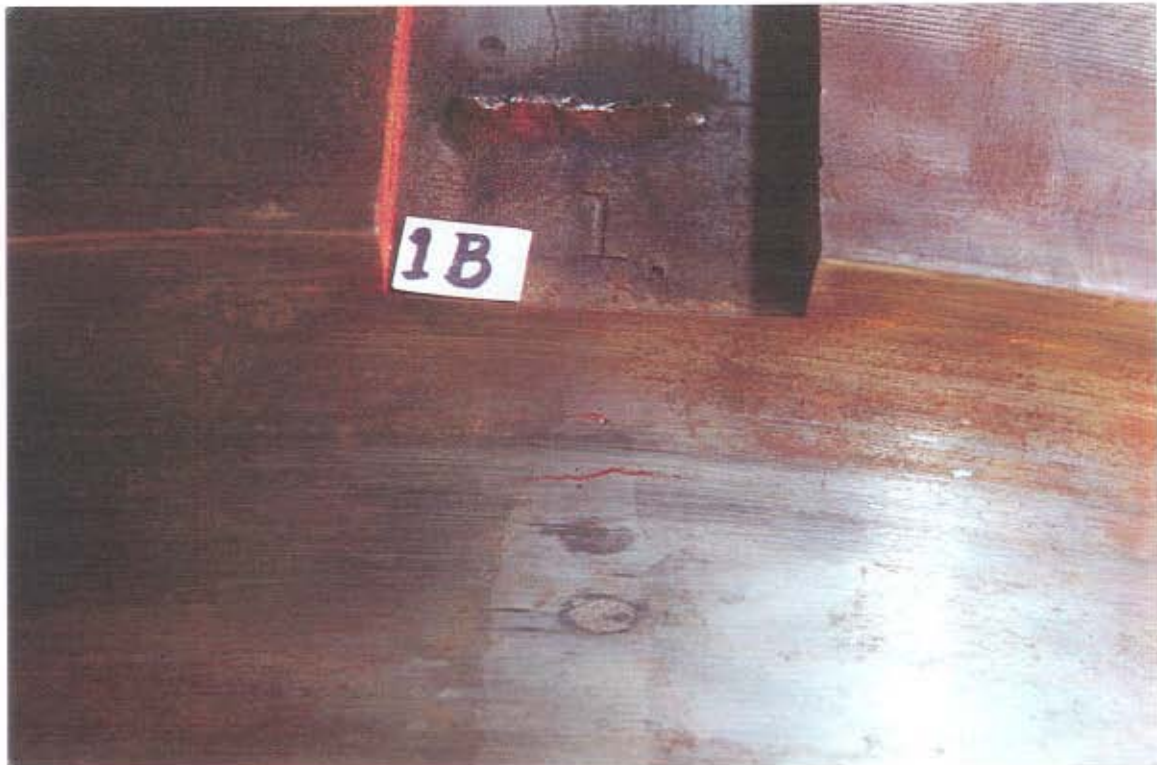
like indications were detected by UT at keyways 3A and 2A along the length of the weld. The crack-like indications were contained within the weld metal material in all cases except keyway 1B where it appeared that the indication extended beyond the weld fusion line into the trunnion shaft base metal.

b) Defect 1B. Note dissimilar metals defining the weld filled oilway

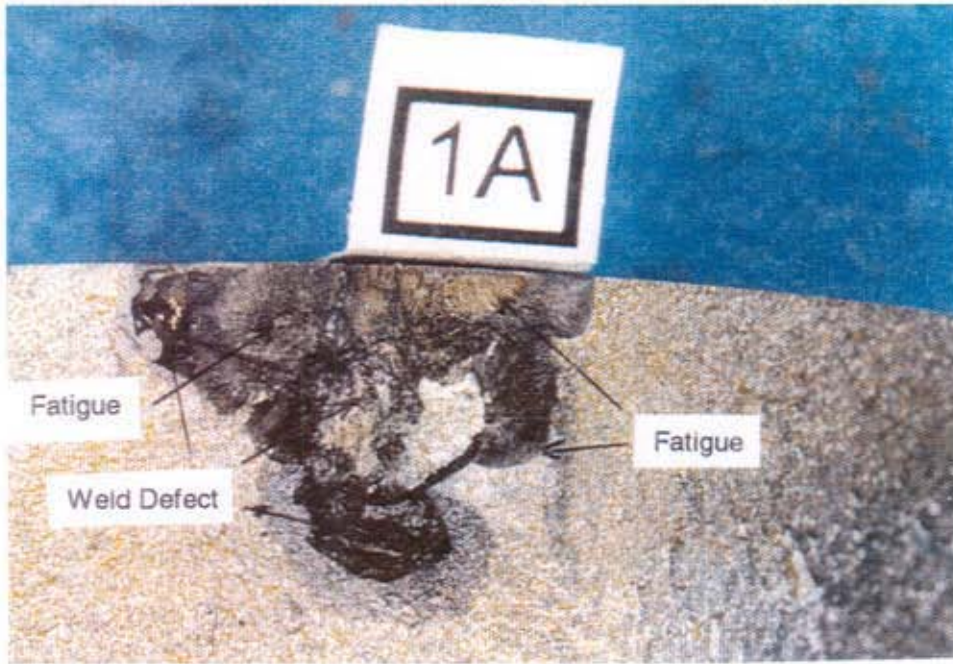
4.1.1 – Oilway weld defects – Surface defects aligned with keyway 1A and 1B using MT methods were subjected to fractographic examination. These defects were identified as 1A and 1B. Defect 1A measured $\frac{3}{4}$ in. wide and had a maximum depth of $\frac{1}{2}$ in. Similarly, defect 1B was $\frac{3}{8}$ in wide with a maximum depth of $\frac{3}{8}$ in. The dark discoloration exhibited on the crack surface is likely due to exposure to lubricants and air. Clear evidence of fatigue crack extension is seen on both crack surfaces after ultrasonic cleaning as shown in Figs. 4.1 and 4.2.

Fig. 4.1 - Initial defects at keyway 1A with fatigue crack extension after ultrasonic cleaning. (ATLSS)

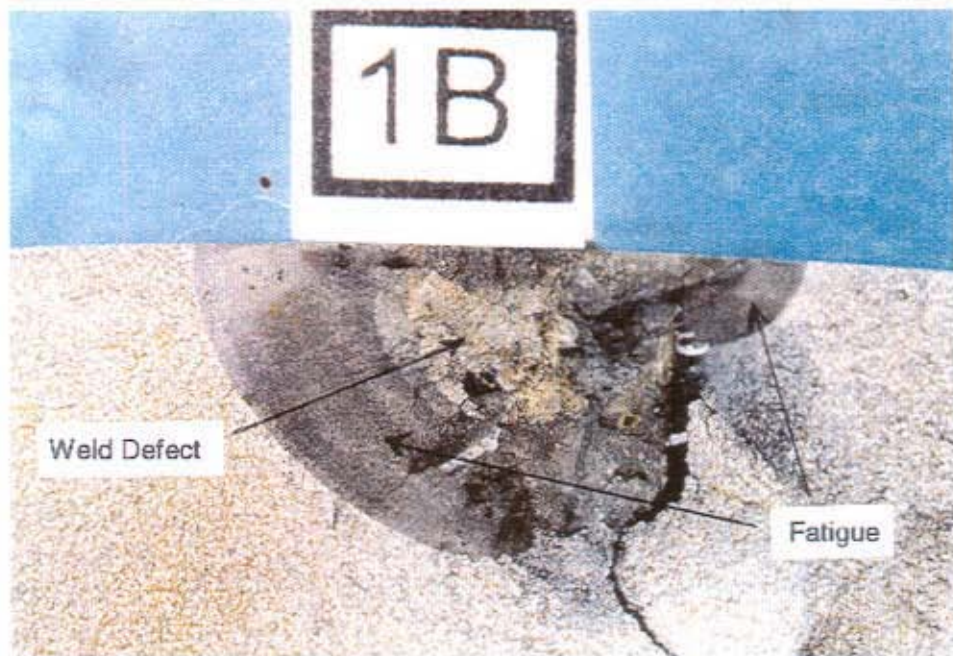
Fig. 4.2 - Initial defect at keyway 1B with fatigue crack extension after ultrasonic cleaning. (ATLSS)

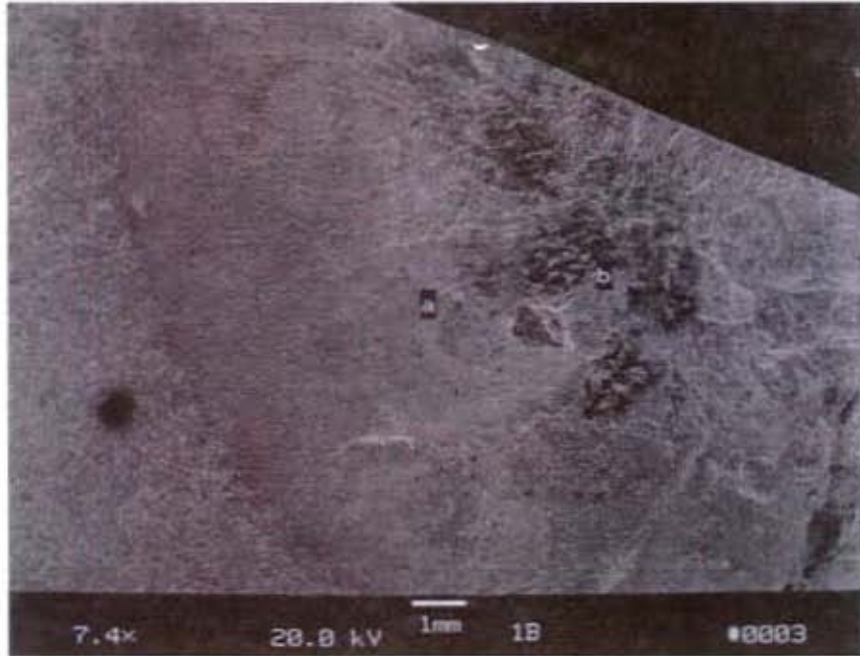
Viewing the crack surface of 1B with the scanning electron microscope (SEM) revealed a smooth, semi-elliptical crack growth region and an initial defect as shown in Fig. 4.3. Increased magnification of the semi-elliptical region verified the presence of fatigue striations while further magnification of the initial defect suggested its origin to be weld metal hydrogen cracking. Less conclusive fatigue crack extension was observed in 1A where several weld metal slag inclusions were identified. When viewed under higher magnification, semi-elliptical regions appeared fatigue-like although no fatigue striations could be seen.

Fig. 4.3 – Semi-elliptical crack growth region shown under SEM Mag. 7.4x. (ATLSS)

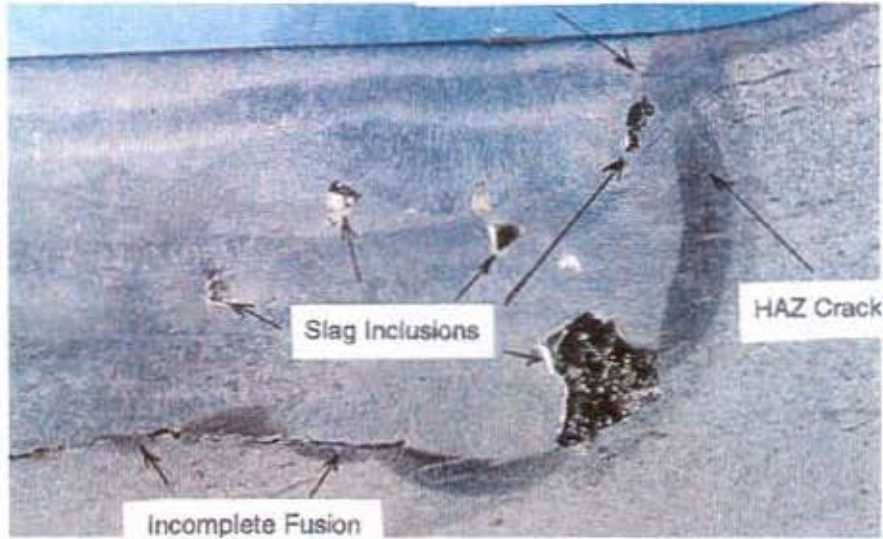
The defect at keyway 3A was selected for metallographic cross-sectioning to characterize the subsurface defects identified by UT. The sample was cross-sectioned longitudinally along the weld

centerline. Numerous weld defects were found along the multi-pass weld, which included incomplete fusion defects and slag inclusions as shown in Fig. 4.4

Fig. 4.4 – Numerous weld defects at keyway 3A after metallographic cross-sectioning. (ATLSS)

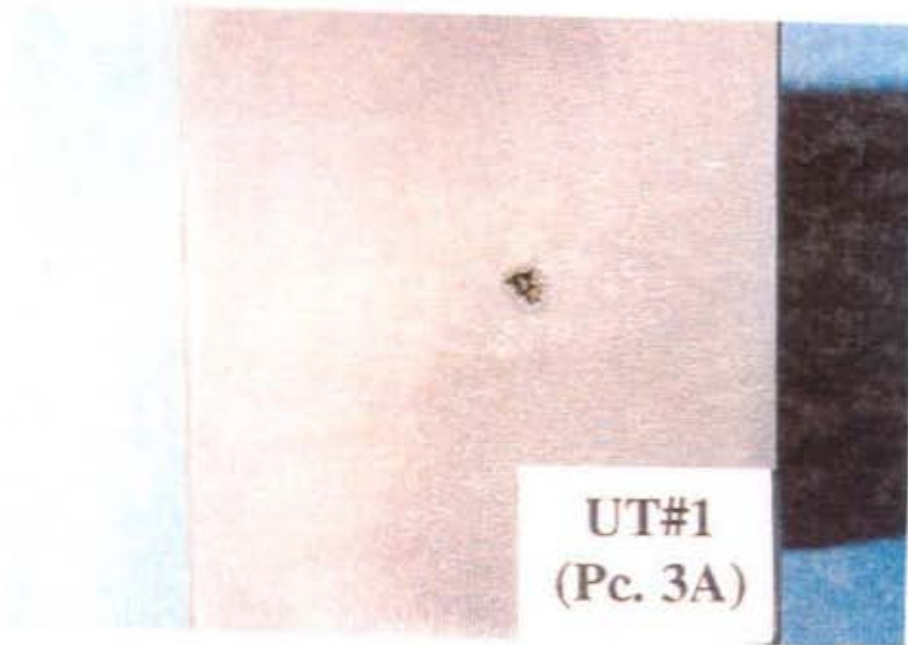
4.1.2 – Internal trunnion defects – Four of the internal defects, UT1, UT2x, UT2z, and UT4, identified during UT examination were investigated. All four indications were internal near the center bore of the trunnion. A saw cut was made in two orthogonal directions at each of the positions determined by UT. With the exception of UT1, no defects were observed. The defect at UT1 was determined to be a shrinkage cavity measuring $\frac{3}{32}$ in. in diameter which occurred during original production of the trunnion. The defect at UT1 is shown in Fig. 4.5. No crack extension was observed microscopically. Due to the small size of UT1, the other defects could have been removed or missed during cutting.

Fig. 4.5 – Internal shrinkage cavity within trunnion. (ATLSS)

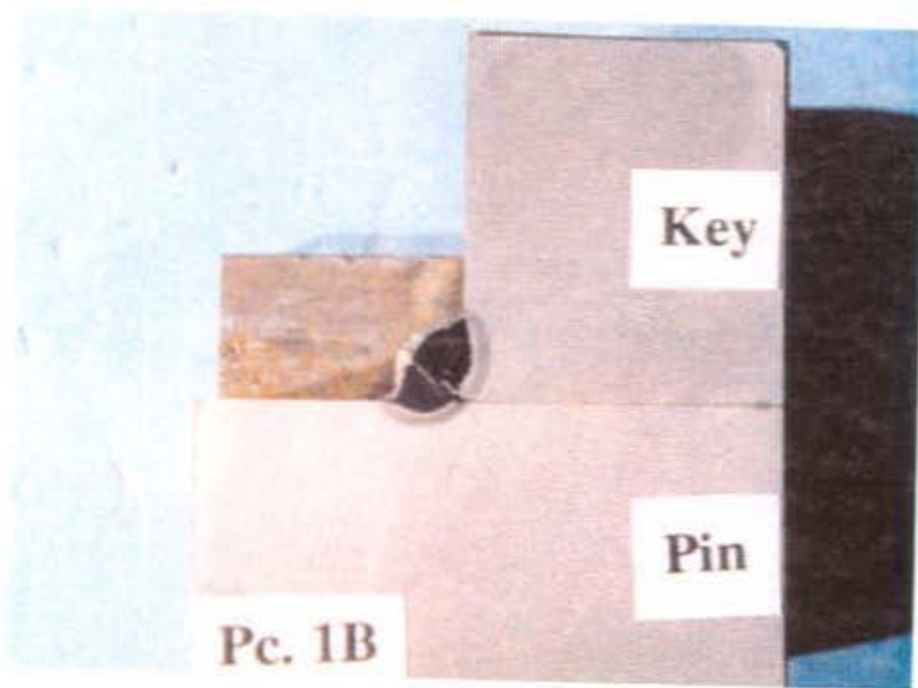
4.1.3 – Keyway retainer fillet weld cracks – The retainer weld from keyway 1B was examined metallographically. The sample was cross-sectioned as shown in Fig. 4.6 where the weld crack is visible. No crack extension into the trunnion base metal was found. The weld metal was identified as austenitic stainless steel.

Fig. 4.6 – Cracked retainer weld at Keyway 1B. (ATLSS)

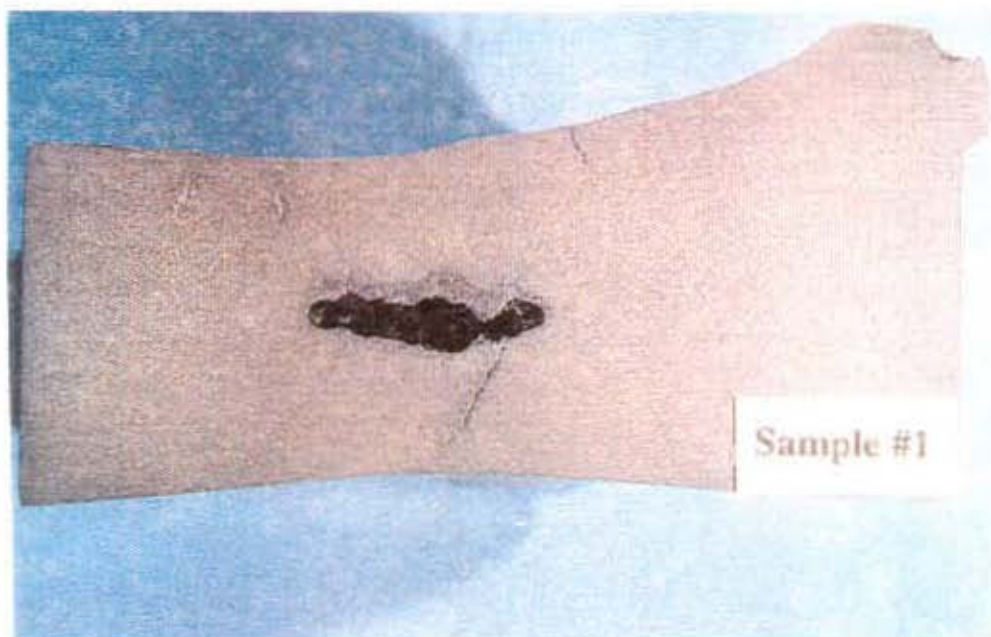
The two cores removed from the sheave were cross-sectioned and examined metallographically. Sample #1 showed multiple surface cracks between $\frac{3}{16}$ in. to $\frac{1}{4}$ in. deep surrounding a large internal shrinkage cavity measuring 1 in. long. The shrinkage cracks were most likely a result of hot tearing during cooling and shrinkage of the sheave casting in the vicinity of the void as seen in Fig. 4.7. No fatigue crack extension of the crack tip regions was observed under microscopic examination. The cracks found in Sample #1 should have experienced fatigue crack propagation due to the expected low threshold stress range for cracks of these depths. This strongly suggests that the stress ranges at this location in the sheave were low.

Fig. 4.7 – Internal shrinkage cavity in sheave Sample #1. Note shrinkage cracks initiating from defect. No indications of fatigue crack extension were observed. (ATLSS)

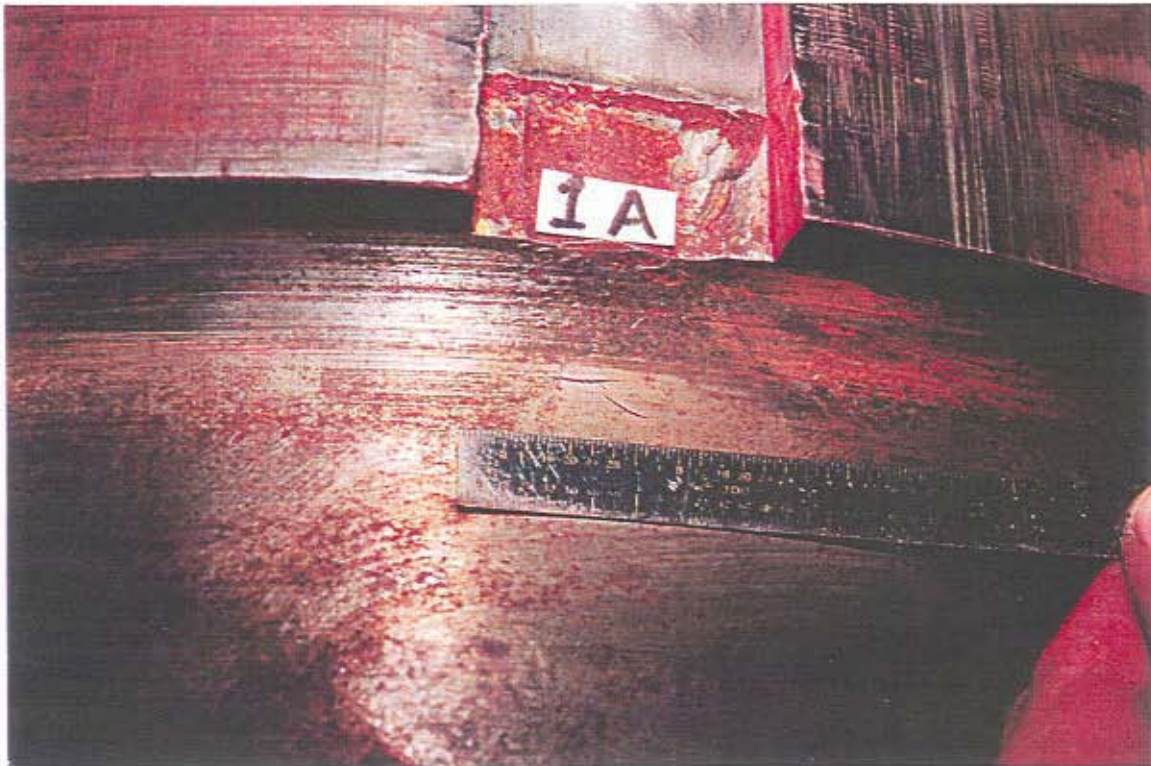
Figure 2 - Surface Discontinuity Detected by MT at Oilway Weld Repair Near Keyway 1A.
(Photo Courtesy of WJE)

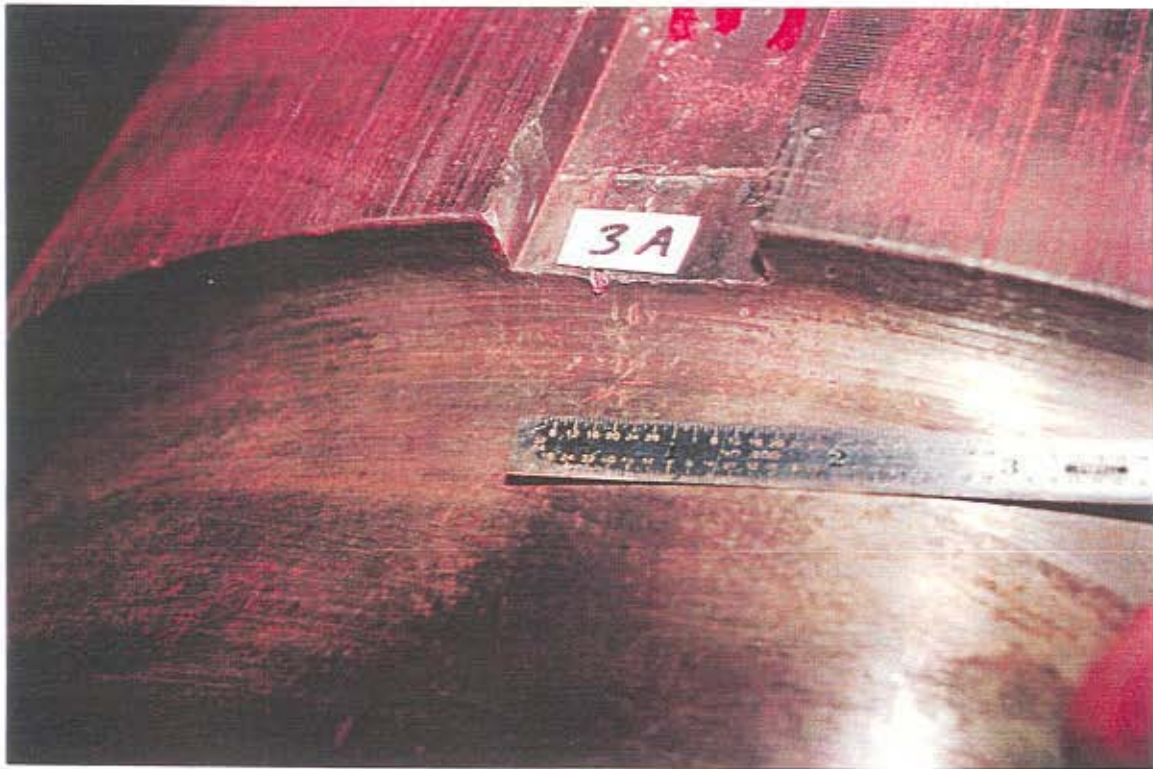
Figure 3 - Surface Discontinuity Detected by MT at Oilway Weld Repair Near Keyway 3A.
(Photo Courtesy of WJE)

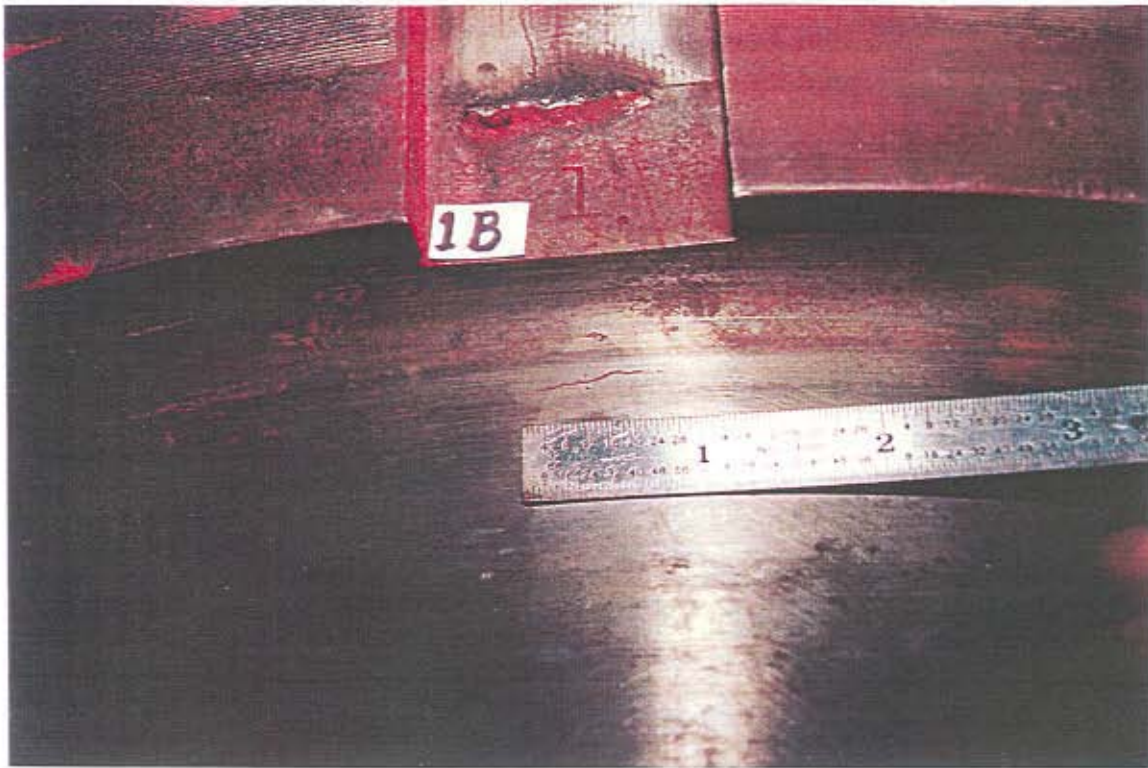
Figure 4 - Surface Discontinuity Detected by MT at Oilway Weld Repair Near Keyway 1B.
(Photo Courtesy of WJE)

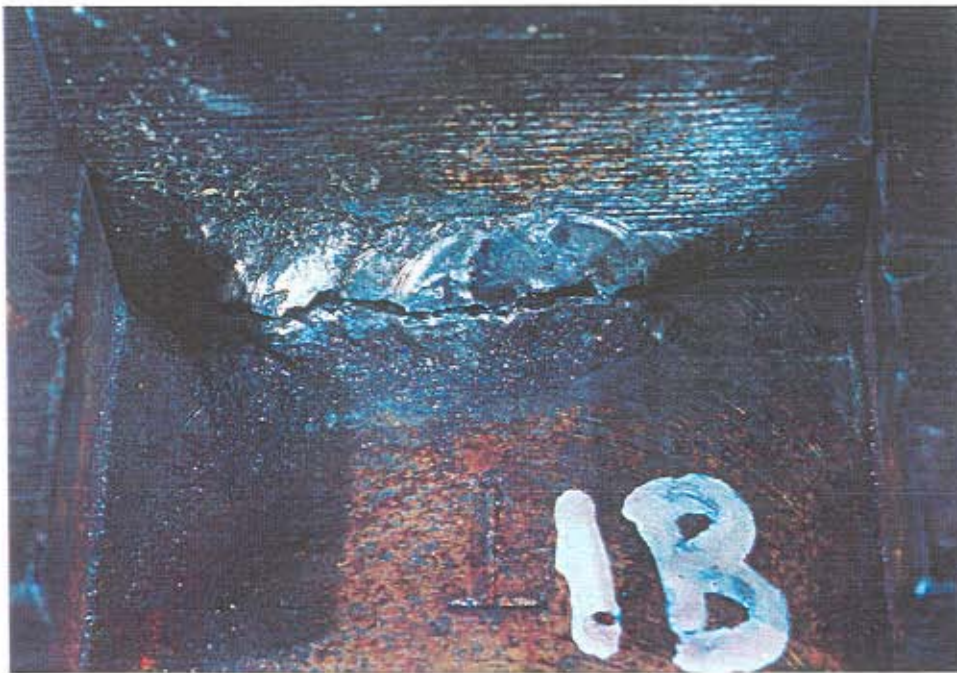
Figure 5 - Typical Key Retainer Fillet Weld Crack Throat Crack (Keyway 1B).
(6/99/2-3)

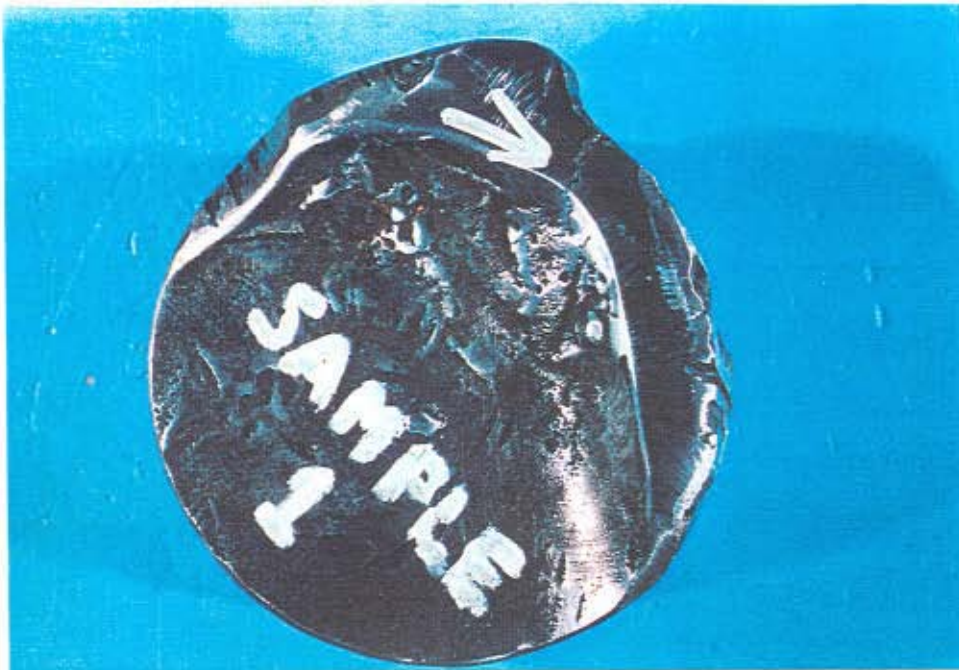
Figure 6 - Sheave Wheel Core Sample #1. Note Surface Crack Indicated by Arrow.
(4/99/14-11)

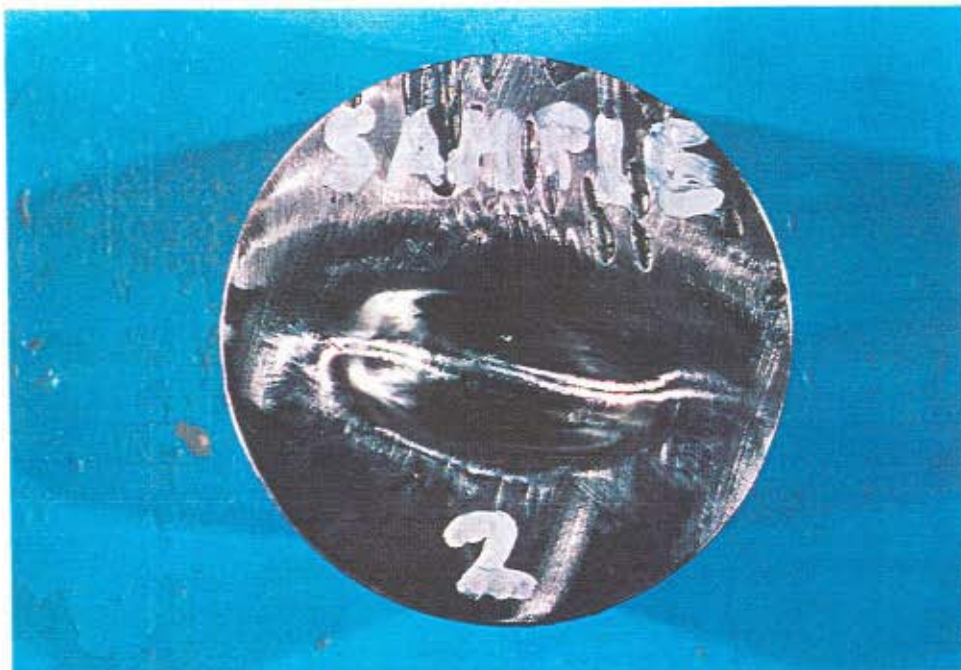
The crack surfaces in Sample #2 were removed by grinding during the MT work before the sample was removed; therefore, no comment could be made as to the origin or growth of the crack. A sub-surface cavity similar to the one found in Sample #1 was identified. This is the most likely source of the MT indications.

Figure 7 - Sheave Wheel Core Sample #2. The Surface Crack Detected Was Ground to Gauge Crack Depth Prior to Coring.
(4/99/14-8)

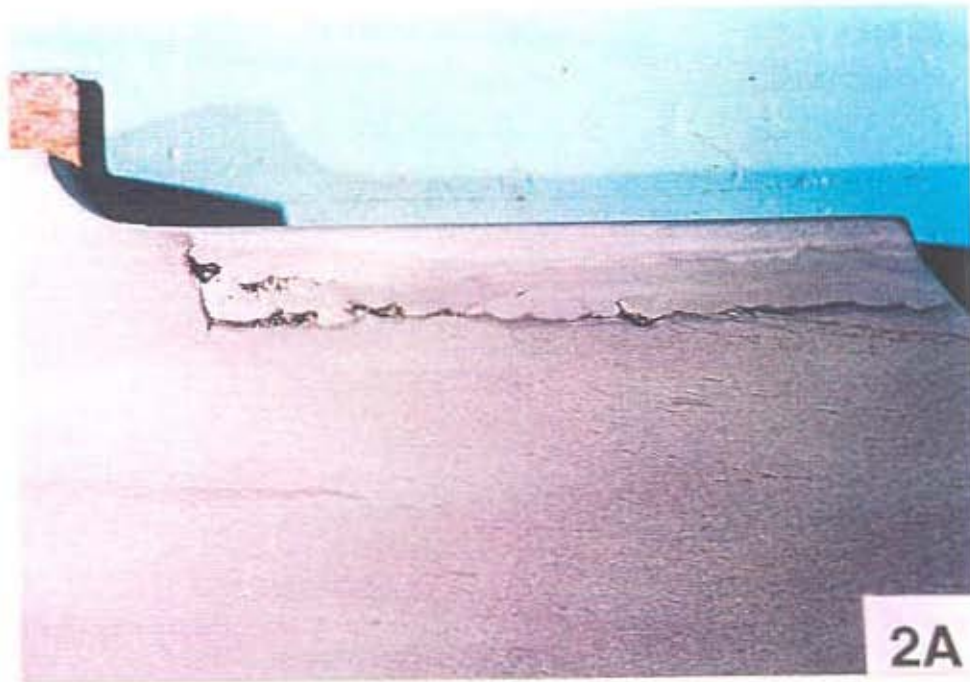
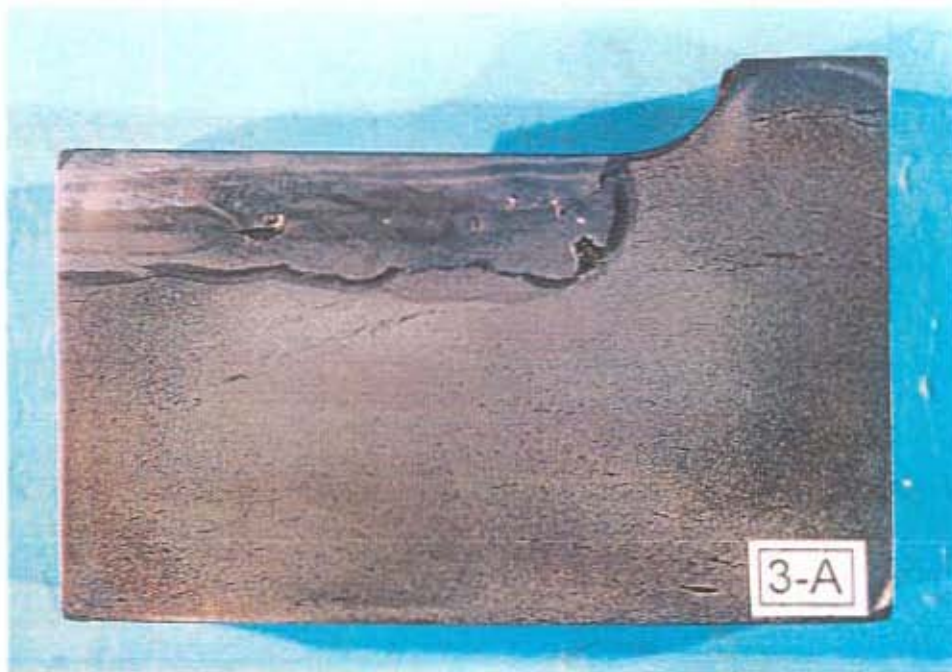
Figure 9 - Etched Cross-Sections of the Oilway Repair Weld at Keyway 2A and 3A Showing Multiple Weld Defects.
(1/00/5-2, 4/99/16-2)

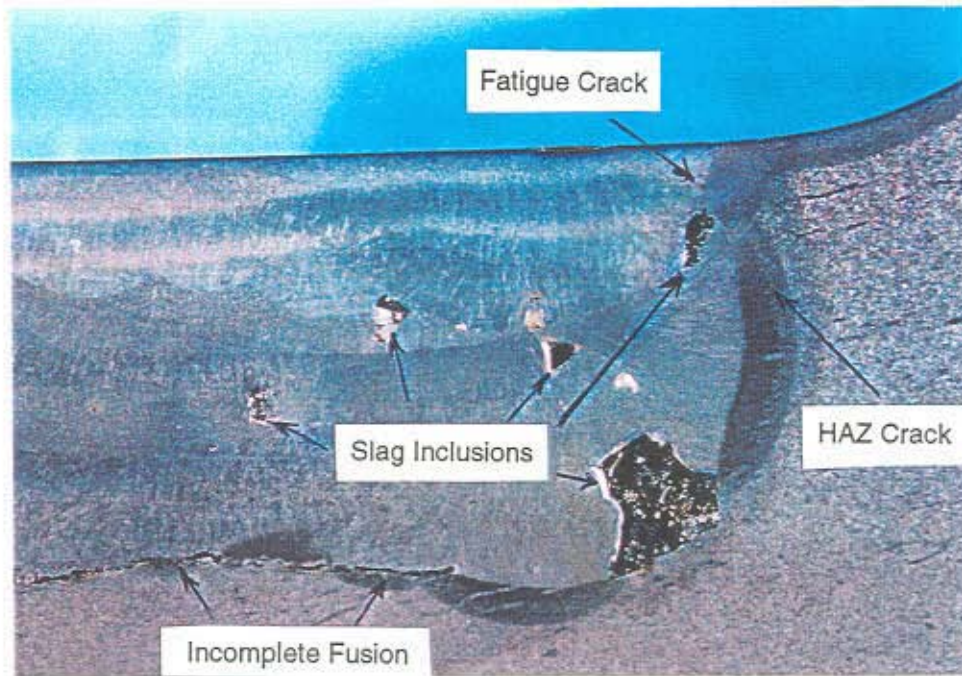
Figure 10 - Enlarged View of the Weld Defects at the Termination of the Oilway Groove Weld Showing Slag Inclusions, Incomplete Fusion and Cracks.
(4/99/16-8)

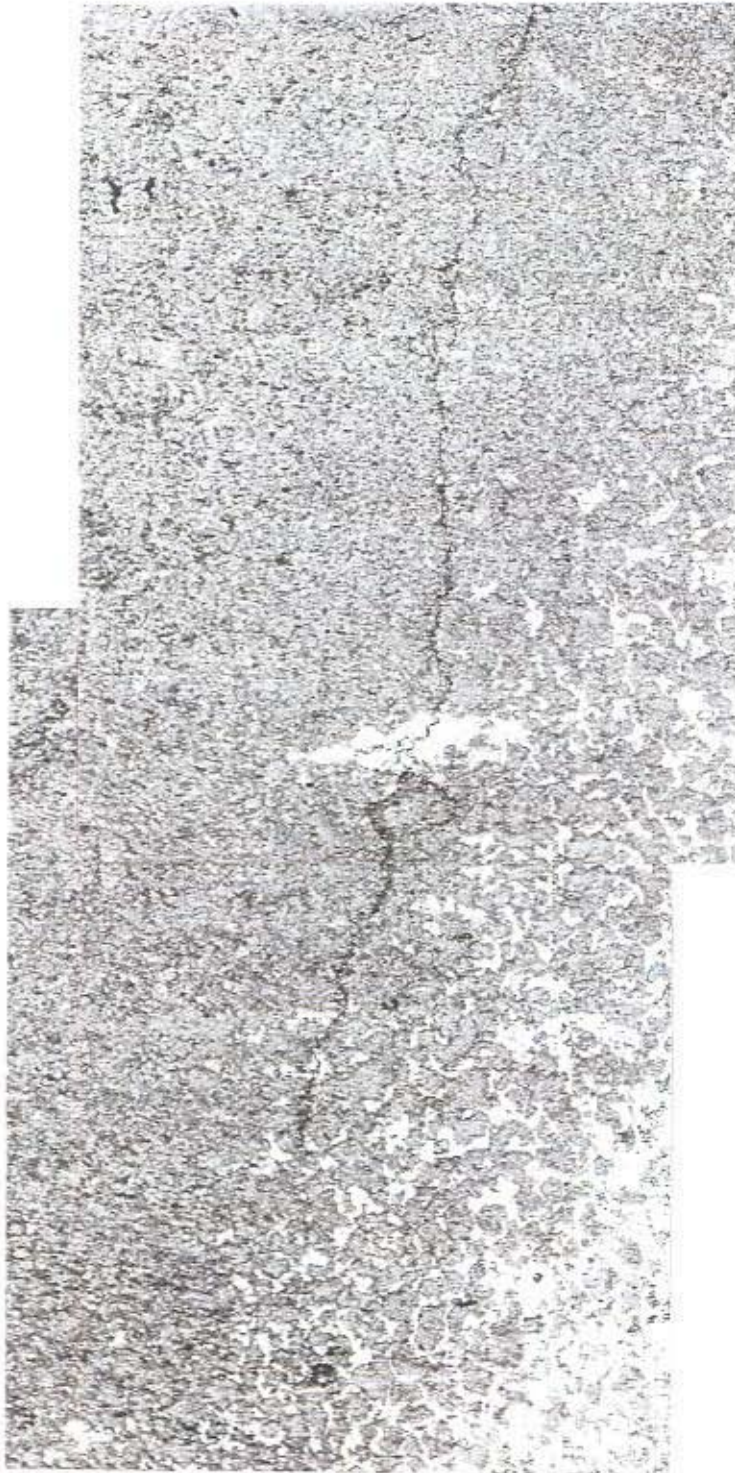
Figure 11 - Hydrogen Induced Crack Observed in the Weld HAZ at Keyway 3A.
[Mag. 100X]

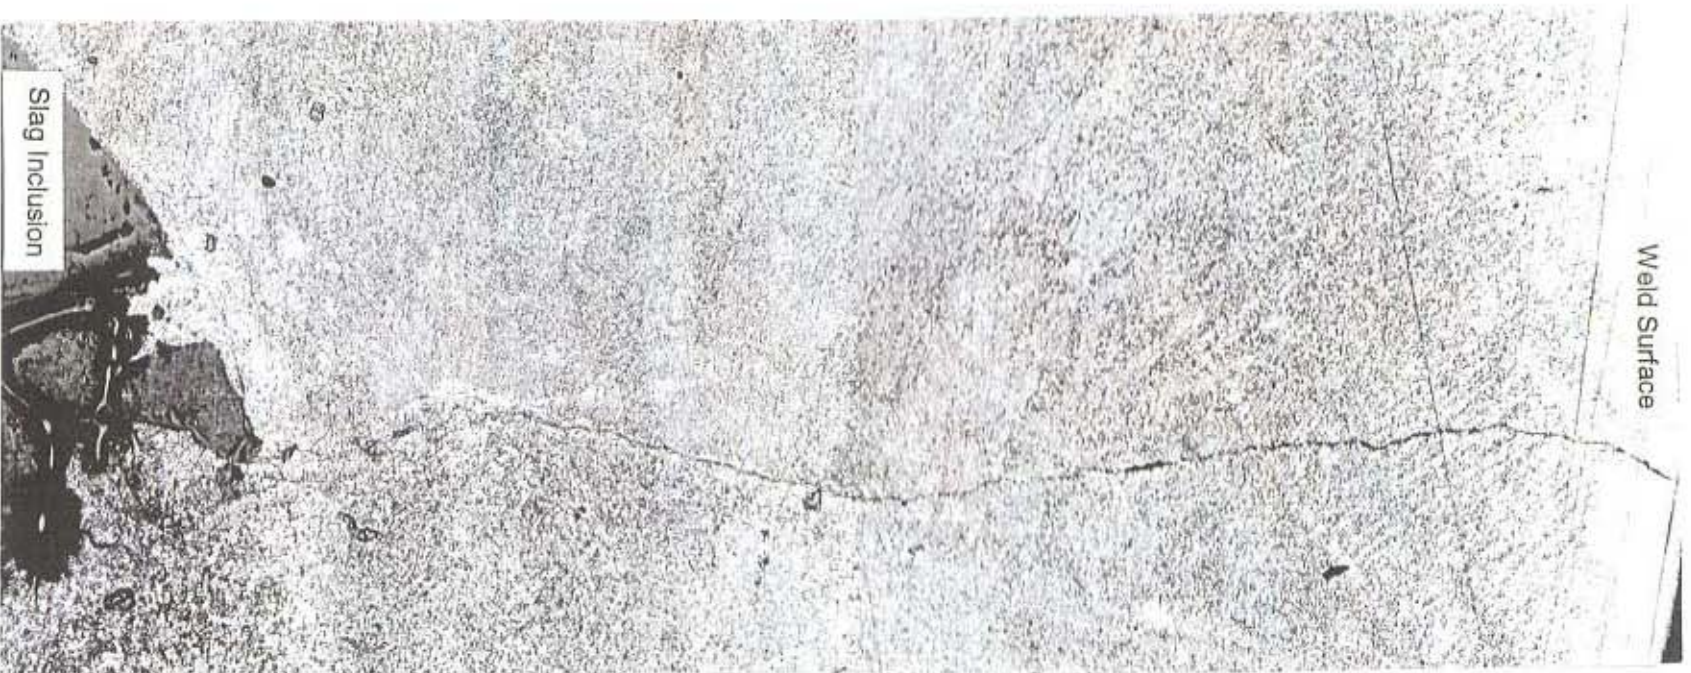
Figure 12 - Fatigue Crack Extension From a Near Surface Slag Inclusion Observed at Keyway 3A. [Mag. 100X]

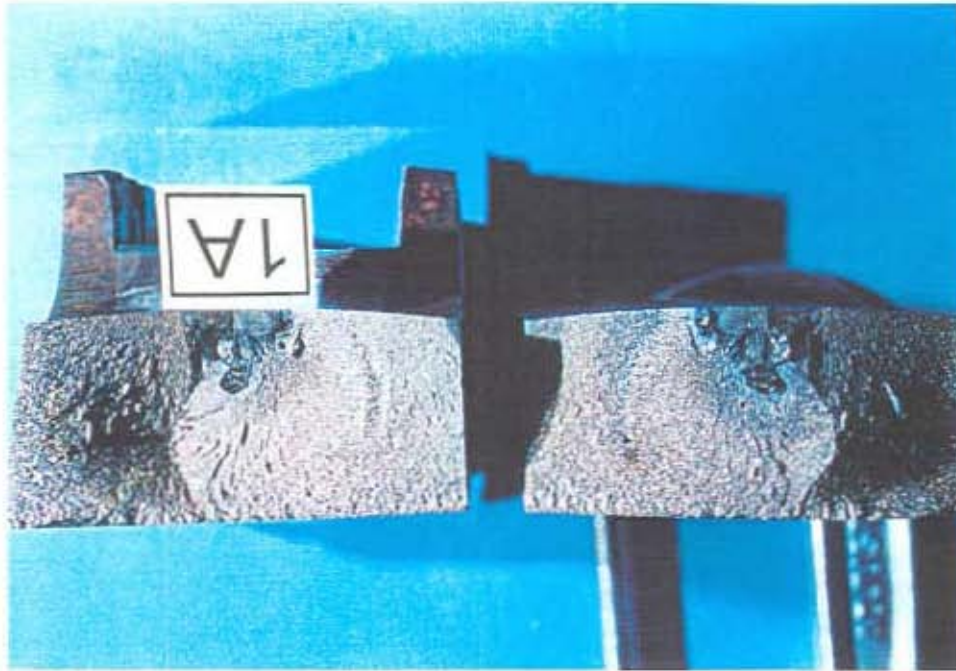
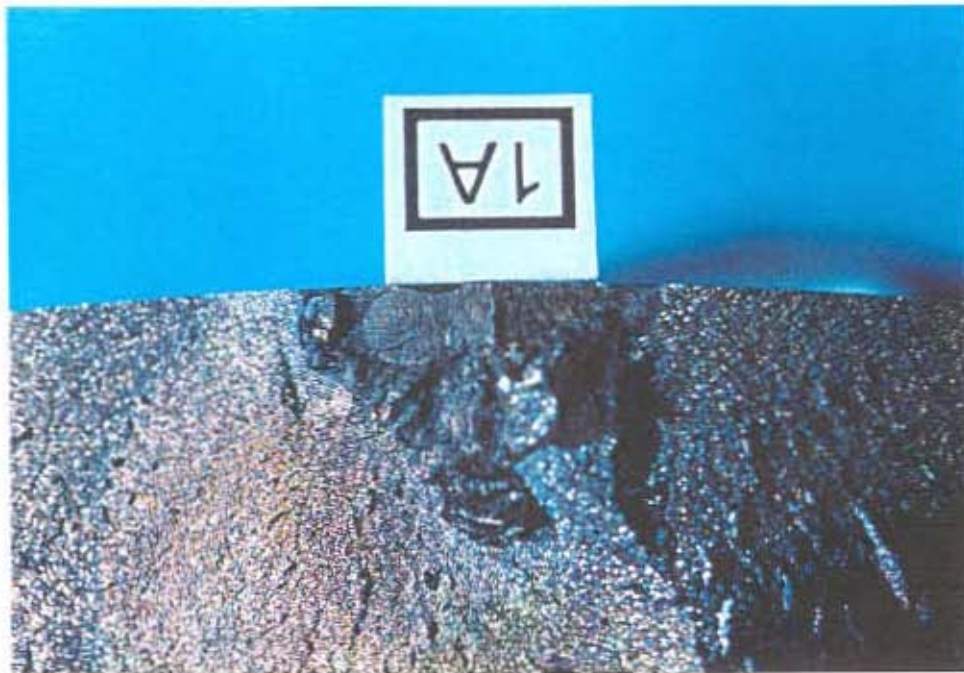
Figure 13 - Exposed Crack Surfaces of the Defect Detected In the Weld Repair at Keyway 1A.
(Top: 6/99/2-10, Bottom: 6/99/2-11)

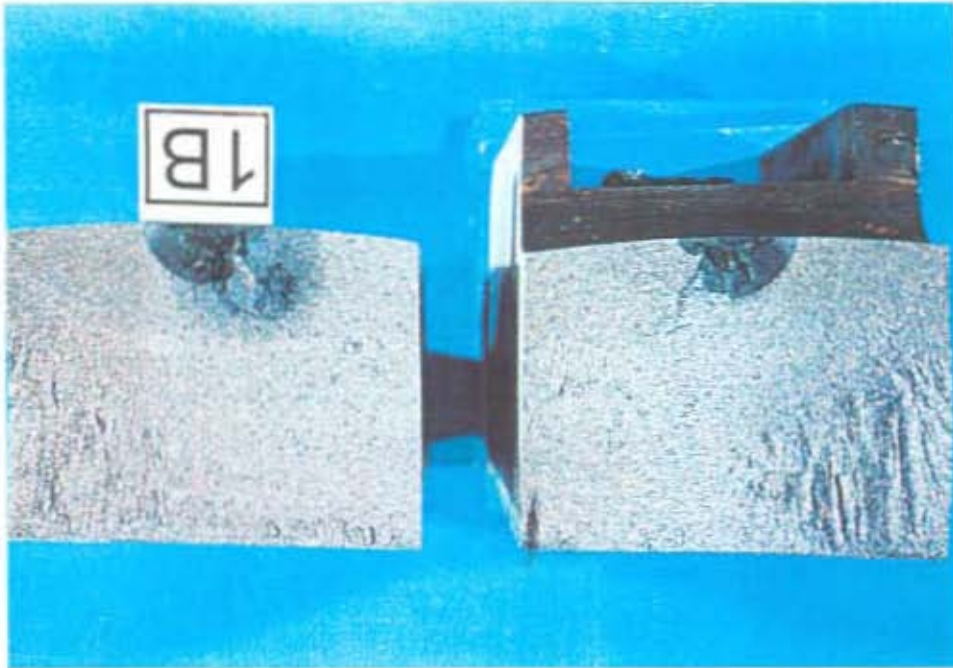
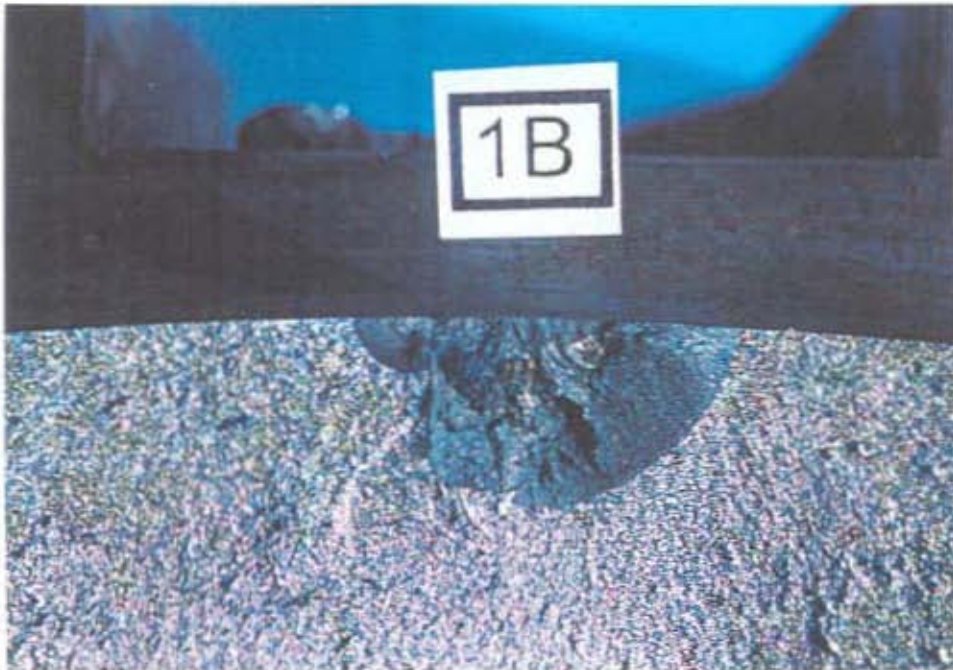
Figure 14 - Exposed Crack Surfaces of the Defect Detected in the Weld Repair at Keyway 1B.
(Top: 6/99/2-5, Bottom: 6/99/2-7)

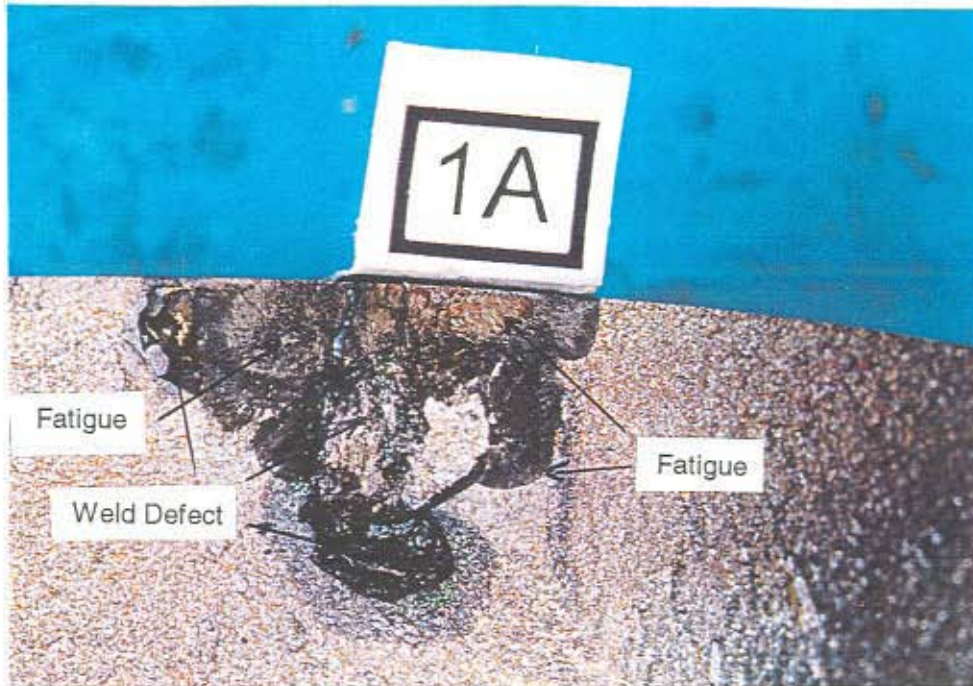
Figure 15 - Crack Surface From Keyway 1A After Ultrasonic Cleaning of the Surface.
Evidence of Fatigue Crack Extension is Seen in Several Areas.
(6/99/3-3)

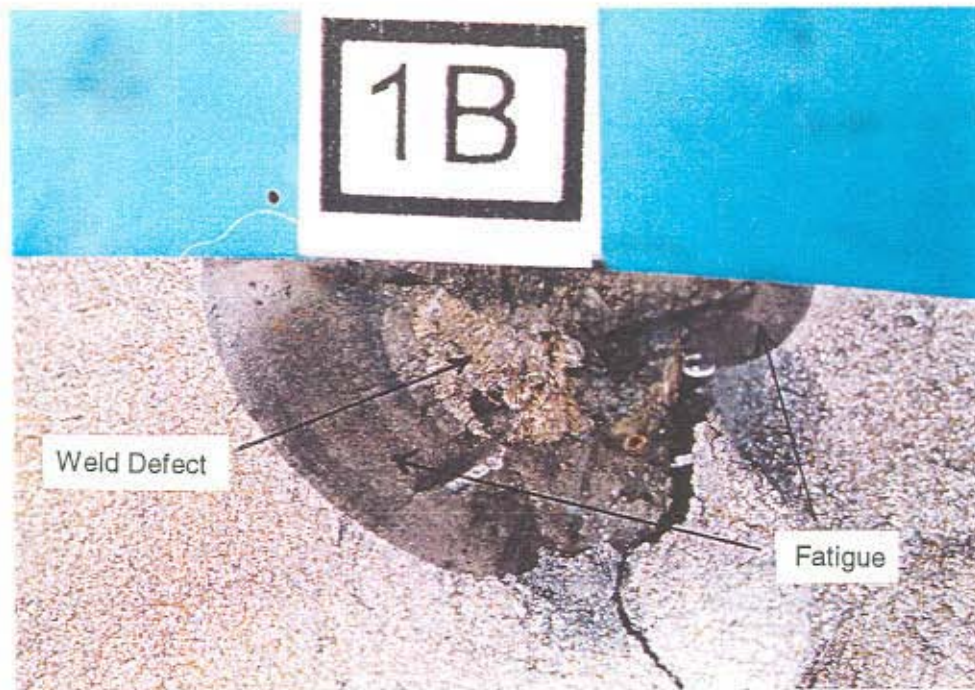
Figure 16 - Crack Surface From Keyway 1B After Ultrasonic Cleaning of the Surface.
Fatigue Crack Extension From an Initial Weld Defect is Clearly Evident.
(6/99/3-1)

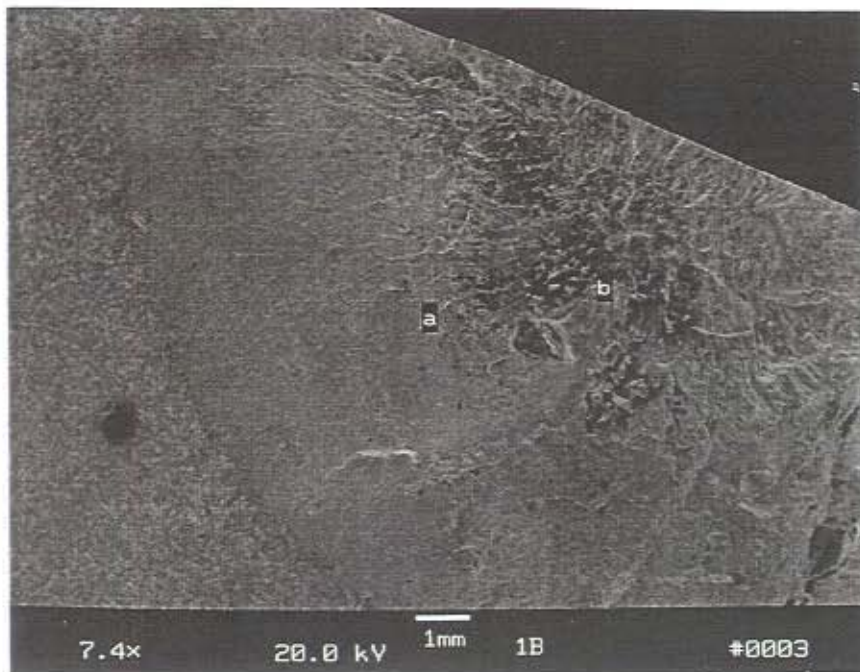
Figure 17 - SEM Micrograph of the Crack Surface of Defect 1B Showing the Initial Weld Defect and Fatigue Extension. [Mag. 7.4X]
