FITNESS FOR PURPOSE EVALUATION OF THE
COUNTERWEIGHT SHEAVE/TRUNNION ASSEMBLY
FOR
OREGON DEPARTMENT OF TRANSPORTATION

WJE NO. 1997.3010

June 2000

WISS, JANNEY, ELSTNER ASSOCIATES, INC.
330 Pfingsten Road
Northbrook, Illinois 60062-2095
(847) 272-7400

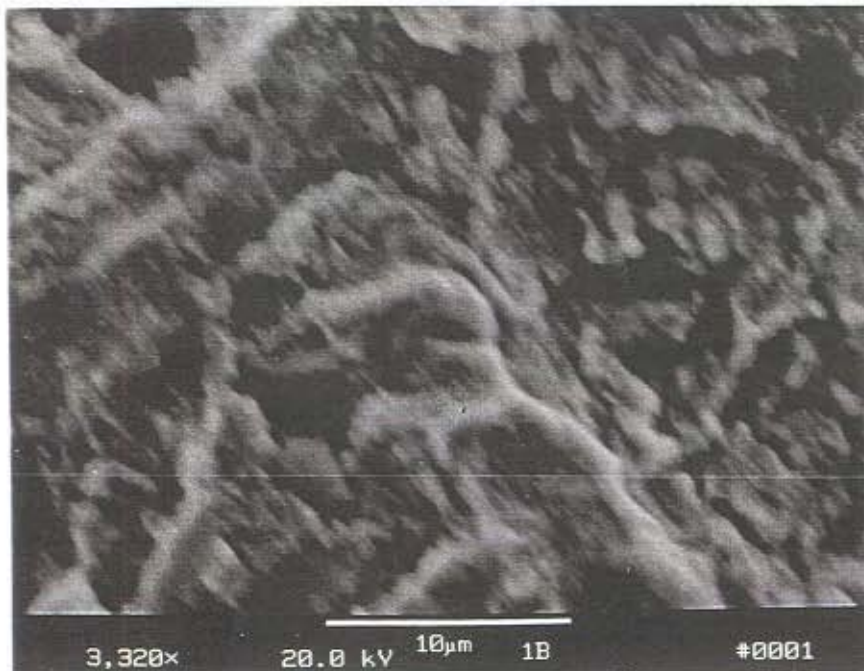
Figure 18 - High Magnification SEM Micrograph Showing Fatigue Striations in the Smooth Semi-elliptical Crack Growth Area (Area "a" in Figure 17).[Mag.3,320X]

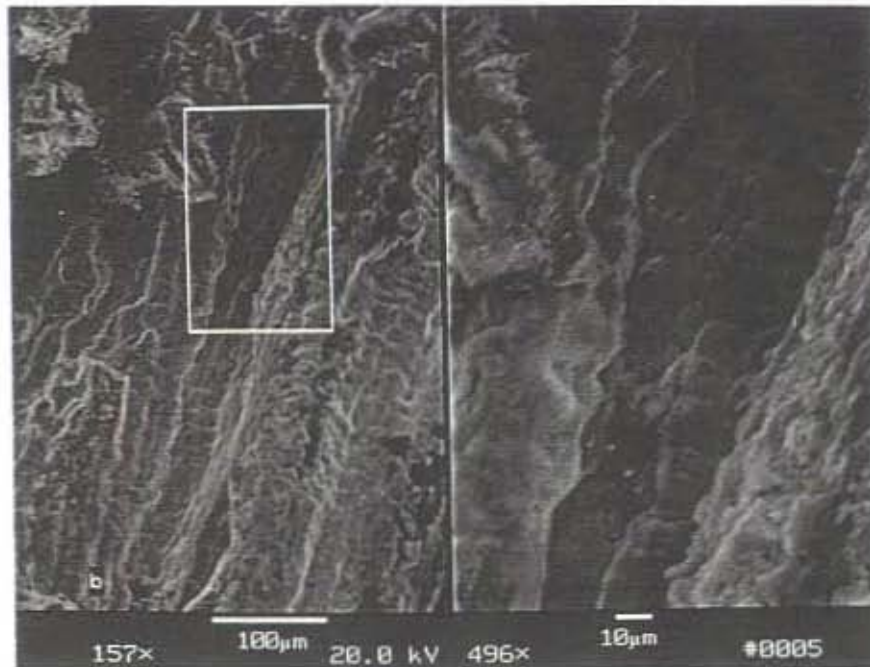
Figure 19 - Crack Surface of Defect 1B Obtained in the Initial Defect Region (Area "b" in Figure 17) Showing Solidification Structures Typical of Hot Cracking in Weld Metal. [Mag. 157X & 496X]

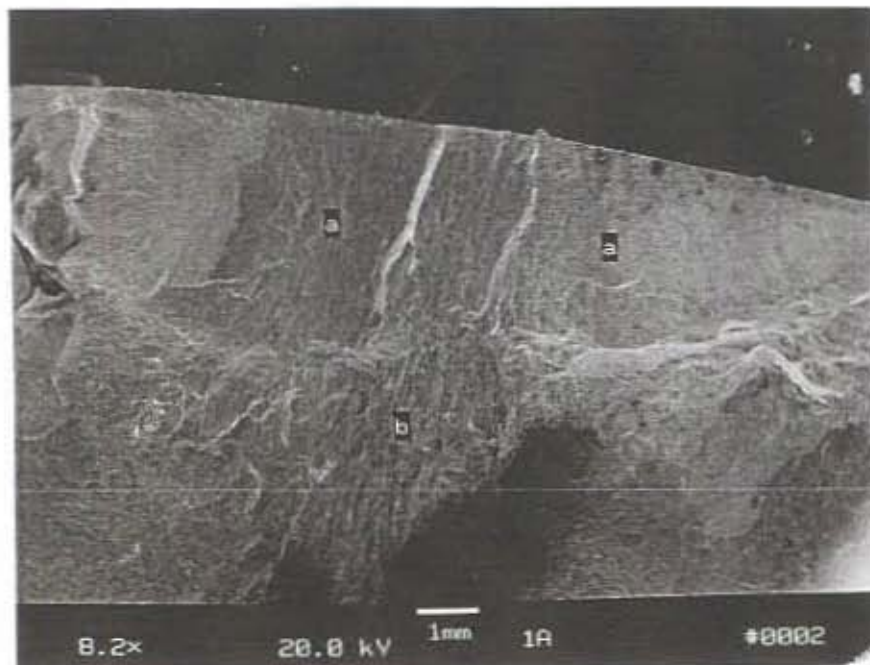
Figure 20 - Low Magnification SEM Micrograph of the Crack Surface of Defect 1A. Evidence of Thumbnail Fatigue Cracks (Areas "a") and Hot Cracking Were Observed (Area "b"). [Mag. 8.2X]

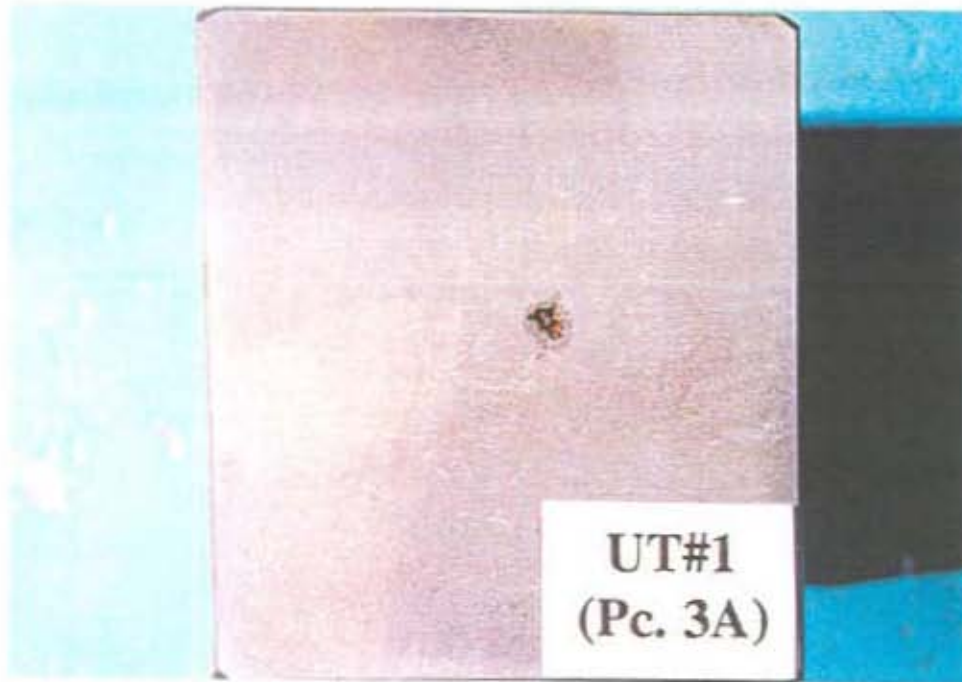
Figure 21 - Internal Trunnion Defect Detected By Ultrasonic Inspection (UT1).
(12/99/7-4)

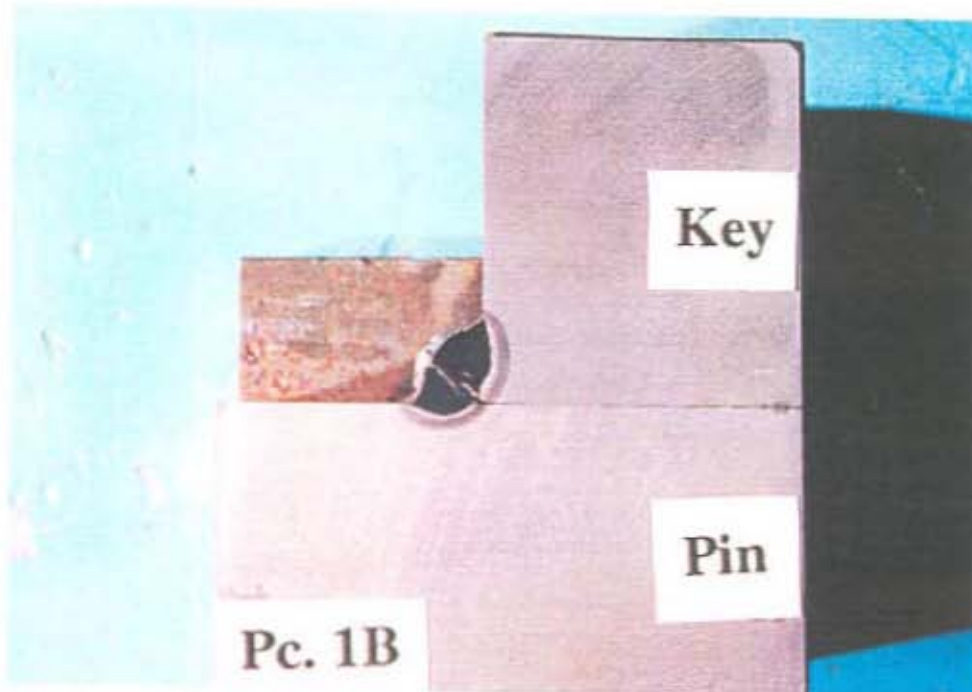
Figure 22 - Cross-section of Cracked Trunnion Key Retainer Fillet Weld (Keyway 1B).
(12/99/7-2)

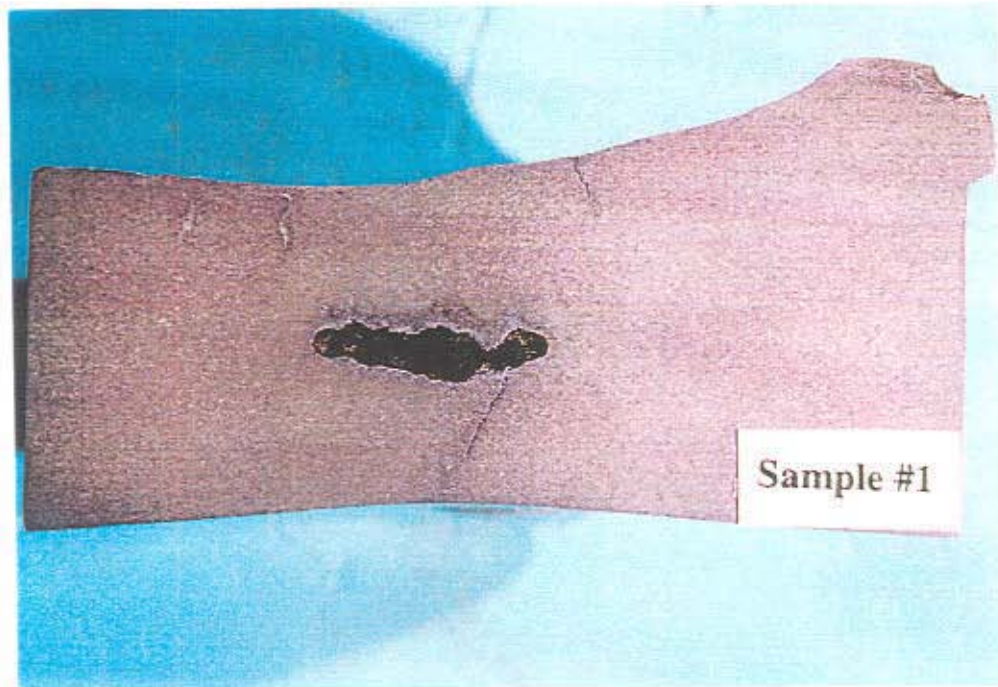
Figure 23 - Cross-Section Through Sheave Core Sample #1. A Large Shrinkage Cavity Is Seen at the Mid-Thickness With Surrounding Hot Tears.
(12/99/7-8)

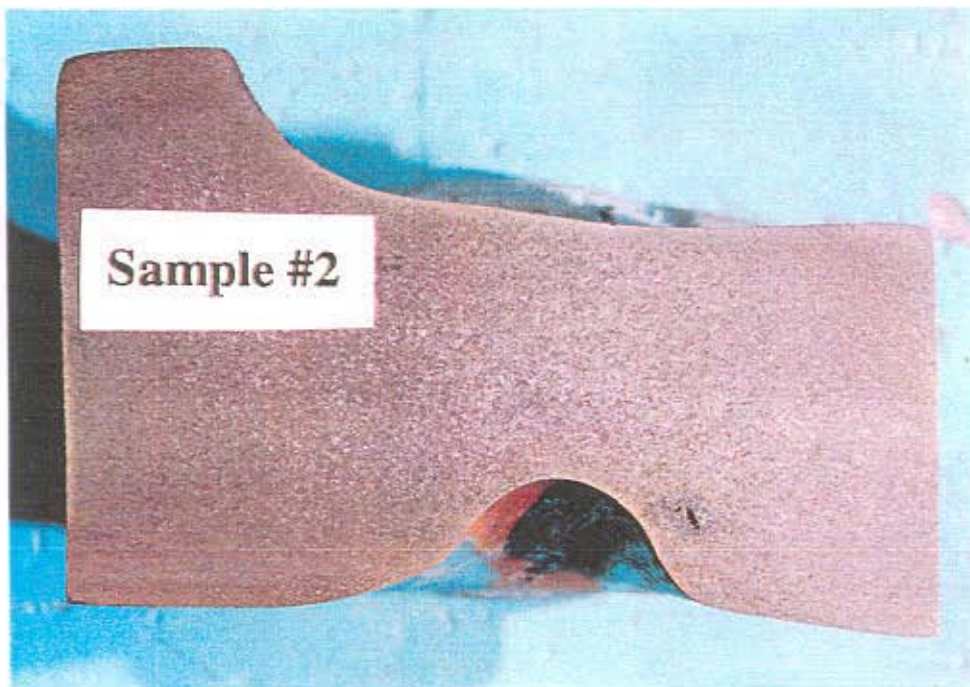
Figure 24 - Cross-Section Through Sheave Core Sample #2. No Primary Defect Was Remaining After Grinding the Surface. A Small Casting Void Is Seen Adjacent to the Ground Area.
(12/99/7-9)

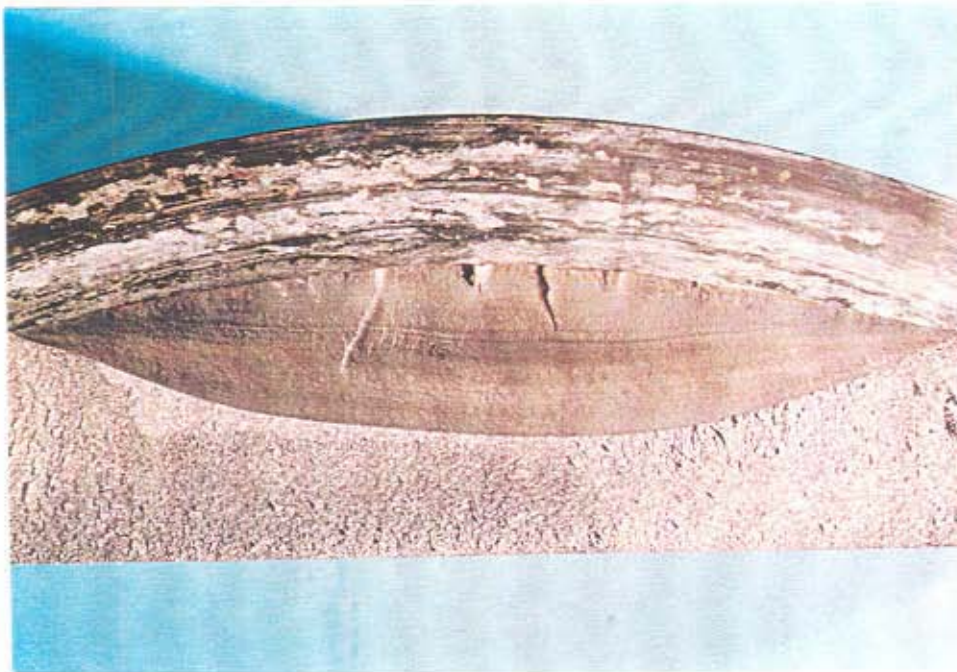
Figure 46 - Semi-elliptical fatigue crack extension from machined radius at trunnion shoulder
(City of Duluth, MN Lift Bridge)
(5/97/15-7)
