APPENDIX G

***Yaquina* Impact and Mitigation Analysis**

Date: 31 July 2012
To: **Columbia River Crossing (CRC) Project Team**
ATTN: Jay Lyman; David Evans and Associates
From: Ben Anderson, Naval Architect, P.E.
Subject: Columbia River Crossing Vessel Impact Analysis
Attachment: Ship Visit: USACE Hopper Dredge YAQUINA

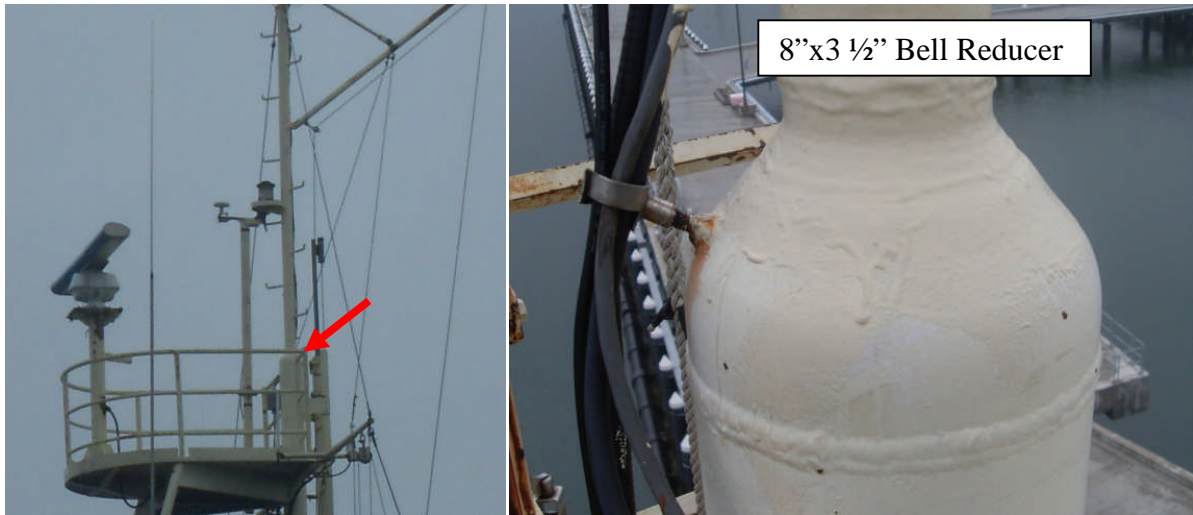
After meeting with the Captain(s) of the vessel, the Second Mate showed me around the ship and guided me through the safety procedures to climb the main mast. Relevant information passed to me with regards to the mast included information about a past failure at the 8"x3 1/2" reducer located just above the Crow's Nest. The cause of failure was reported to be due to excessive shaking caused by ship slamming. This failure was reported and repaired several years ago and there have been no problems since repairs.

Figure 2: Point of past mast failure due to excessive vibrations.

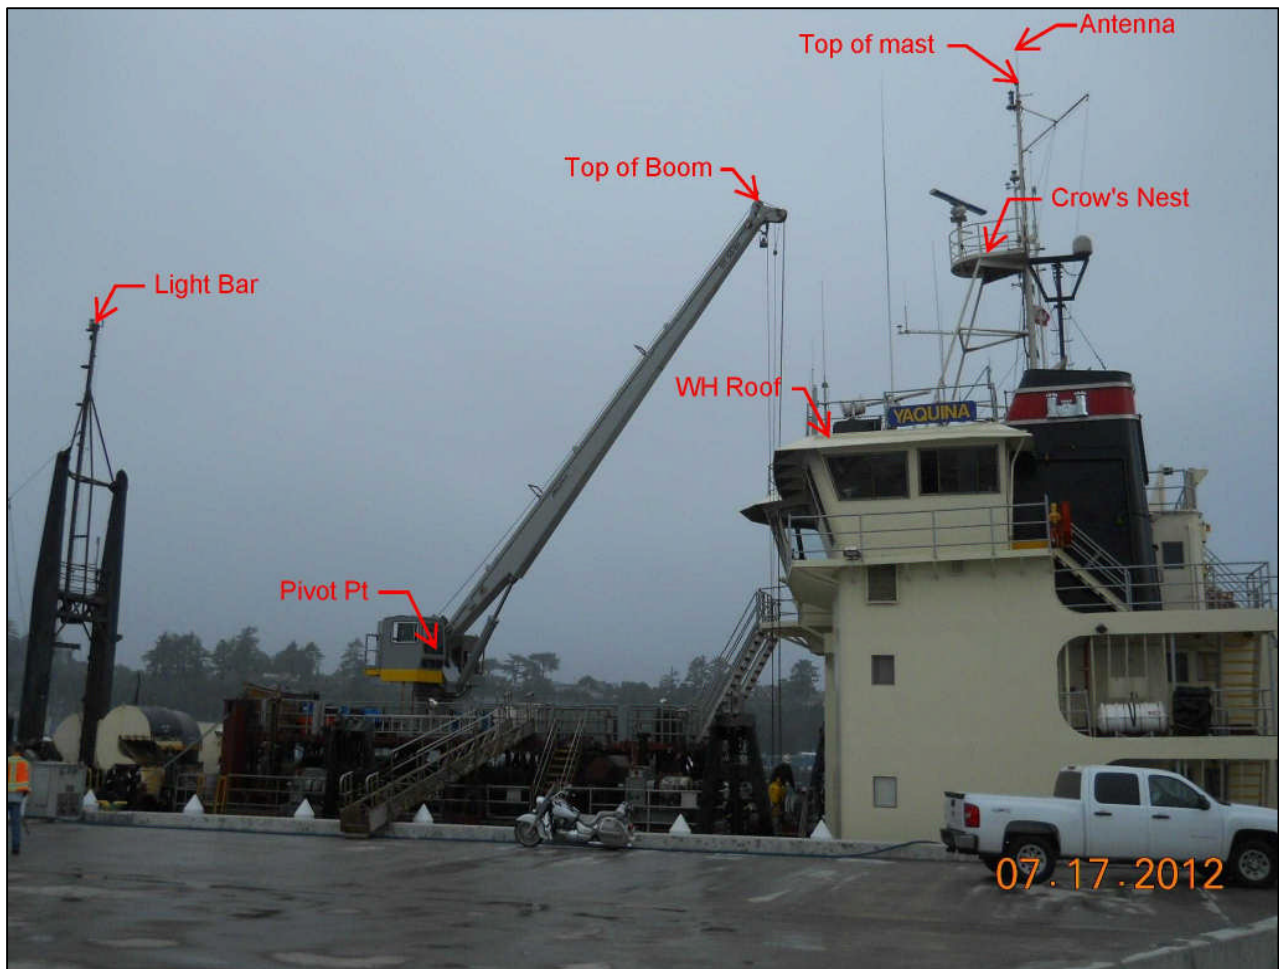
Figure 3: Survey points on YAQUINA.

The crane boom was surveyed but not considered due to its ability to be cradled at a low height above water. From the above table and below figure it is assumed for this report everything located above the Crow's Nest will either have to be permanently relocated or temporarily moved during passing under the proposed new I-5 Bridge.

In order for YAQUINA to pass under the new I-5 Bridge at high river level, with a 10' air gap, the mast would need to be no greater than 69' above water (at a given draft of 12.5' fwd, 12' mid, and 11.5' aft; assumed operating drafts for transit).

Assuming normal operating drafts, everything one foot higher than the existing Crow's Nest platform would need to be removable, hinged, or removed/repositioned all together. The recommended modifications are listed below:

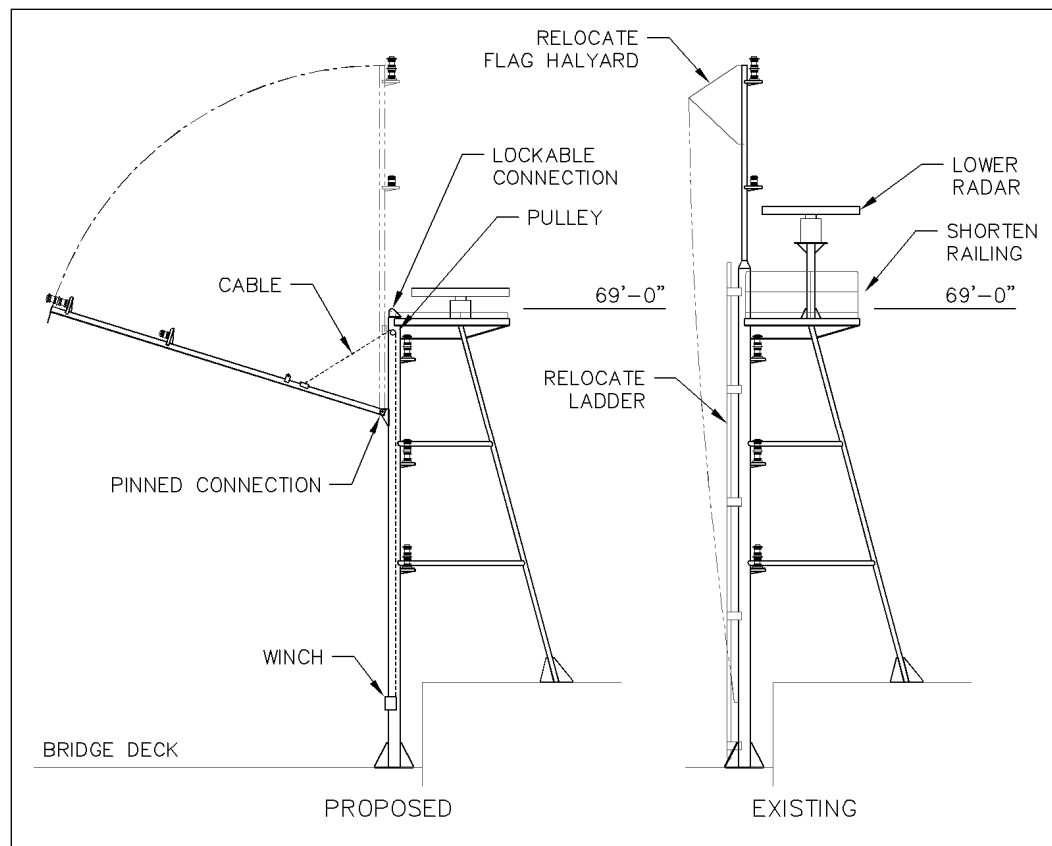
Figure 6: Sketch of proposed YAQUINA modification.

The radar was left on the Crow's Nest platform due to operational needs. It will be approximately 1' above the required air draft of 69', making the bridge clearance at high river level 9' rather than 10'. Moving the radar to a lower position on a new pedestal is feasible, but the cons include a decreased radar visibility (mast, stacks, and Pilothouse) and a higher frequency of shutting down the radar due to crew members going aloft.

The proposed modification above enables the ship owner to lower and raise the upper portion of the mast by means of a manual (or electric) winch located on the Pilothouse upper deck. The height of the mast, when winched in the upright position, could be approximately 3.5' lower than existing while meeting USCG navigational requirements. This will help reduce the weight of the pinned mast. The upper mast weight can also be decreased due to the reduced strength requirement since it no longer needs to be climbable. Before, the mast had ladder rungs for crew to climb up for maintenance/installation needs. The new pinned mast can now be lowered for all maintenance/installation needs. The locking connection at the Crow's Nest platform level can be dampened to help mitigate vibration effects. Adjustable mast stays can also be installed as determined by calculations.

The ladder and safety cable will be moved off center to the starboard side. This will allow the mast to lie firmly against the existing 8" mast base. The flag halyard and gaff pipe will need a new foundation coming off of the 8" mast, with its highest point near the Crow's Nest platform. Lights and associated foundations shall be positioned to meet USCG guidelines. Wind bird and GPS

antenna can be positioned on the yard arm. Electric cables will need to be adjusted to account for the pinned connection. It is possible to contact the USCG to ask for permission to deviate from the USCG navigation light position requirements. If this is pursued, several additional options could be explored. However, all would entail cutting the existing mast and modifying the radar height.
