Replacement Bridge BRT Impacts and Mitigation Hayden Island Offset

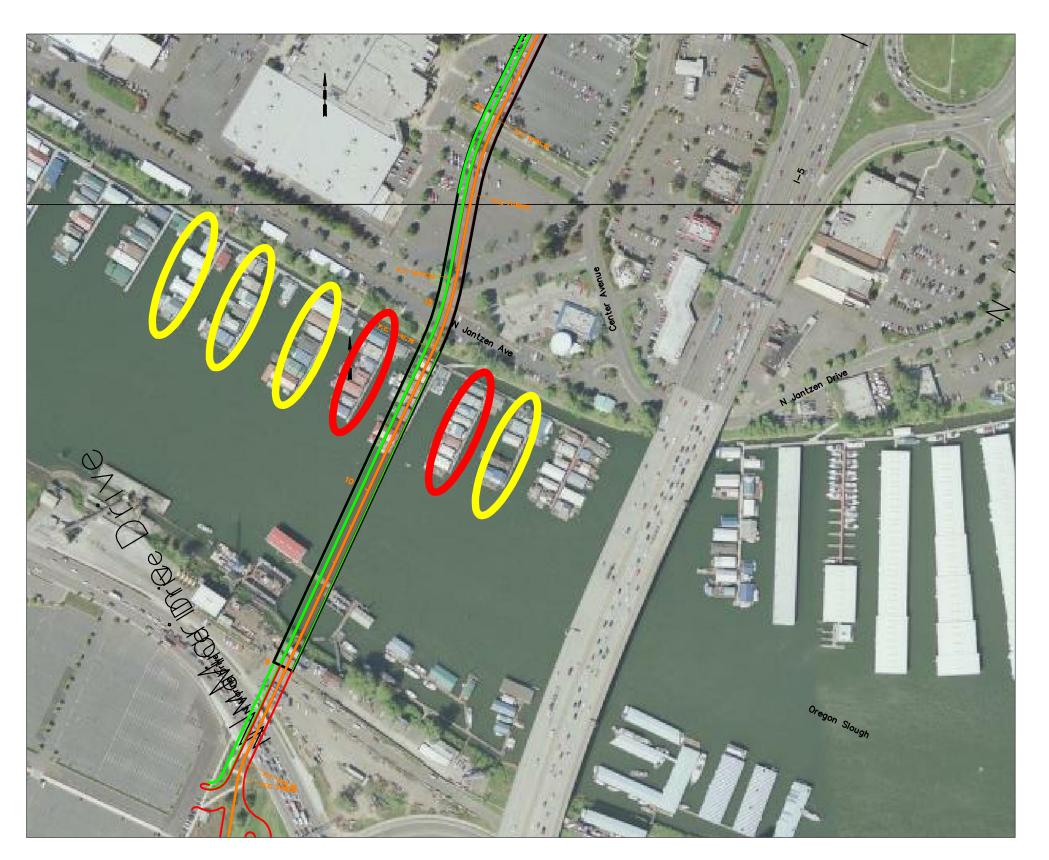
- 14 BRT severe noise impacts red circles
- 28 BRT noise impacts yellow circles

<sup>8</sup> to 12 foot noise walls for diesel buses. The noise walls would be able to mitgate all noise impacts.

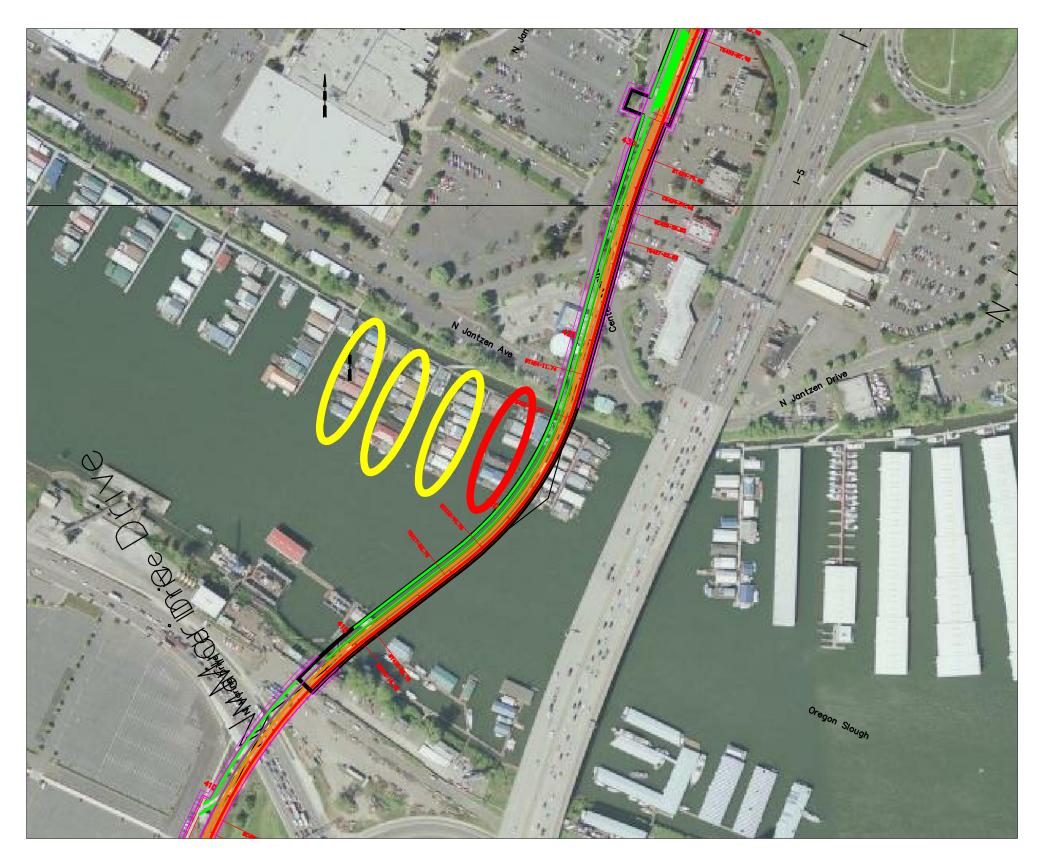
Replacement Bridge BRT Impacts and Mitigation Hayden Island Adjacent

- 7 BRT severe noise impacts red circles
- 28 BRT noise impacts yellow circles

• 8 to 12 foot noise walls for diesel buses

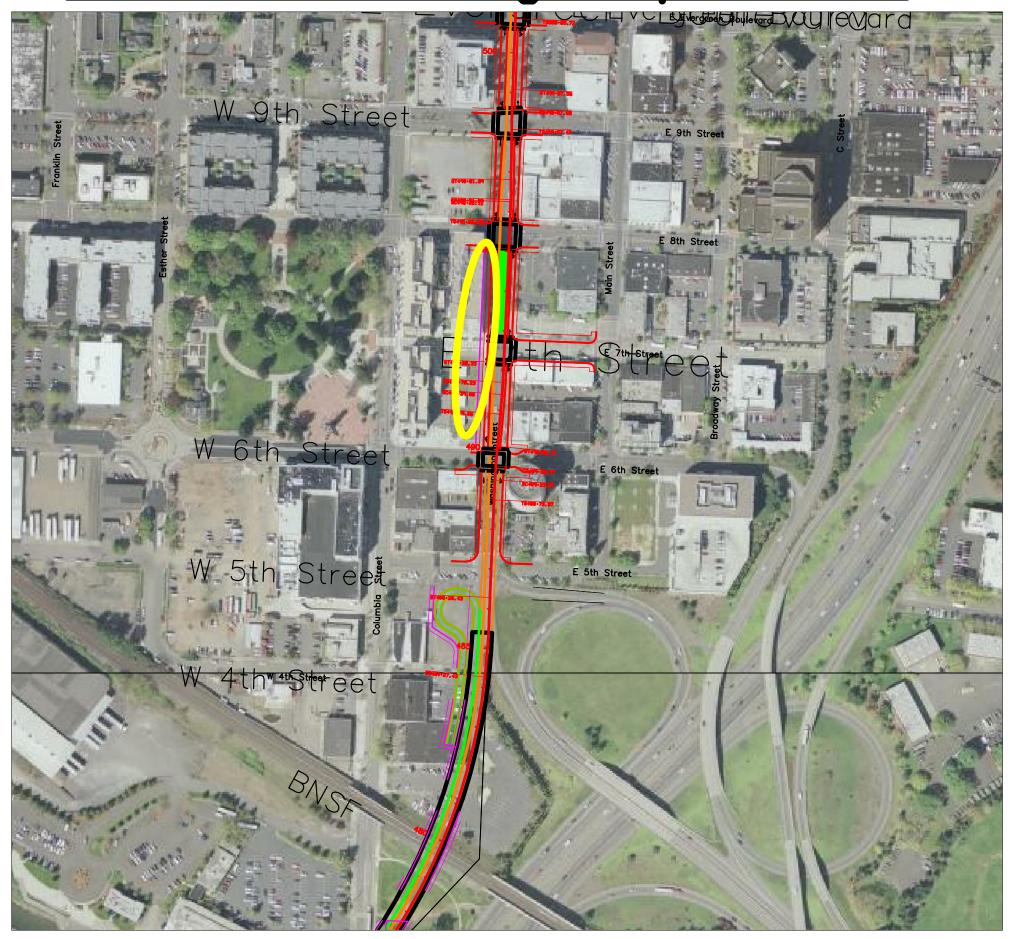
BRT Impacts and Mitigation Washing ton Downtown

50 impacts along the apartment 3rd and 4th floor facing Washgington

None - noise levels in the units are within HUD standards.

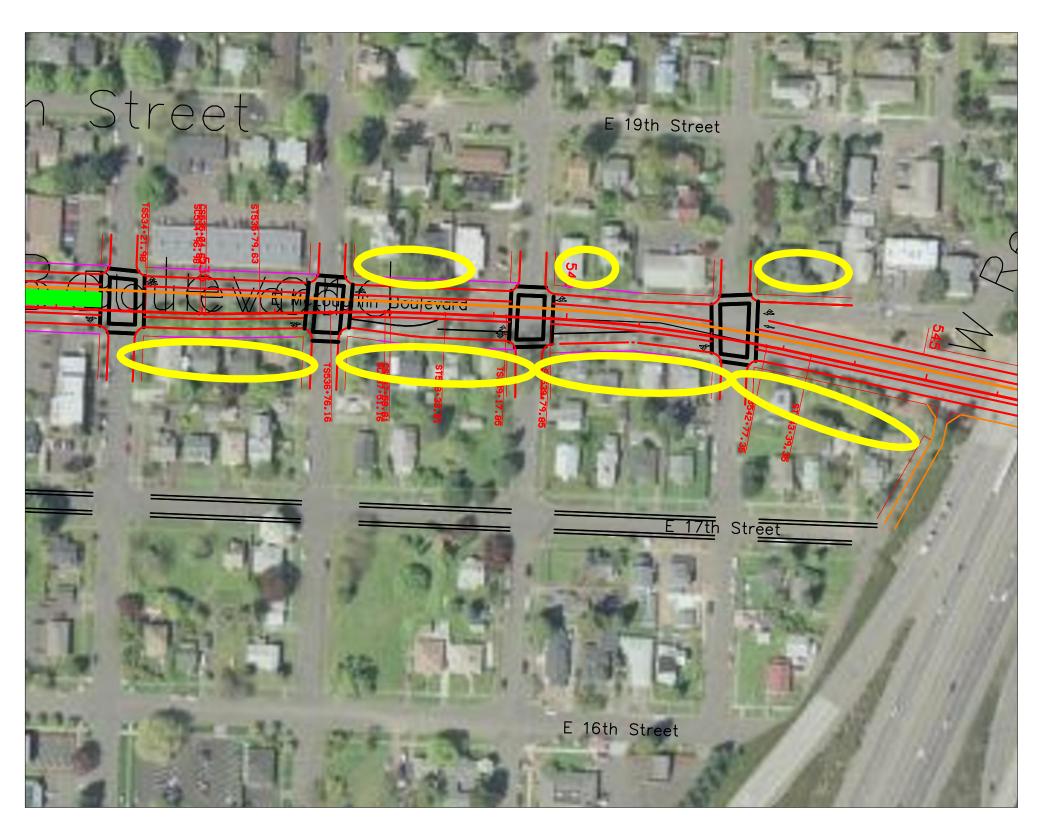
BRT Impacts and Mitigation McLoughlin Boulevard

• 22 noise impacts On McLoughlin

Sound insulation to within HUD standards.

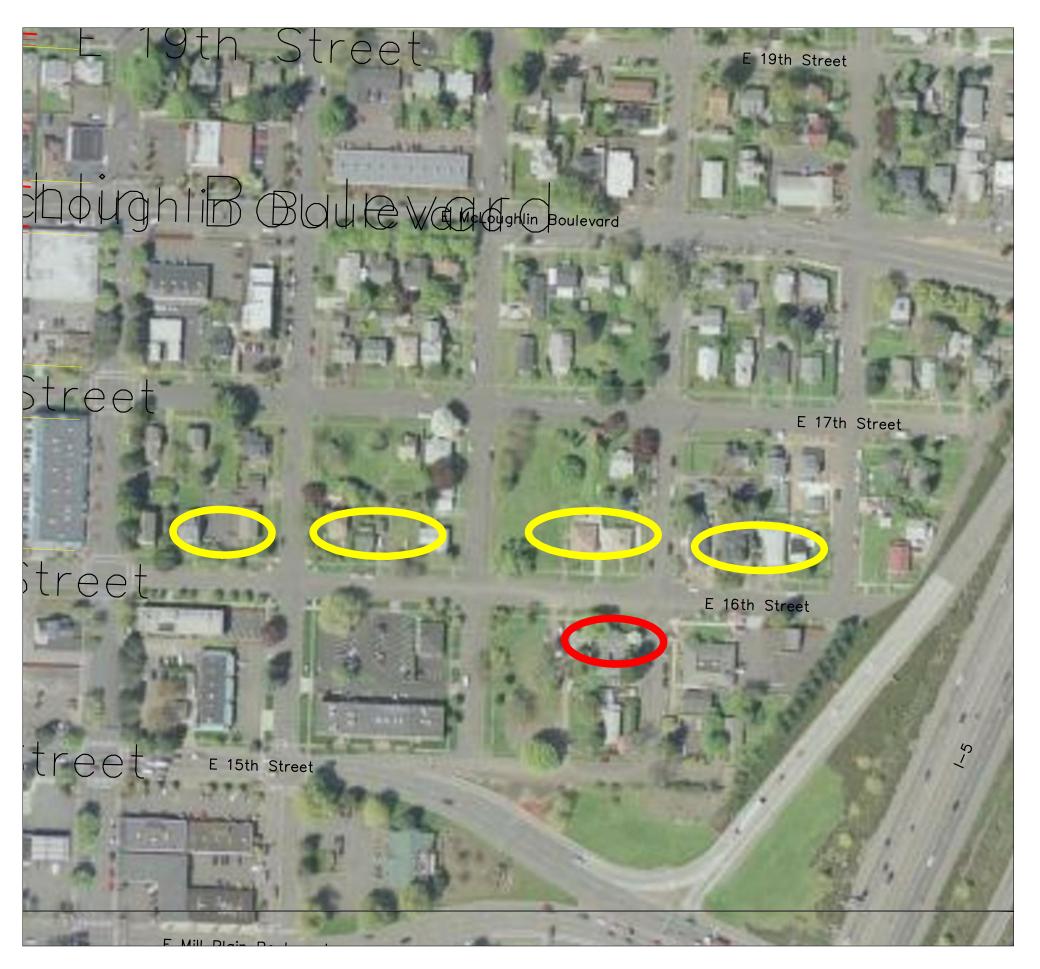
BRT Impacts and Mitigation 16th Street Alignment

- 11 noise impacts Broadway yellow circle
- 5 server noise impacts red circle
- Mitigate using sound insulation program to wihtin HUD standards.

Note, if the analysis is perfored assuming I-5 noise mitigation, the impacts remain the same serverity

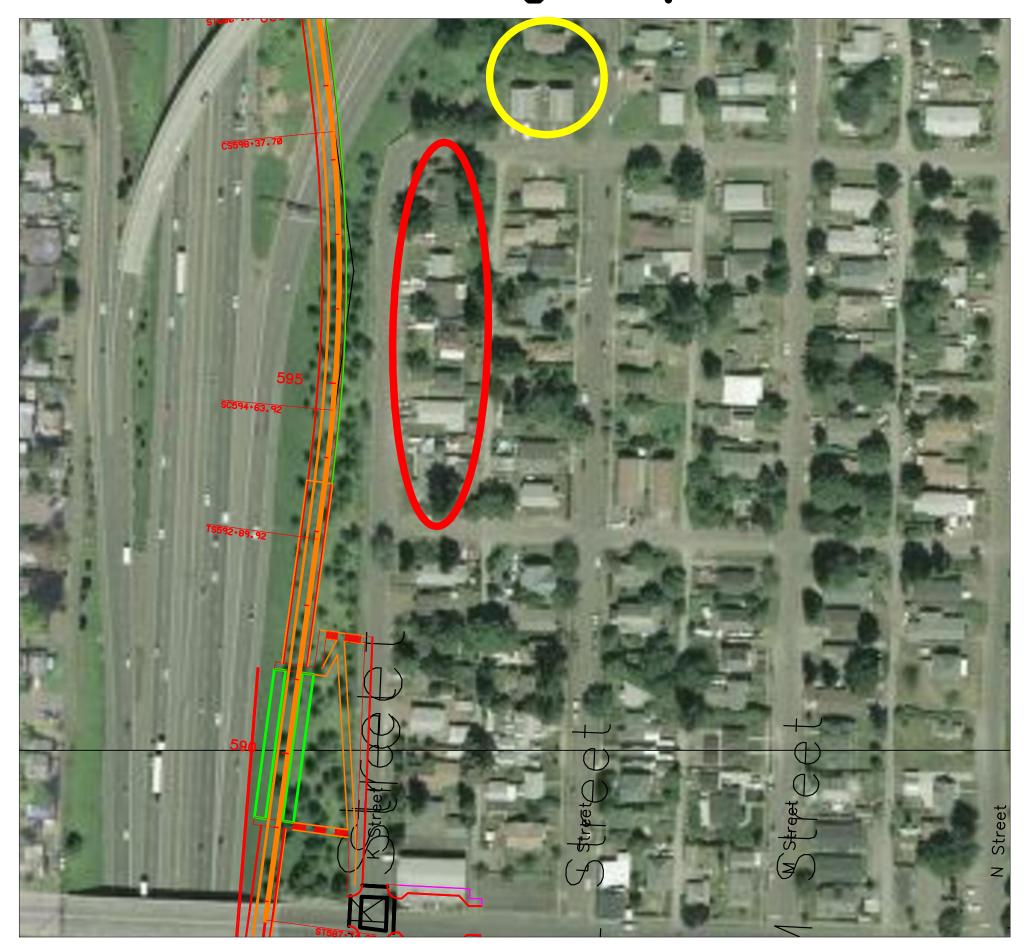
BRT Impacts and Mitigation

- 12 severe noise impacts along I-5 red circles
- 3 noise impacts along I-5

Impacts due to flyover bus acceleration at 6% grade

Note: if the analysis is preformed with the I-5 noise mitigation considered, all 15 impacts are server

Sound walls on the structure - 8 to 12 feet.

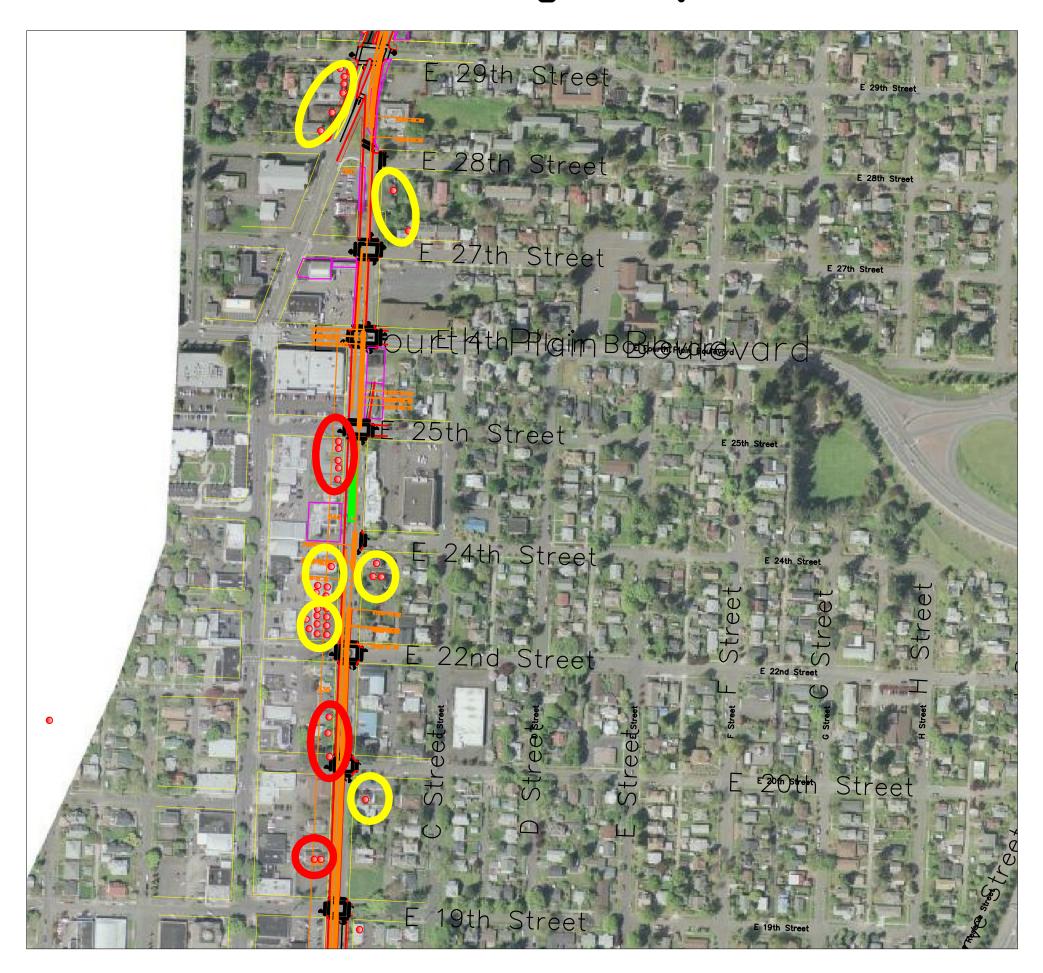
BRT Impacts and Mitigation Broadway 2-way

- 10 severe noise impacts Broadway red circles
- 29 noise impacts along Broadway
- Mitigate using sound insulation program to wihtin HUD standards.

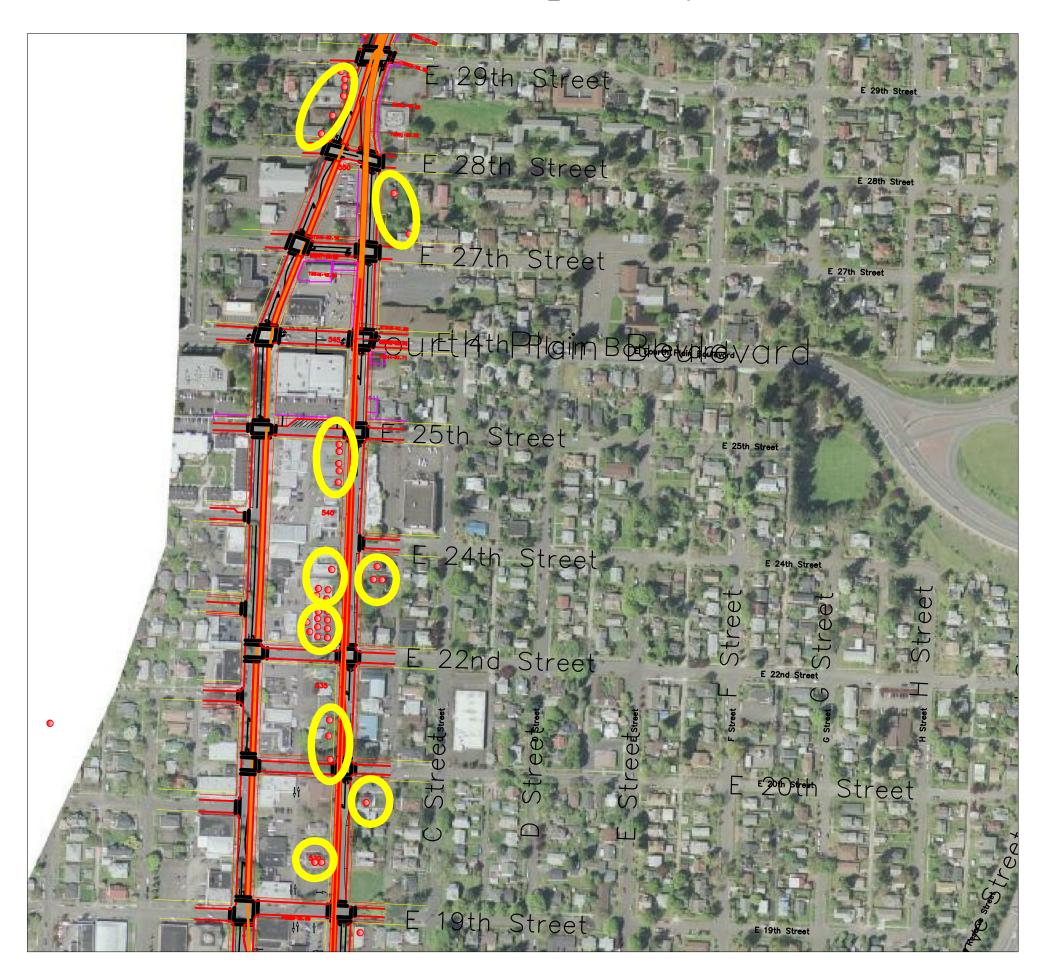
BRT Impacts and Mitigation Broadway Couplet

• 39 noise impacts along Broadway

Mitigate using sound insulation program to wihtin HUD standards.

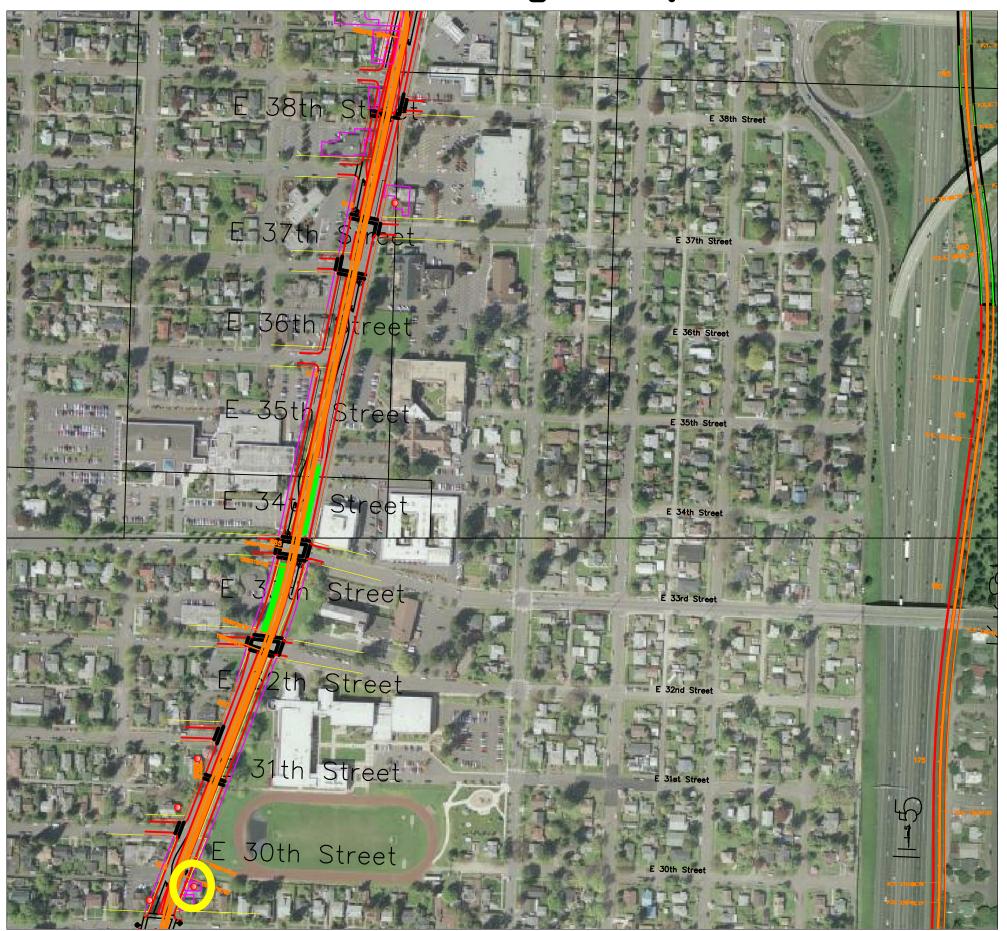
BRT Impacts and Mitigation Main North of 29th

• 1 noise impacts Broadway - yellow circle

Mitigate using sound insulation program to wihtin HUD standards.
