FITNESS FOR PURPOSE EVALUATION OF THE
COUNTERWEIGHT SHEAVE/TRUNNION ASSEMBLY
FOR
OREGON DEPARTMENT OF TRANSPORTATION

WJE NO. 1997.3010

June 2000

WISS, JANNEY, ELSTNER ASSOCIATES, INC.
330 Pfingsten Road
Northbrook, Illinois 60062-2095
(847) 272-7400

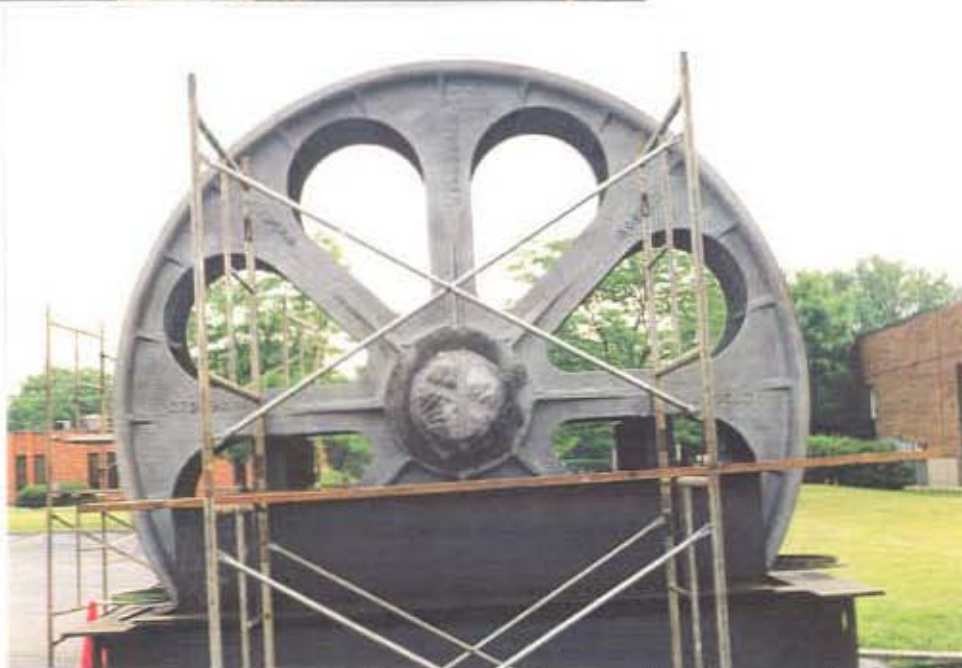
Fig. 2.2 – Sheave/trunnion assembly after sandblasting

Grease was cleaned from the assembly upon its arrival in Northbrook. A containment enclosure was erected around the assembly to capture lead-based paint during sandblasting operations. The sheave was subsequently sandblasted to white metal as shown in Fig. 2.2. The trunnion and sheave key fillet welds were protected during the sandblasting. The sandblast waste was disposed in a licensed special waste landfill.

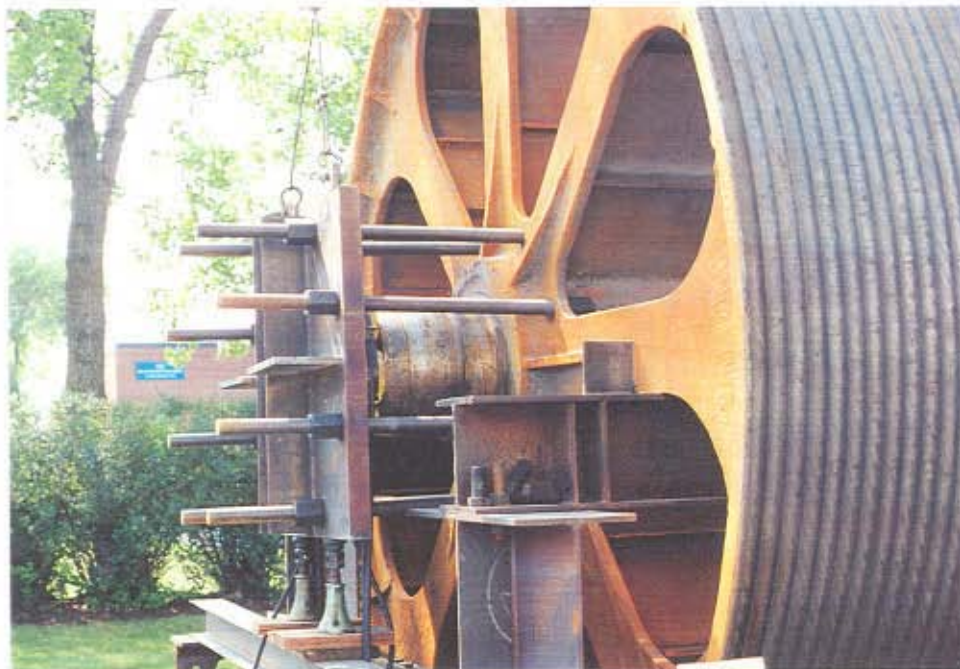
Fig. 2.4 – Jacking system used to remove trunnion intact

During lift span mechanical rehabilitation projects, trunnions are occasionally removed from the sheave by hydraulic jacking or a jacking press. However, if high jacking forces in excess of 600 kips do not result in displacement, trunnions are typically removed by destructive methods. Because the trunnion in this project was to be removed intact, a removal plan was implemented which involved pushing the tapered trunnion from the sheave wheel without damaging it. After several unsuccessful attempts to push the trunnion from the sheave using jacking forces up to 600 kips, a high capacity jacking system was designed, fabricated and subsequently used to move the trunnion. The jacking system is shown in Fig. 2.4. Jacking forces in excess of 1,000 kips were applied to finally initiate movement.

As the trunnion was pushed from the sheave, the large trunnion shoulder became wedged within the sheave wheel. Slots were cut in the sheave wheel at the center hub and rim so that jacks could be inserted into the rim slots to pry open the hub. Using several jacking operations, the undamaged trunnion was pushed all the way through the sheave wheel and removed.

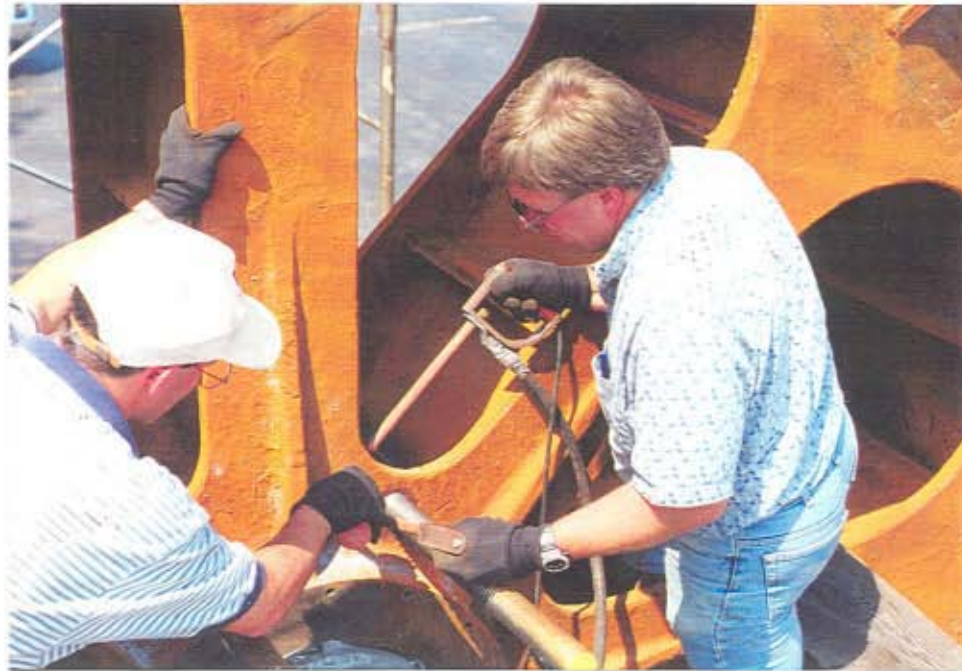
Fig. 3.1 – Magnetic particle testing of sheave spokes using prods

The sheave was inspected using both direct and indirect methods of magnetization. An alternating current yoke was used where access would permit or where necessary to achieve the appropriate magnetic field. Alternating current prods with a magnetizing current maintained at 75 to 100 amps per inch were utilized in portions of the sheave where the sheave geometry impeded application of the appropriate magnetic field when using the yoke. Application of the prods is shown in Fig. 3.1. Magnetic particle test areas were overlapped to assure sufficient inspection coverage and to mitigate possible masking of discontinuities due to over-saturation of the magnetic field.

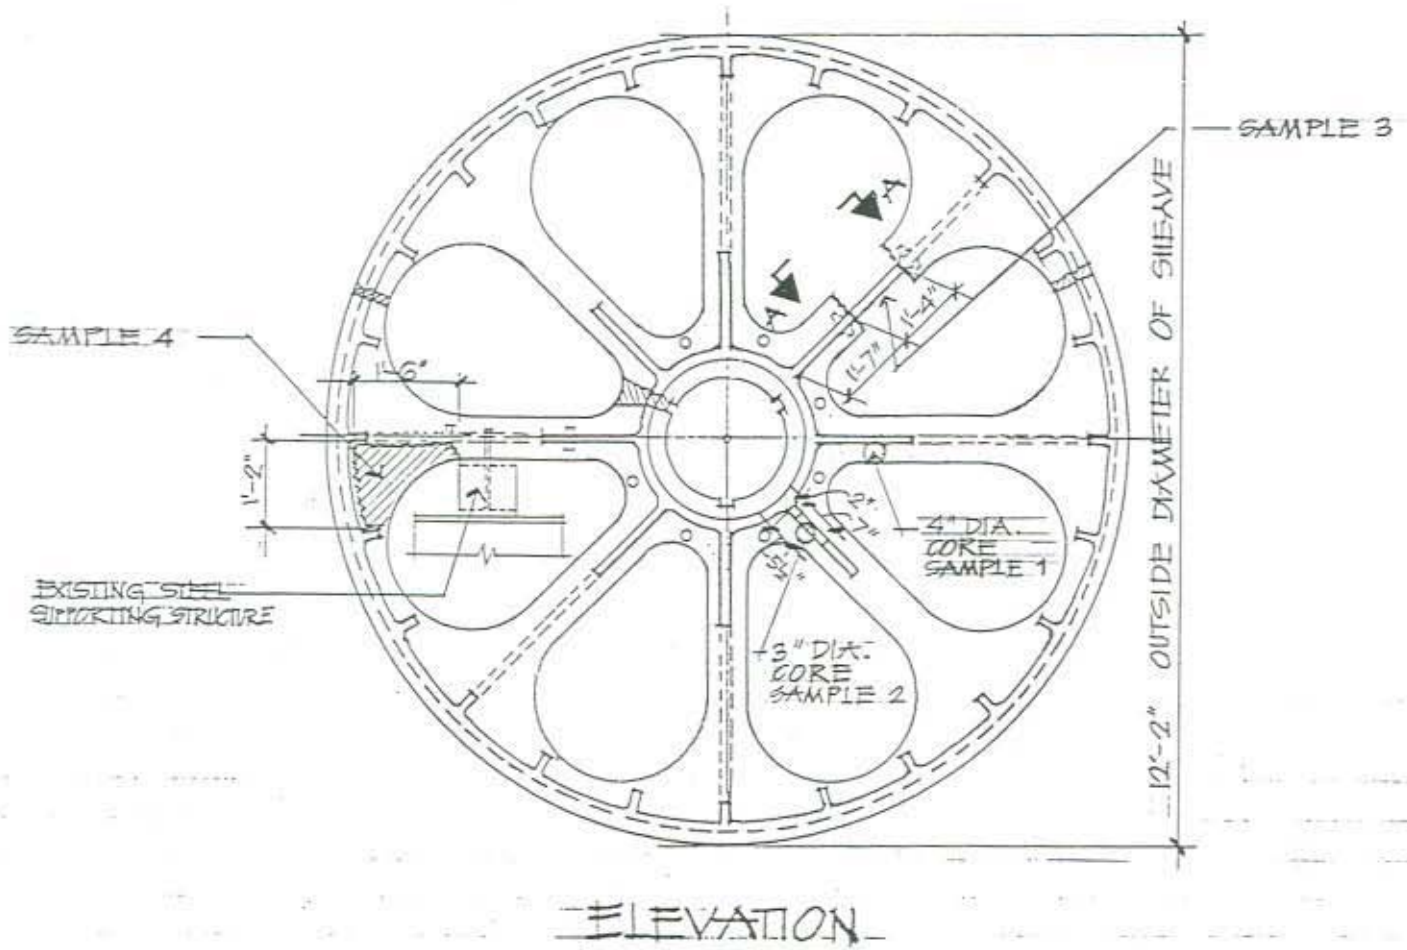
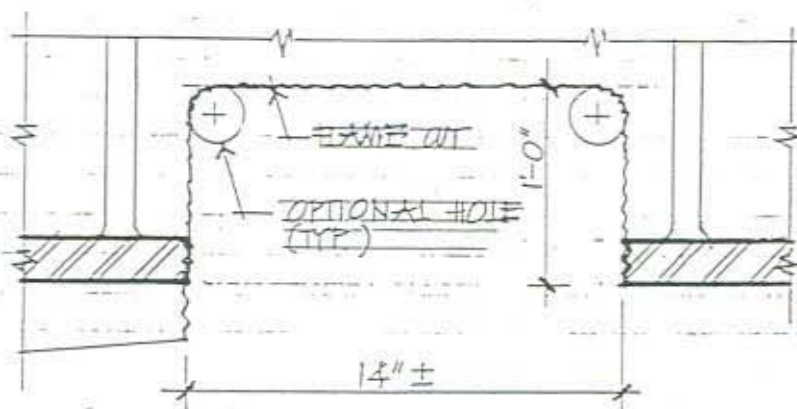
Fig. 3.3 – Sheave sample locations

oriented. Two of the deeper cracks located in high stress regions were removed by coring for fractographic examination. Figure 3.2 shows one of these cracks shown highlighted by magnetized particles in the sheave spoke. In addition, two large steel samples were cut from the sheave wheel for material and chemical testing. Figure 3.3 identifies the sheave sample locations.

<u>SAMPLE NO.</u>	<u>DESCRIPTION</u>
1	4" DIA. CORE CONTAINING CRACK
2	3" DIA. CORE WITH GROUND CRACK
3	SPOKE & WEB PLATE SAMPLE FOR MATERIAL TESTING
4	SPOKE / RIM SAMPLE FOR MATERIAL TESTING

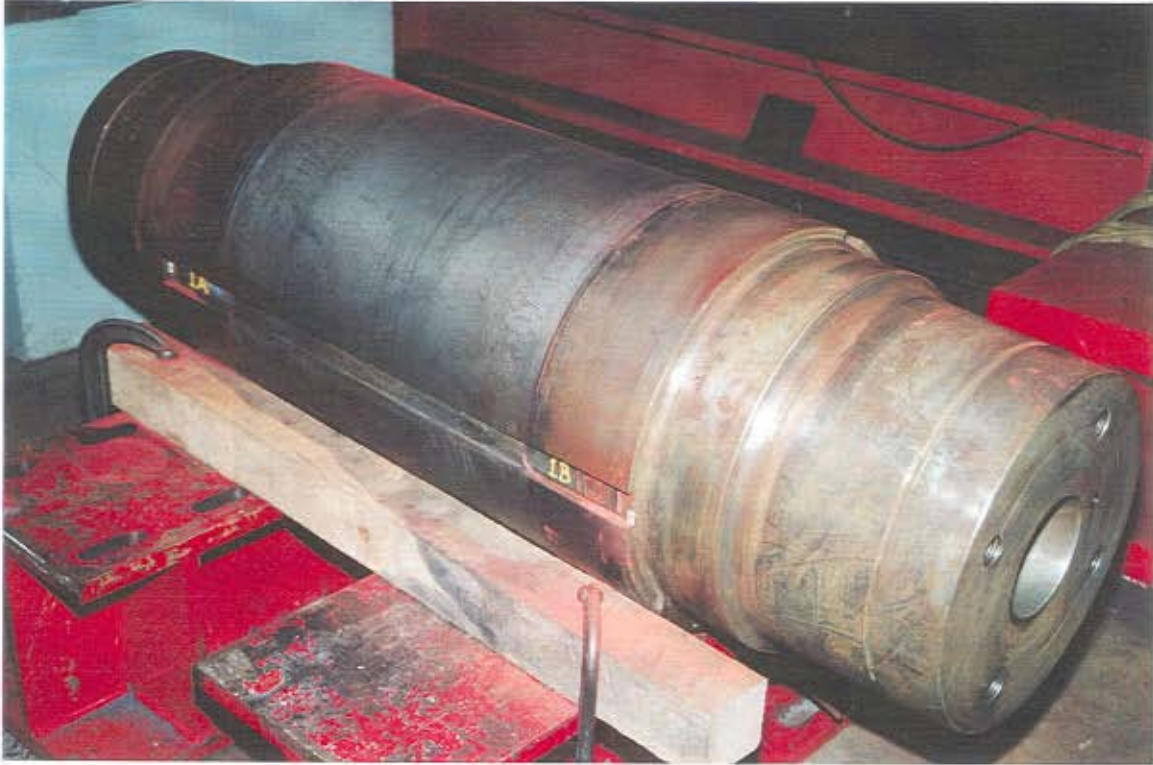
Fig. 3.4 – Trunnion after removal from sheave and prepared for NDE

Inspection of the exterior surfaces at the trunnion ends detected cracks that apparently originated in the oilway groove weld filler metal. The cracks were not detected with axial or center bore ultrasonic scans, however some could be detected using shallow surface scans with a shear wave probe. Most of these cracks required magnetic particle examination for detection as shown in Figs. 3.5a and 3.5b. Indications often appeared to follow weld metal fusion lines, were frequently oriented transverse to the axis of the trunnion, and sometimes extended into adjacent base metal. The cracks detected at weld metal filled oilways were not associated with previously detected ultrasonic indications identified during previous UT work. However, the axial location appears to be approximately one inch from the 13 in. axial location indicated in many of the acoustic emission tests. The inability to detect the oilway cracks with scans from the trunnion center bore or end surfaces may be primarily attributed to the poor fusion of the weld filler metal, which establishes an acoustic interface that impedes or reflects the propagation of the interrogating wave.

Two types of defect indications were identified in the trunnion as a result of the in-depth NDE work. The first defect type was either a surface crack-like discontinuity or sub-surface discontinuity at a welded oilway. The second defect was an internal discontinuity in the vicinity of the inner bore. Both types of defects were selected for additional examination. A summary of the defect indications is provided in Table 3.1. Ultrasonic data sheets locating these defects are found in Appendix A.

All of the surface or sub-surface discontinuities detected both by MT and UT methods were located near keyways where modifications to fill oilways with weld metal had been performed during the 1960 retrofit work. Surface defects were identified by MT at keyways 1A, 3A, and 1B. Sub-surface crack-

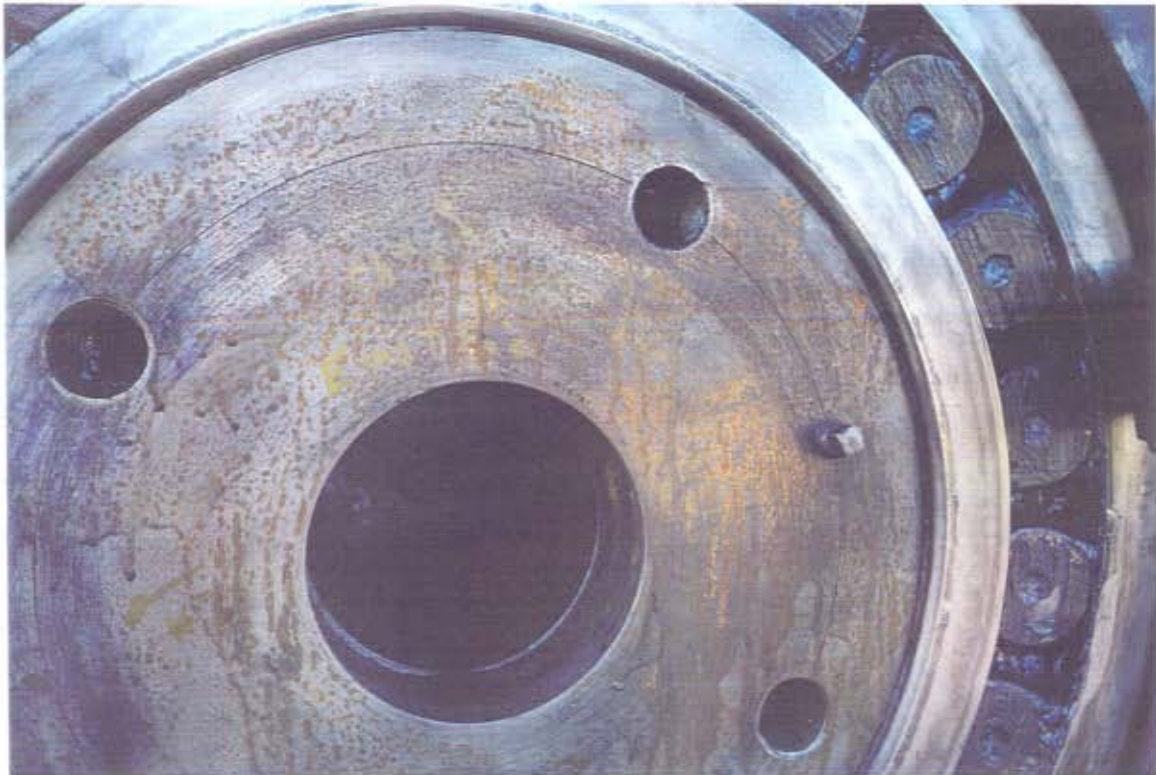
Fig. 5.1 – Preparation of south tower trunnion for ultrasonic examination

Prior to inspection, the accessible trunnion surfaces were cleaned and prepared for ultrasonic scanning as shown in Fig. 5.1. ODOT personnel removed covers and bearing retainers from the trunnion ends and cleaned lubricant from the center bore and end surface. The end surfaces were smoothed using course grit emery cloth while a beaded hone was used to prepare the center bore surface for scanning. Some scale within the bore had to be removed by chipping before scanning. Calibration of the ultrasonic flaw detector and the various transducer assemblies was performed using several test standards including a Type 2 IIW calibration block, a trunnion calibration standard fabricated with material from the north

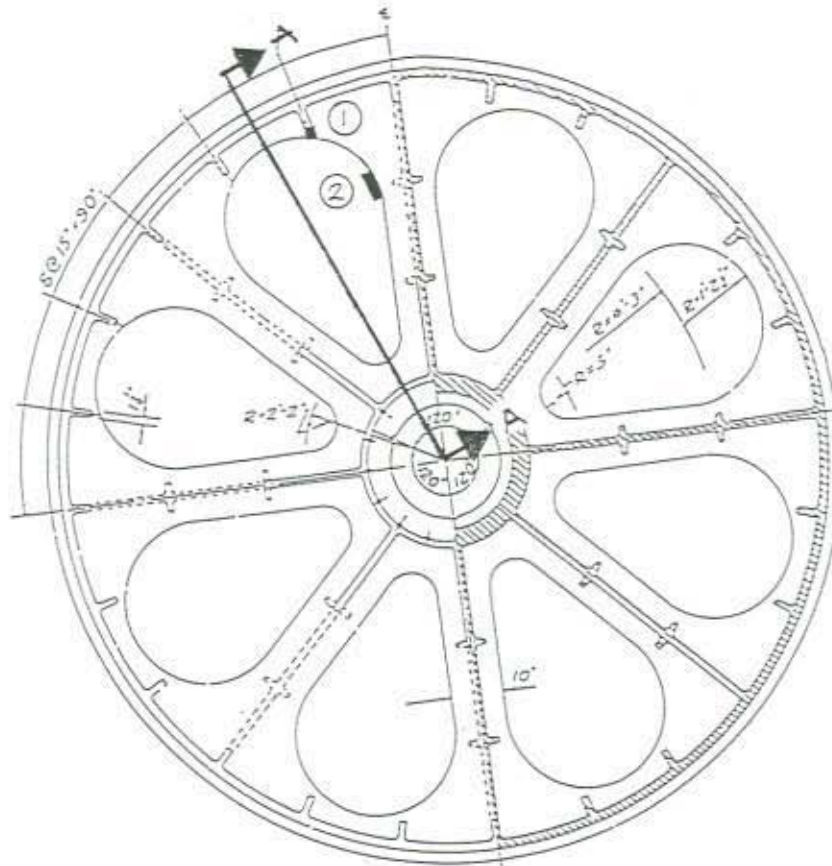
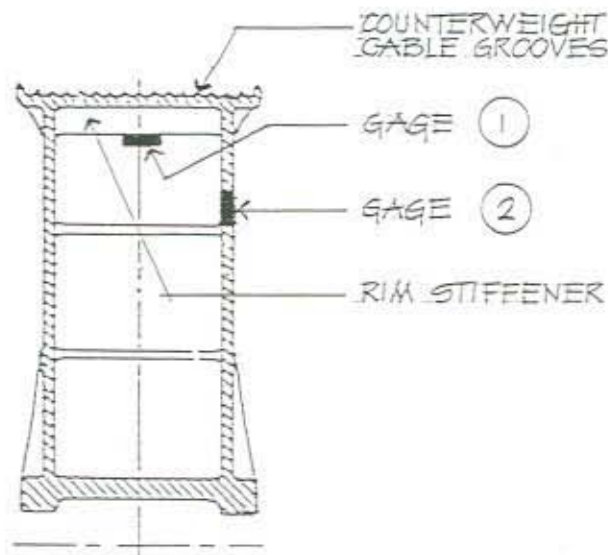
Fig. 6.1 – Location of sheave wheel strain gages

Two uniaxial weldable strain gages were attached to the sheave wheel at locations determined by the finite element analysis to exhibit high stresses. Gage 1 was welded on the under side surface of the transverse rim stiffener. Gage 2 was installed on the spoke flange tip at the tangency point of the spoke and large radius near the rim of the wheel. Figure 6.1 shows the layout and numbering of the two strain gages. Photographs of the instrumented sheave wheel are provided in Fig. 6.2.

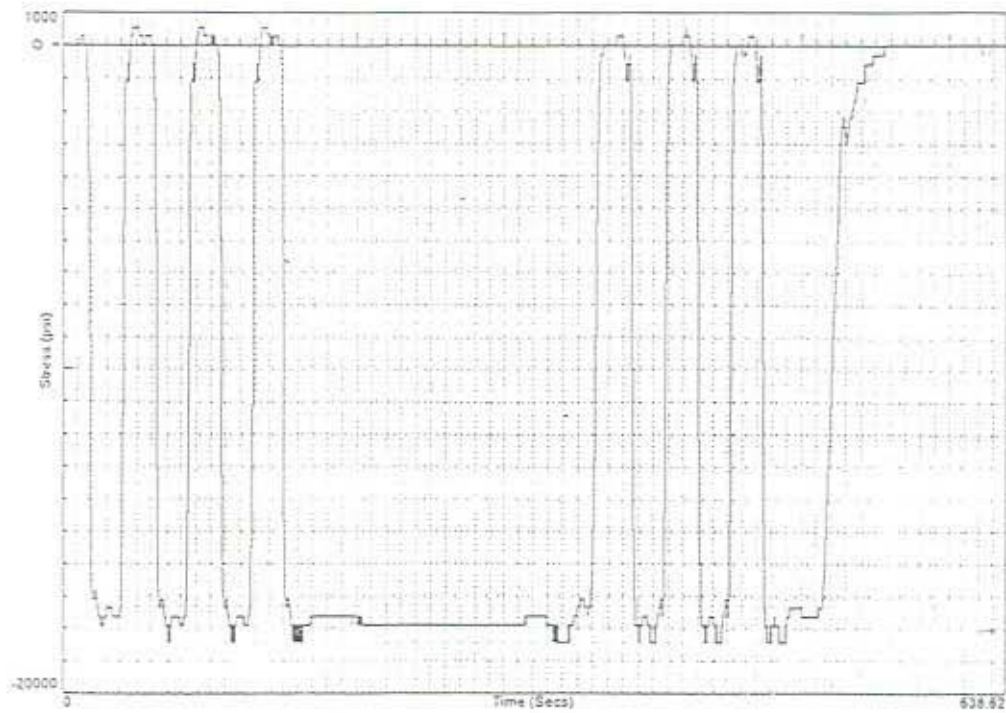
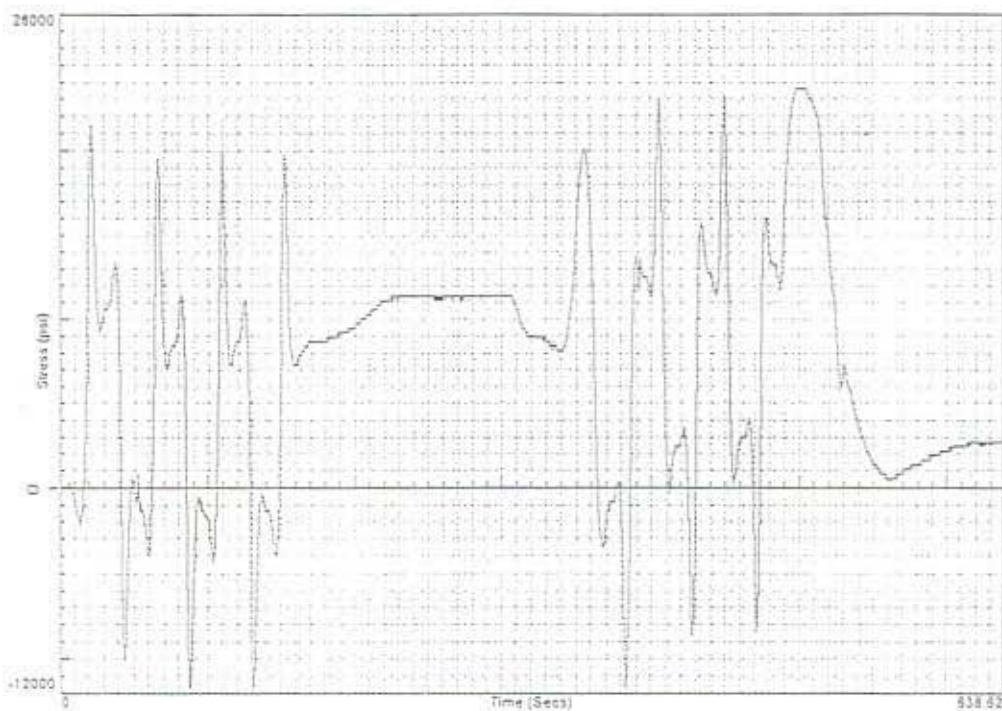
Fig. 6.3 – Dynamic stress response measured during lifting and closing of bridge

Figure 6.3 shows the change in stress at Gages 1 and 2 computed from measured strain during the lifting and lowering operation of the span. Both gages were zeroed at the fully seated or closed position. The lift span was raised to the maximum height of 135 ft resulting in $4 \frac{2}{3}$ rotations of the sheave wheel. The lift span was held at the maximum height for about 90 seconds and then lowered to the seating position. Strain data was converted to stress using the equation $S = \epsilon E$ where ϵ is strain recorded from the response and E is the Modulus of Elasticity for steel 29×10^6 psi.

Assuming the DGES model to be correct, the ratio of measured to calculated is $19.0/17.2 = 1.10$ or within 10 percent. This suggests excellent agreement between actual and predicted stresses. For the Gage 2 location, spoke flange tip, the FEA calculated a stress range of 28.5 ksi for a total wire rope load of 613 kips. Comparing the DGES model values to the field test measurement results in a ratio of $31.0/28.5 = 1.09$ or within 9 percent. Again this indicates excellent agreement between the FEA model and field testing results. Note that the total wire rope load was measured by WJE during the north tower trunnion replacement and was found to be approximately 720 kips. This results in values within 6 and 8 percent.

FLANGE TIP OF SPOKE
 GAGE ② $S_r = 31$ ksi
 $N \approx 225,000$ cycles

RIM STIFFENER
 GAGE ① $S_r = 19$ ksi
 $N \approx 1,000,000$ cycles

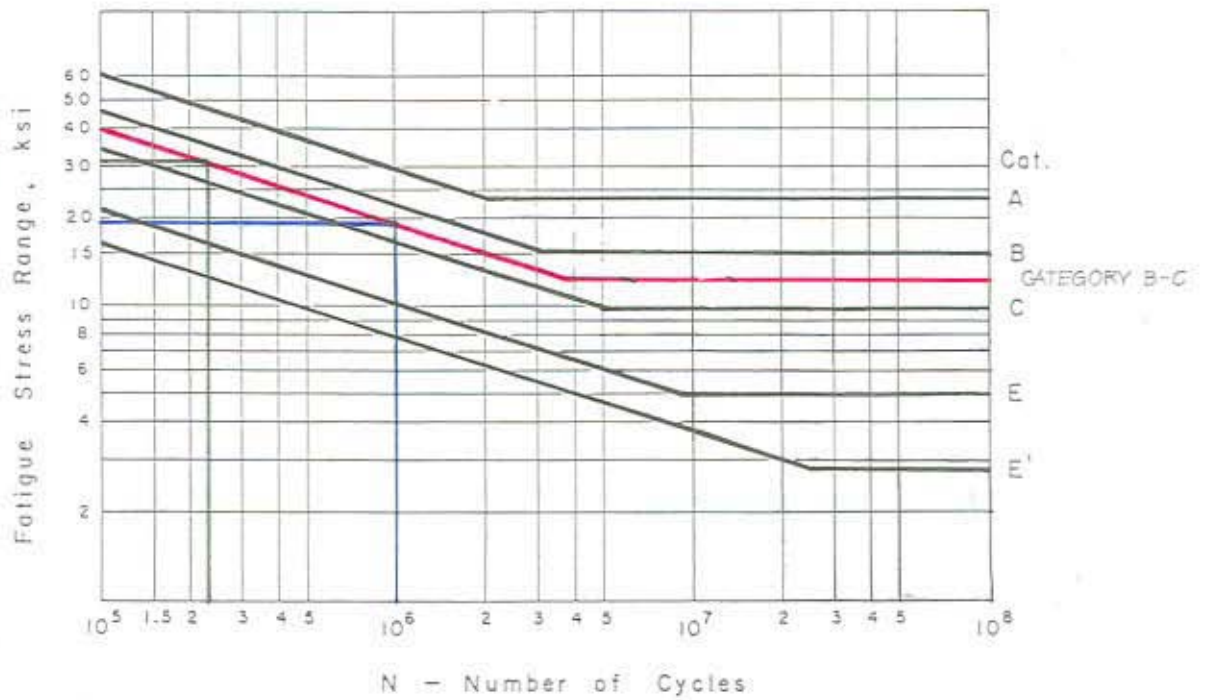
Fig. 7.1 – Fatigue resistance curves for various details with the Category B-C added for assessment of the sheave wheel material.

NOTE: SHEAVE WHEEL CASTING PERFORMANCE BETWEEN CATEGORY B AND C.

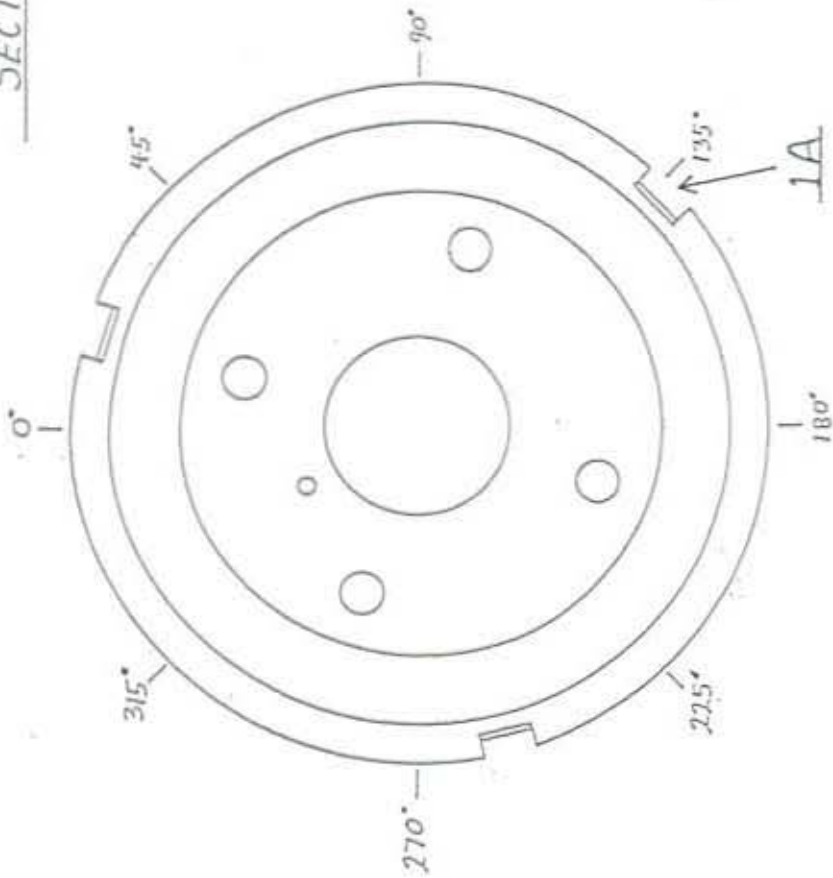
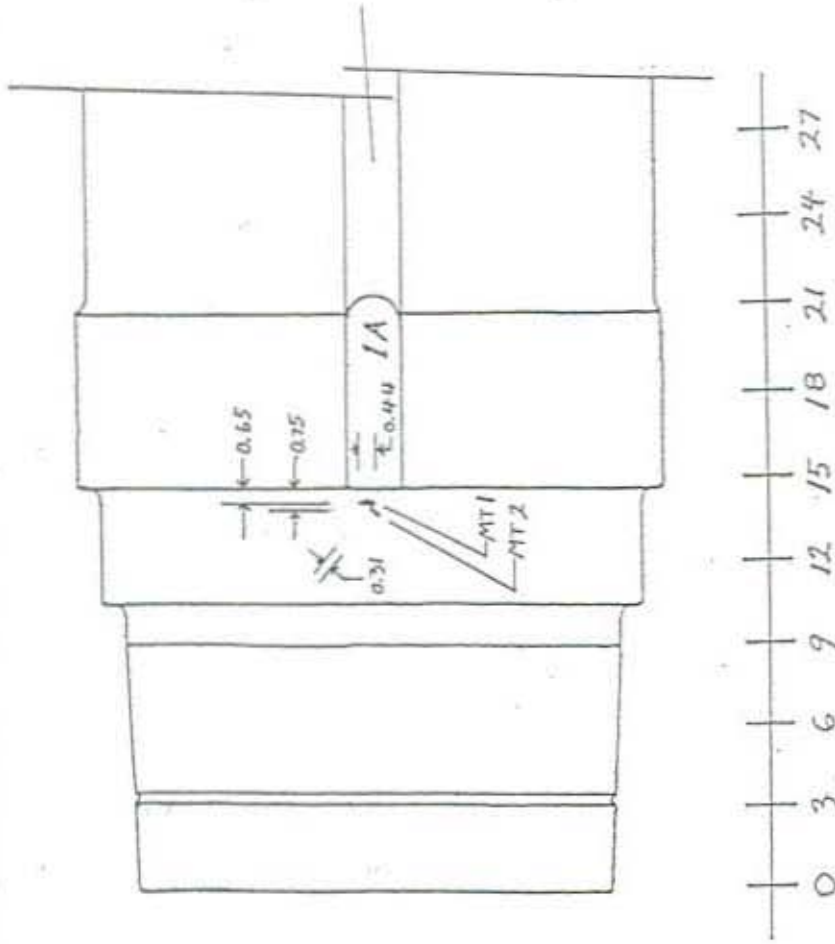
SECTION AT KEYWAY 1A

SURFACE AT KEYWAY 1A (EAST END)

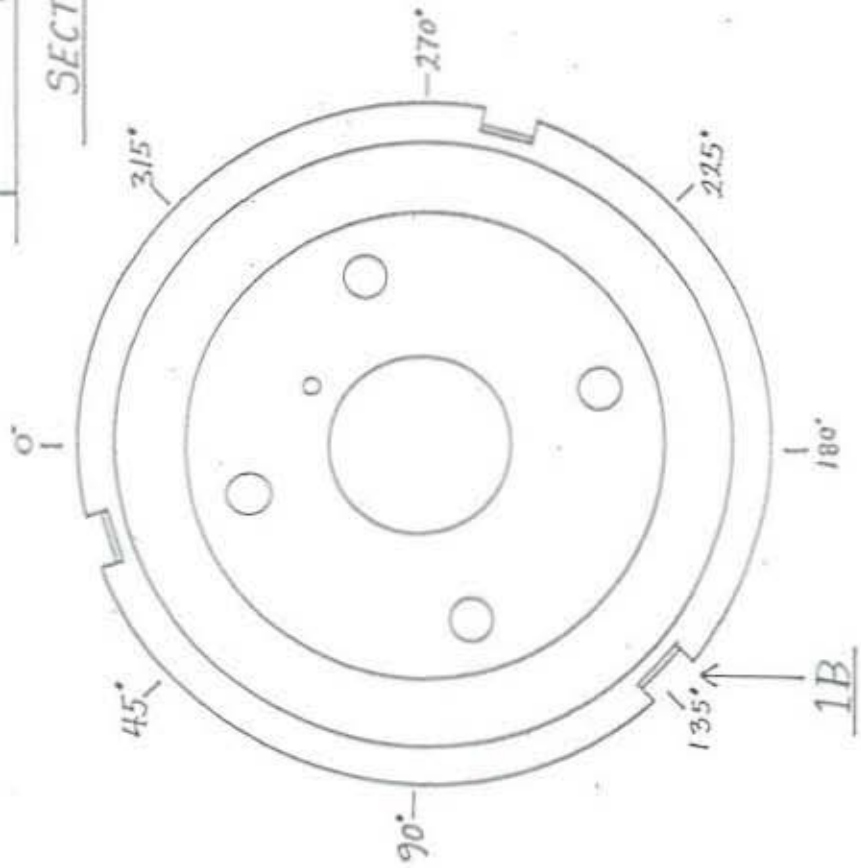
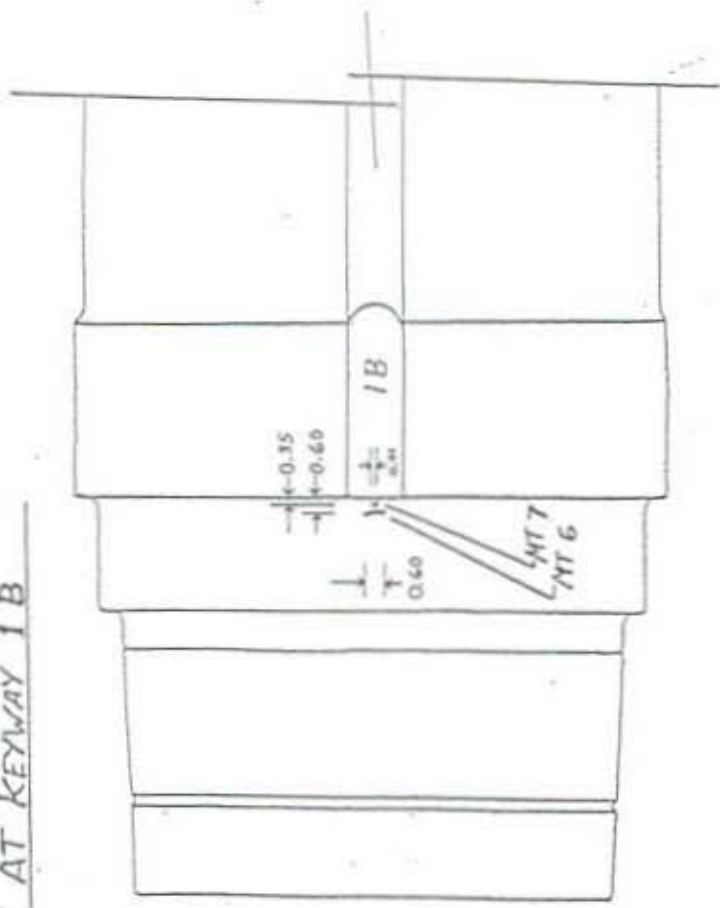
SECTION AT KEYWAY 1B

SURFACE AT KEYWAY 1B (WEST END)

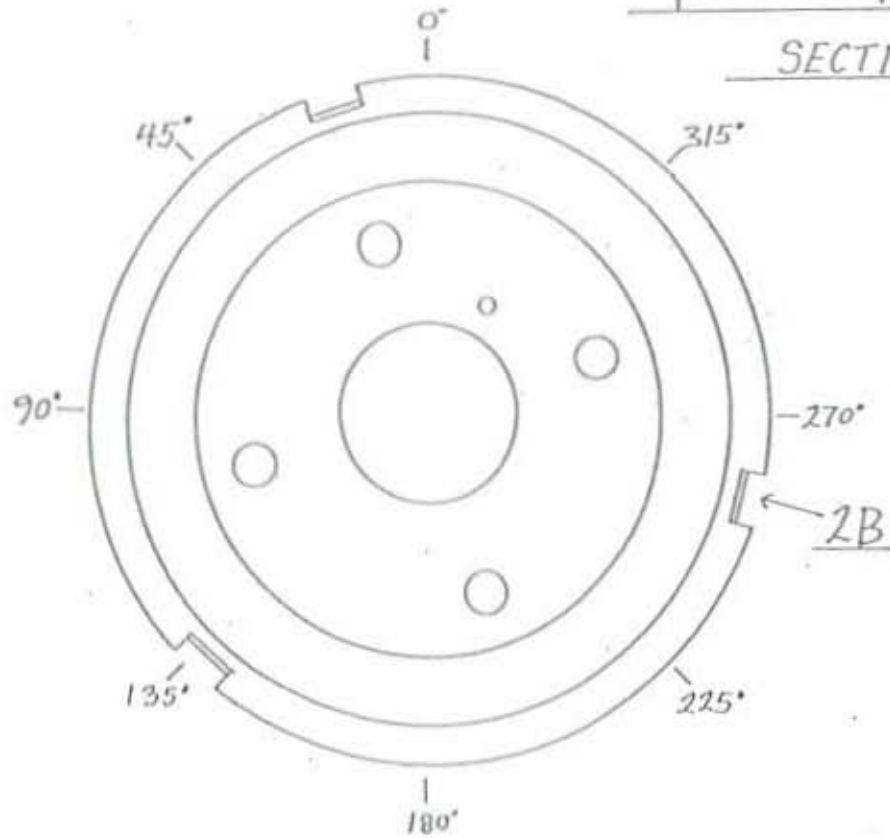
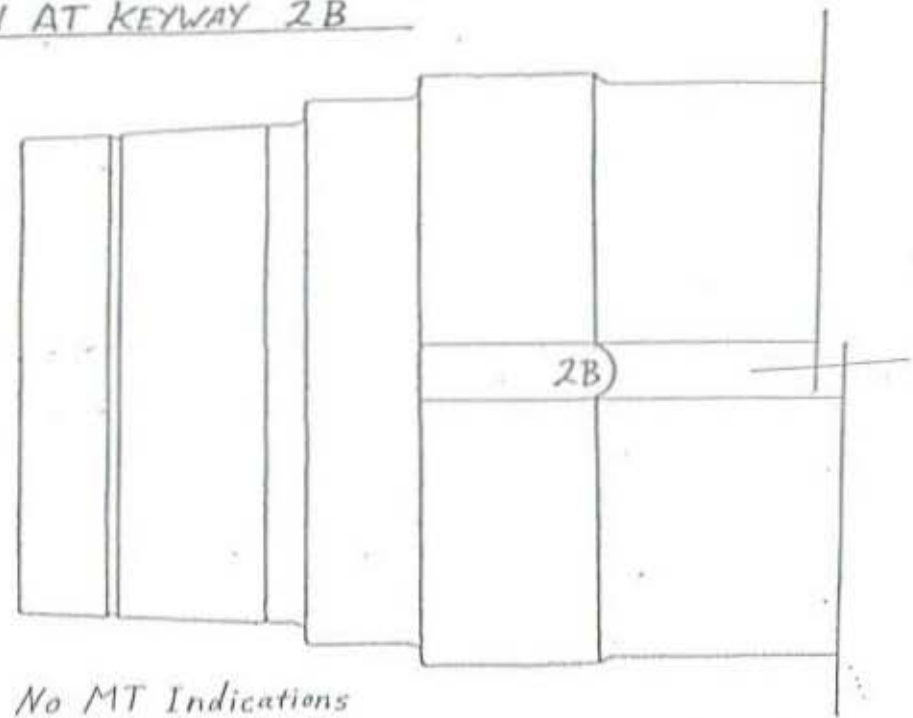
SECTION AT KEYWAY 2B

No MT Indications

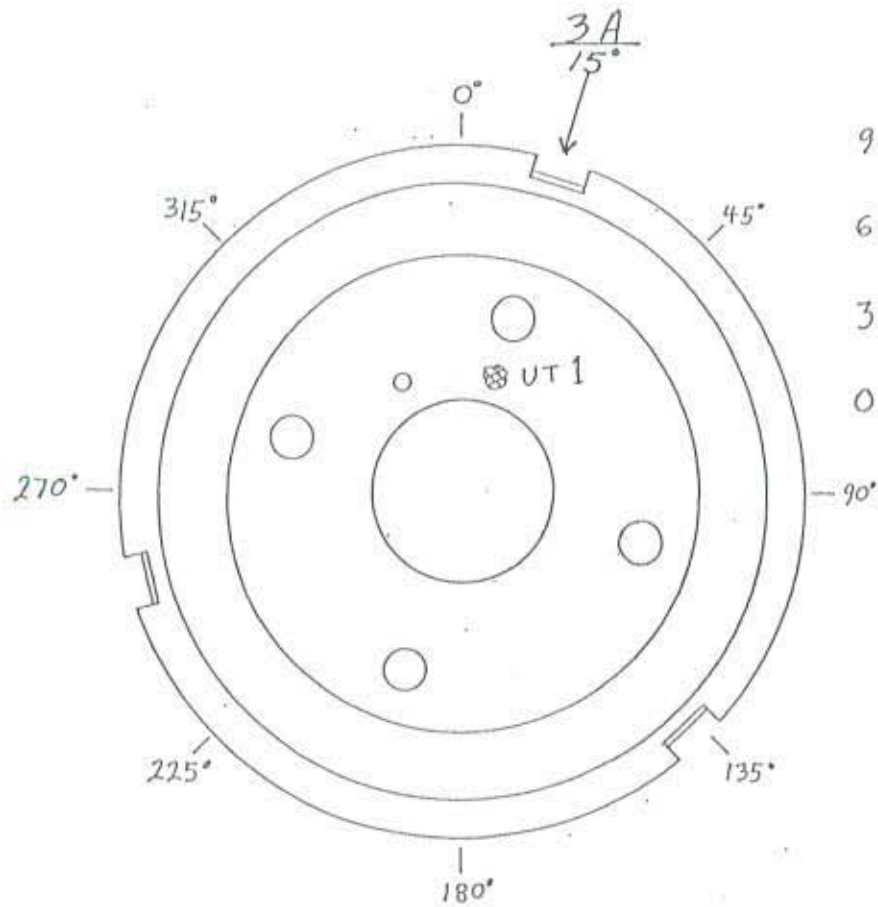
Discontinuities located by UT Axial Scan

UT1Z Aprox 15.5 from end

* Detected by 45°
Bore Hole Scan

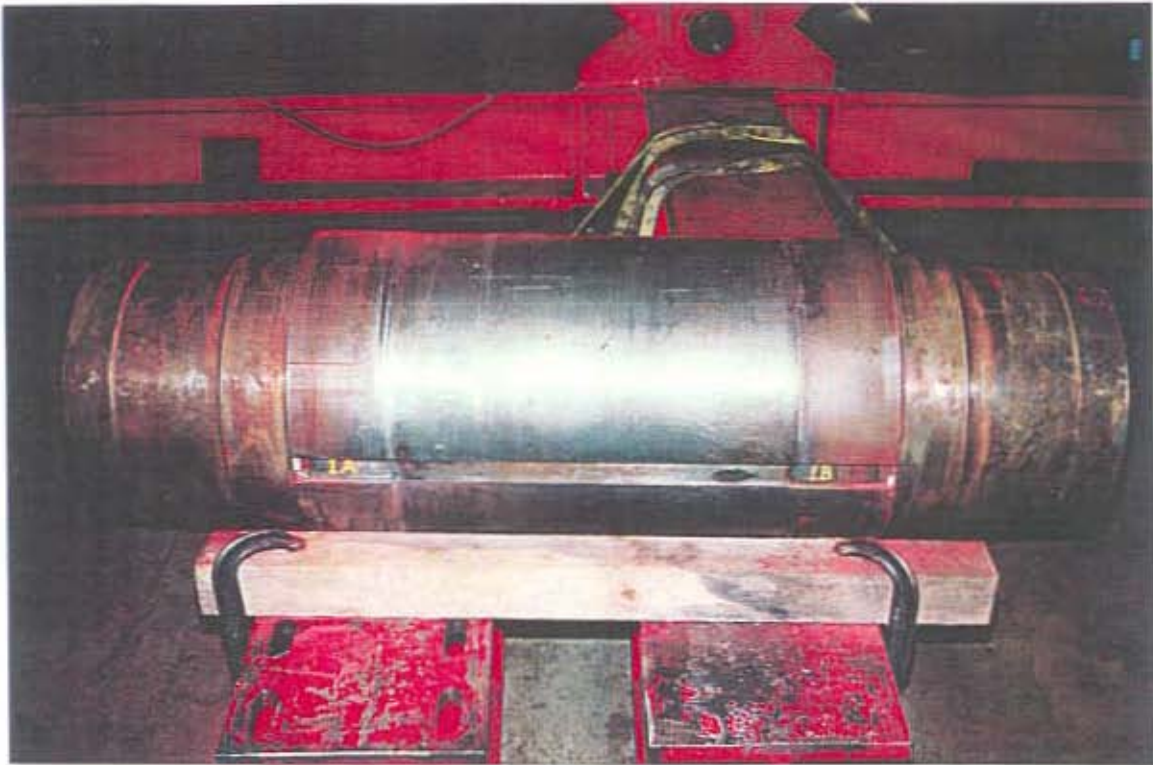
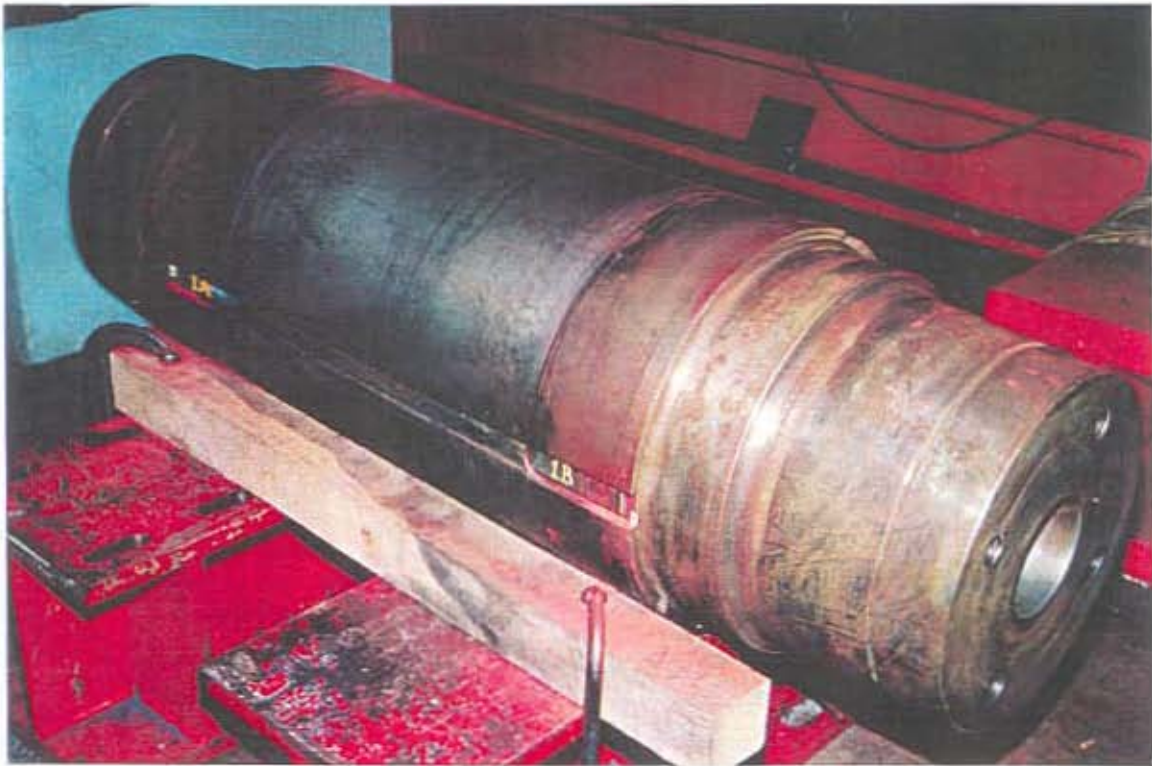
Based upon a re-inspection of the trunnion performed by WJE after removal of the sheave/trunnion from the bridge and disassembly, a detailed NDE evaluation of defect indications in the trunnion was prepared for subsequent sectioning to visually identify and characterize the indications. A general view of the disassembled trunnion as it was received at the ATLSS laboratories is shown in Figure 1. For identification the three east end trunnion keyways were labeled 1A, 2A, and 3A. West end keyways were identified as 1B, 2B, and 3B. Identification, descriptions, and location sketches of defect indications detected by UT and MT during the re-inspection are included in Appendix A for reference. Two principal types of defect indications were detected in the trunnion; 1) Surface crack-like discontinuities or sub-surface discontinuities oilway repair welds; and 2) internal discontinuities in the vicinity of the inner bore of the trunnion. Several defect indications representative of both types were selected for evaluation. Table 1 provides a summary of the defect indications selected.

Figure 1 - General Views of the Disassembled Trunnion As-Received at the ATLSS Laboratories.
(Photos Courtesy of WJE)

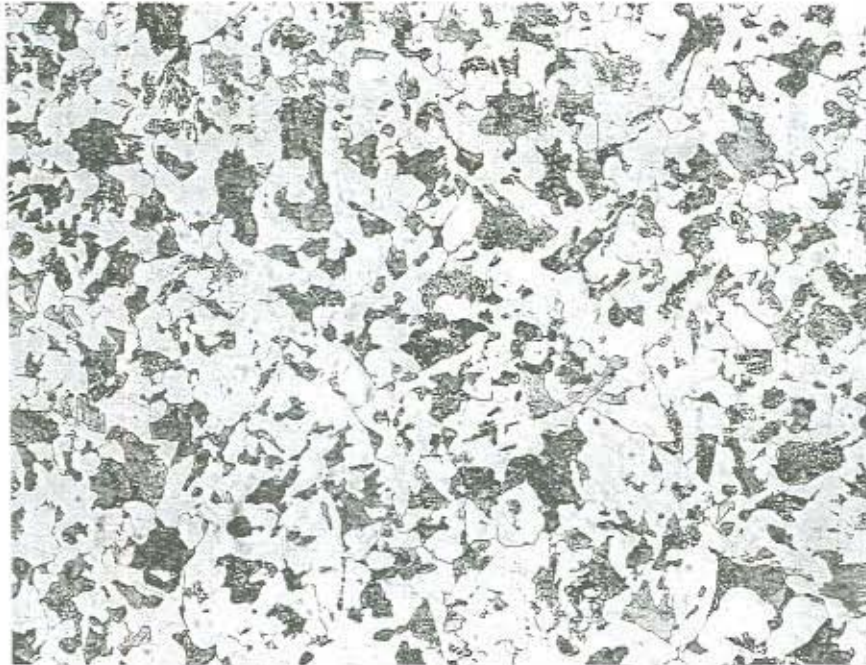
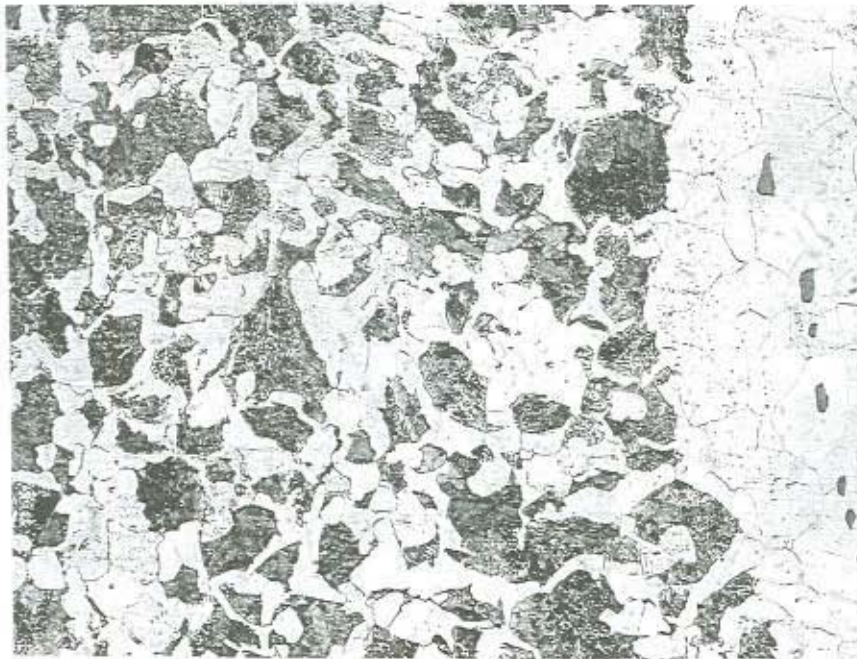
Etched microstructures of the trunnion near the outside surface and near the inner bore are shown in Figure 25. The microstructure at both locations is ferrite-pearlite with a slightly larger ferrite grain size and pearlite fraction at the inner location consistent with the higher carbon content measured in this region. The microstructure was generally uniform with some areas of proeutectoid ferrite veining. A portion of a ferrite vein is seen in the inner trunnion microstructure.

Figure 25 - Microstructure of the Trunnion. [Mag. 200X]
Top) Near Outer Diameter Bottom) Near Inner Diameter

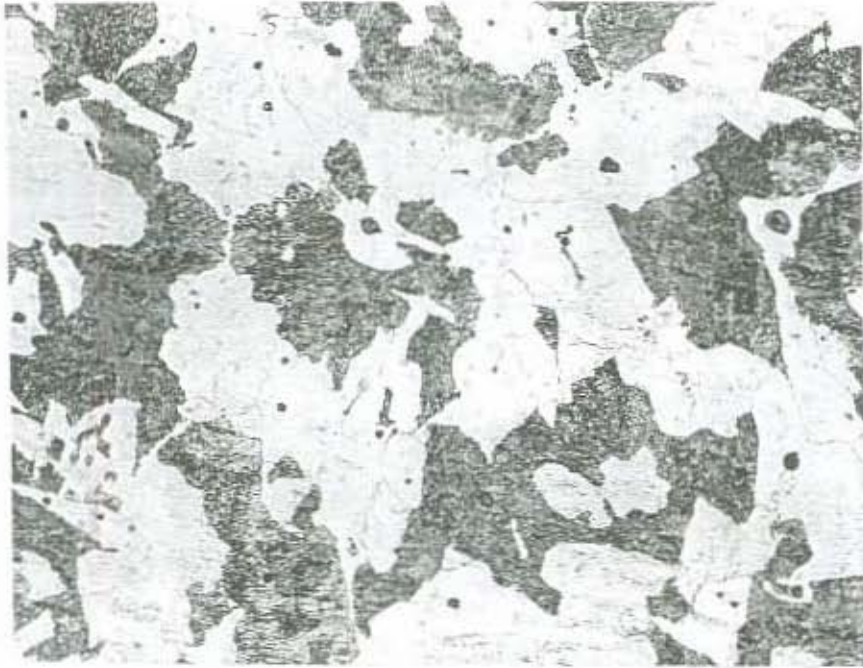
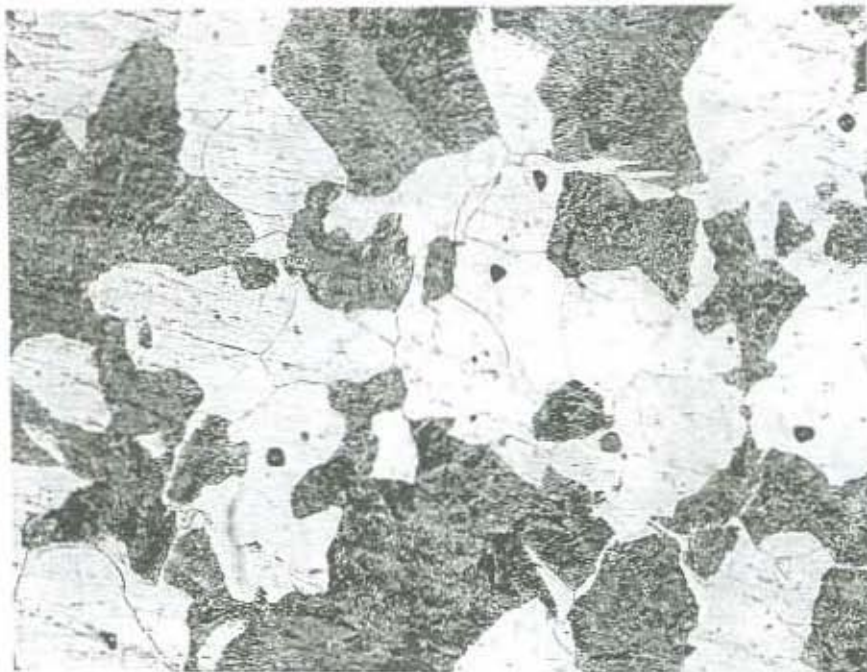
The microstructures of the cast steel sheave at the two sample locations are shown in Figure 26. The microstructures are also ferrite-pearlitic. The ferrite grain size is coarse as would be expected in a large casting.

Figure 26 - Microstructure of the Sheave. [Mag. 200X]
Top) Sample #3 Bottom) Sample #4
