FITNESS FOR PURPOSE EVALUATION OF THE
COUNTERWEIGHT SHEAVE/TRUNNION ASSEMBLY
FOR
OREGON DEPARTMENT OF TRANSPORTATION

WJE NO. 1997.3010

June 2000

WISS, JANNEY, ELSTNER ASSOCIATES, INC.
330 Pfingsten Road
Northbrook, Illinois 60062-2095
(847) 272-7400

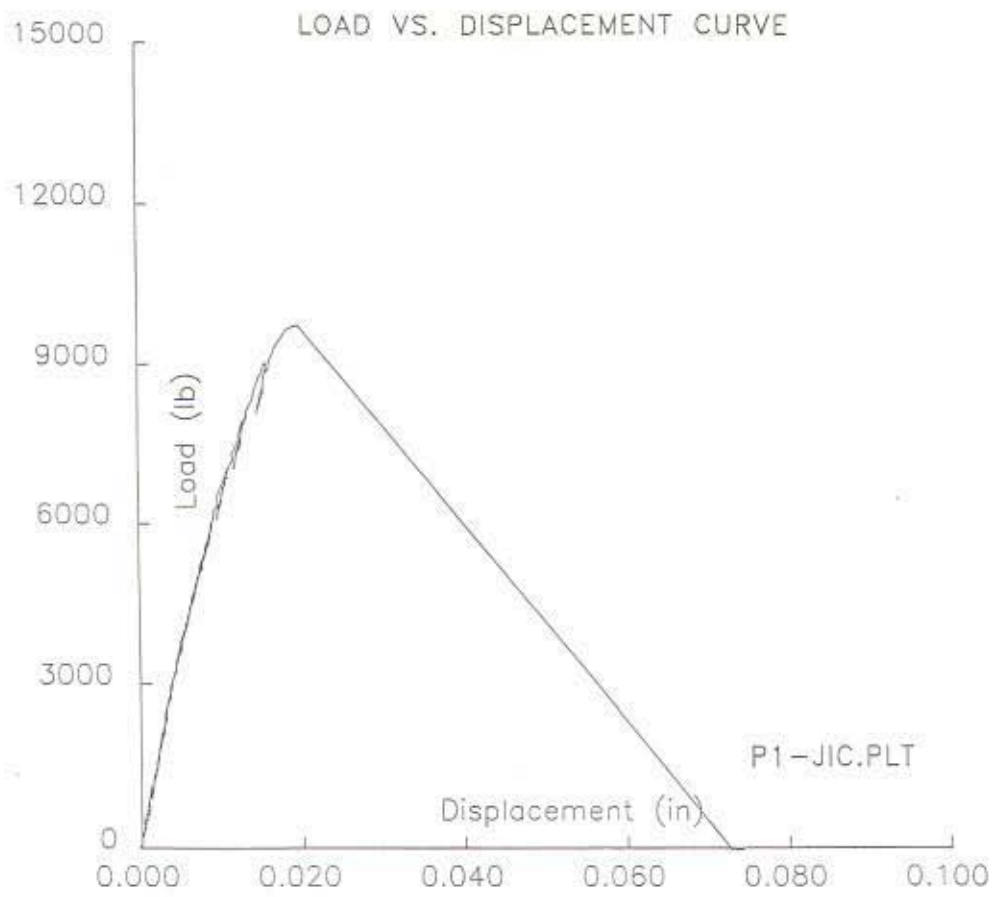
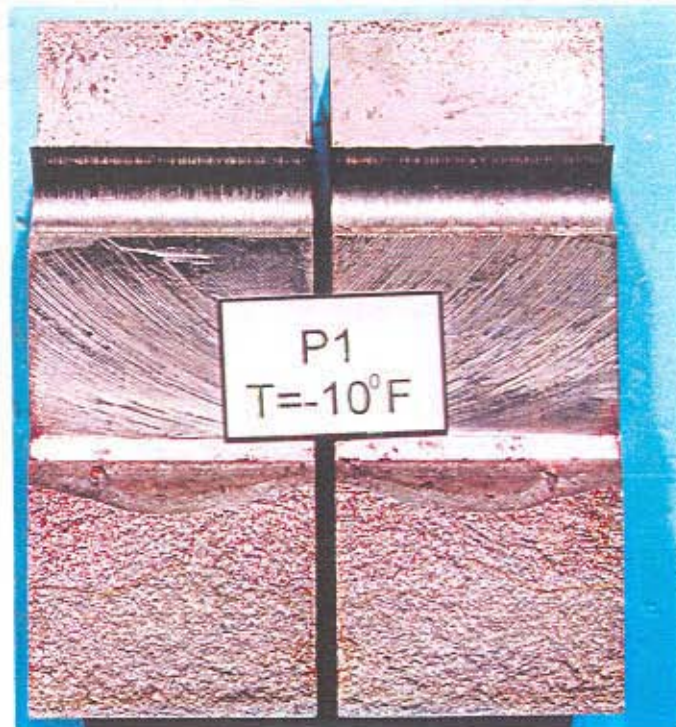
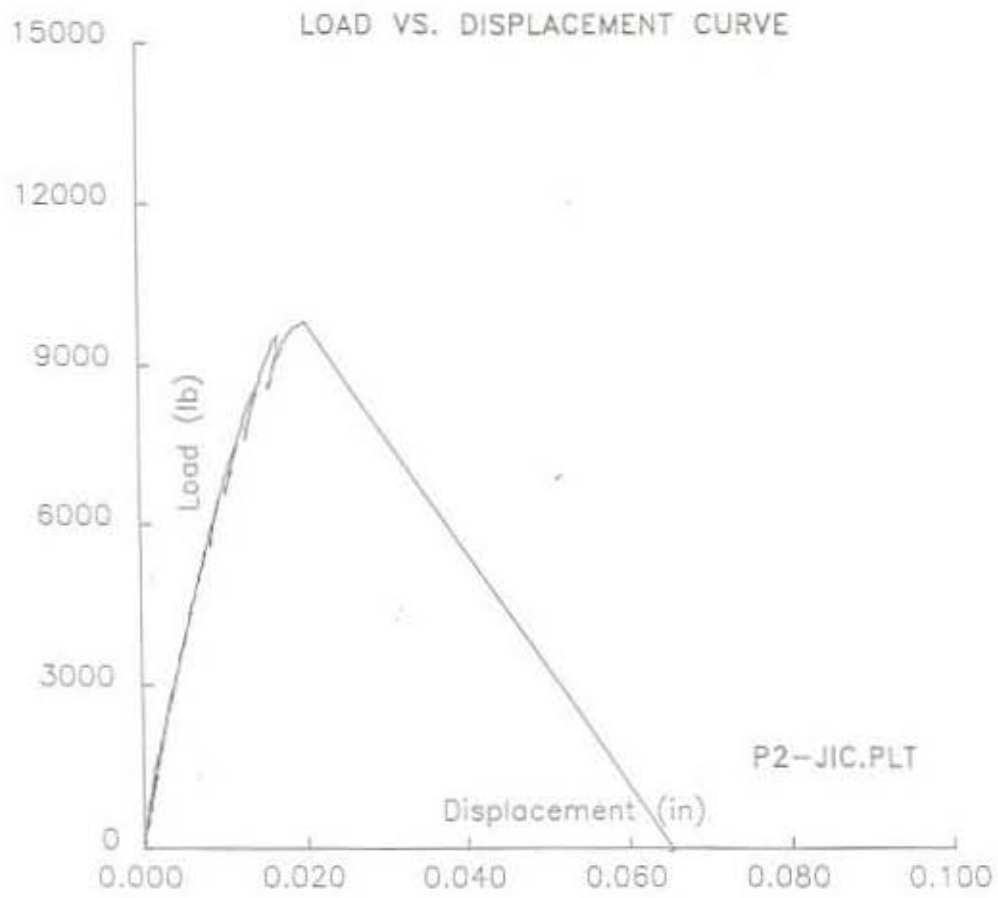
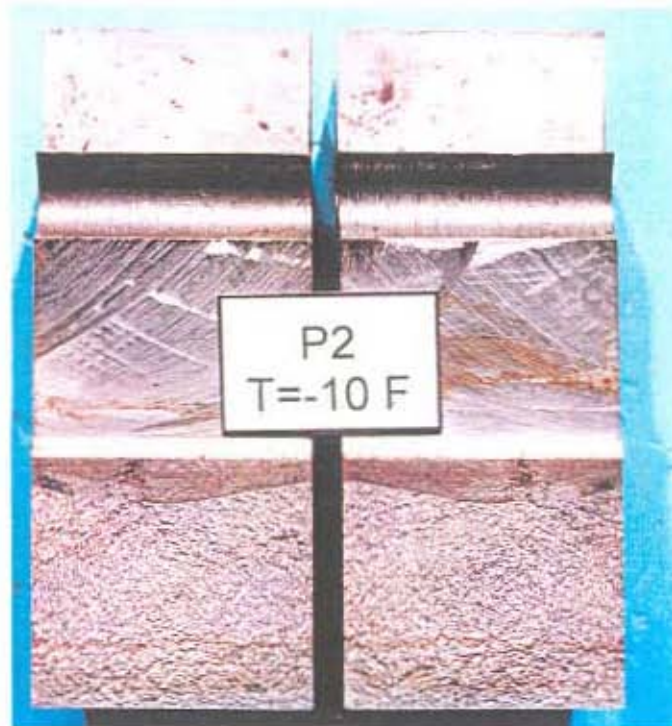
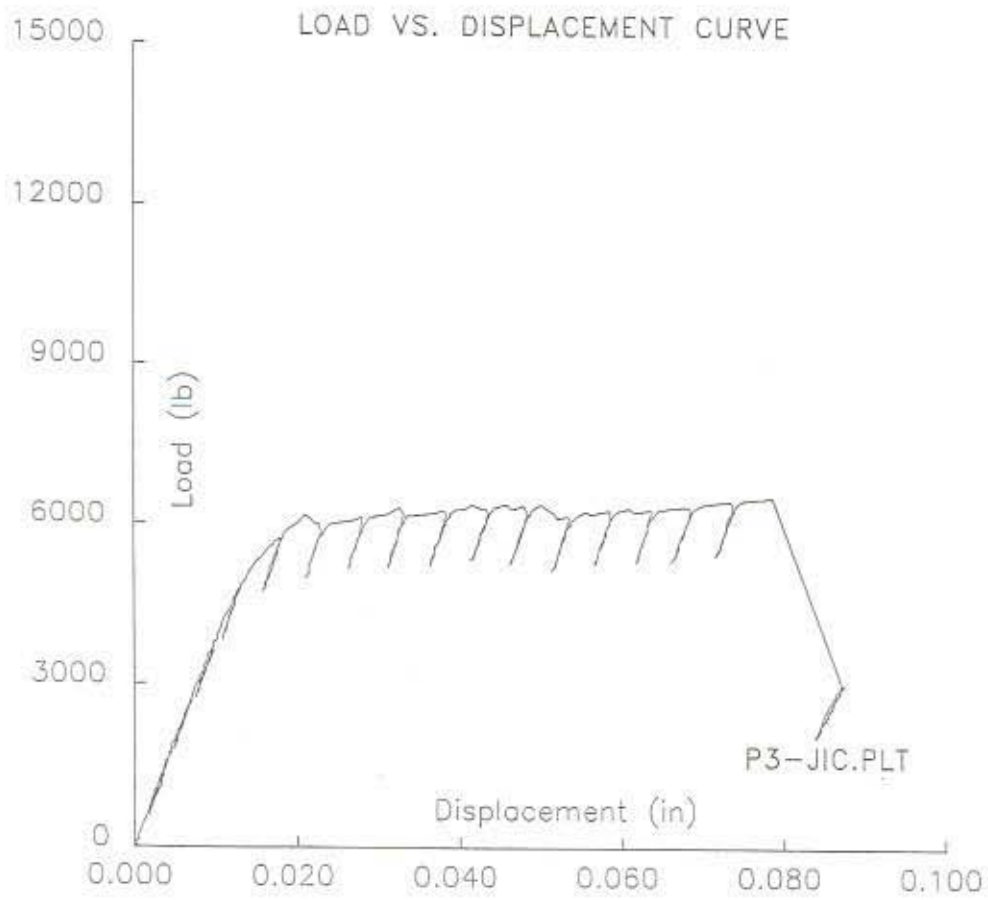
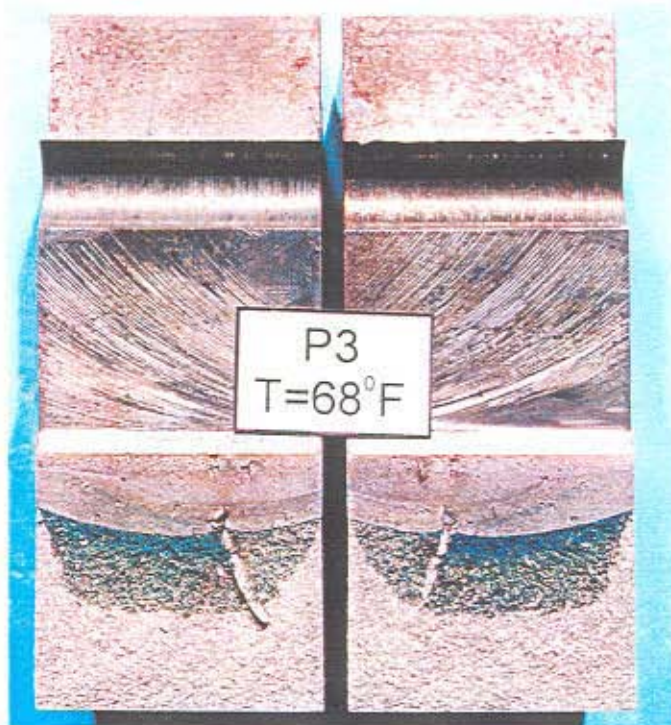
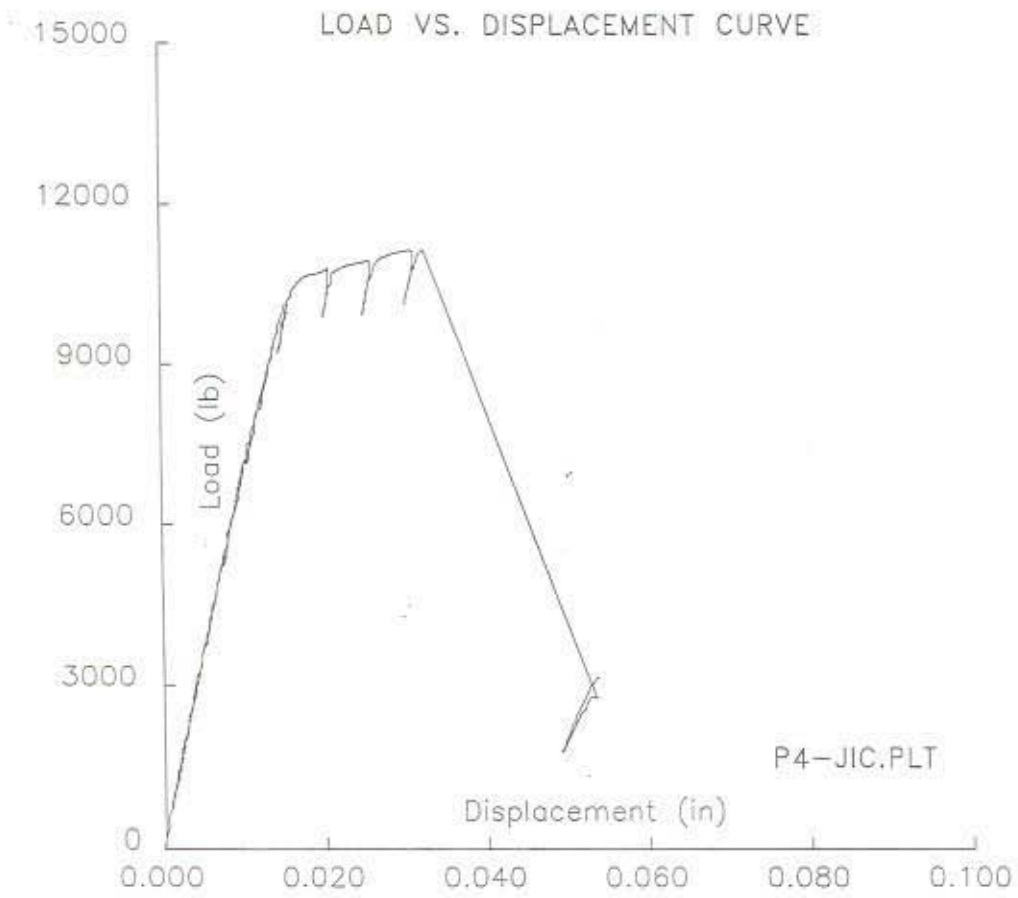
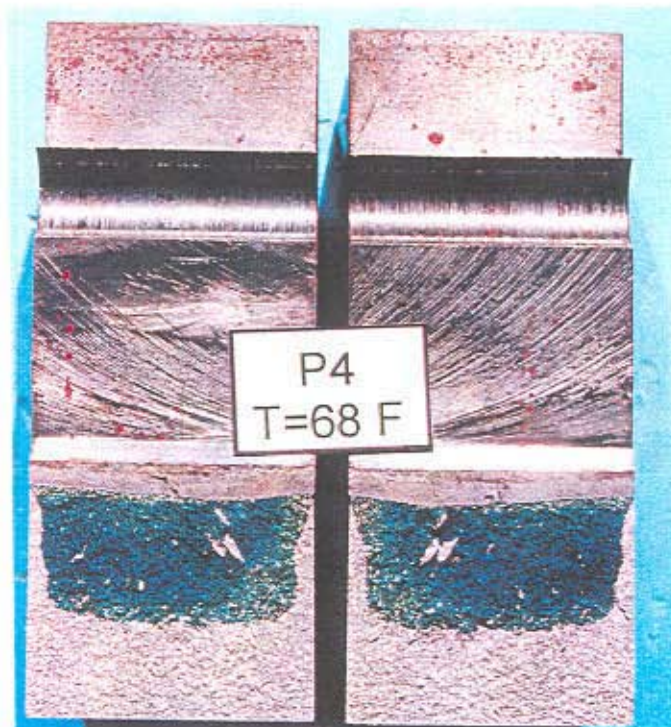
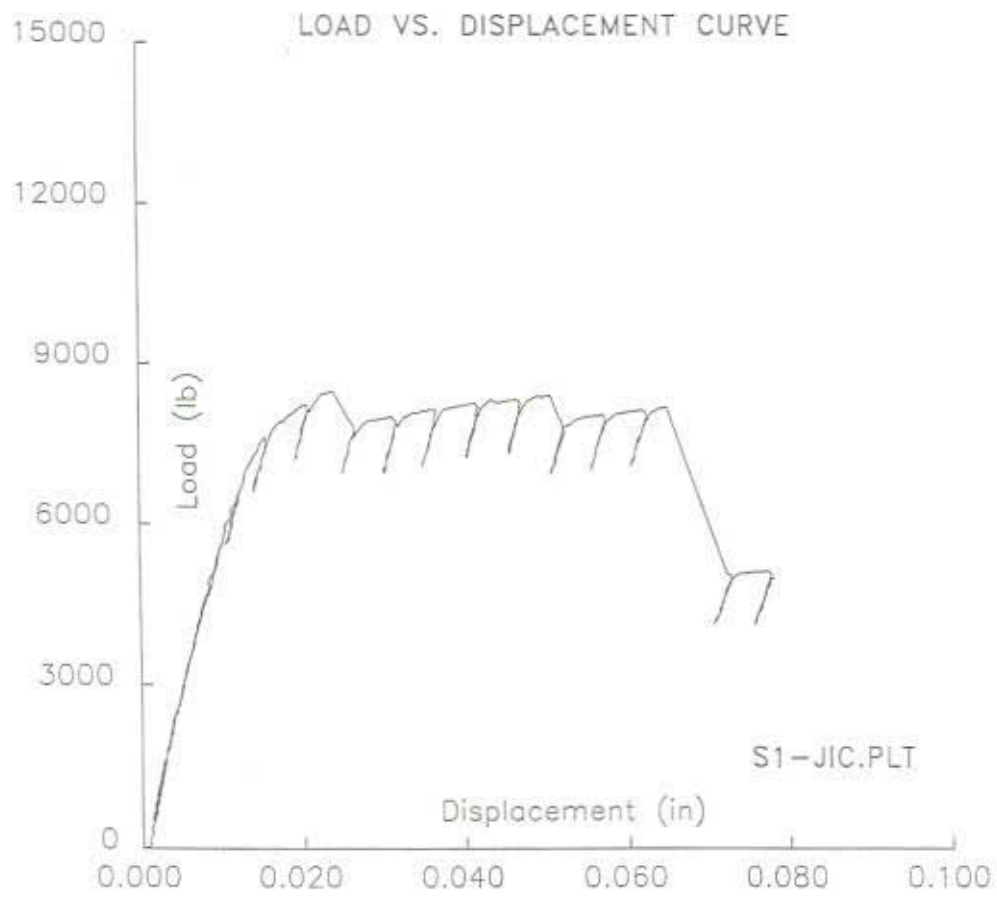
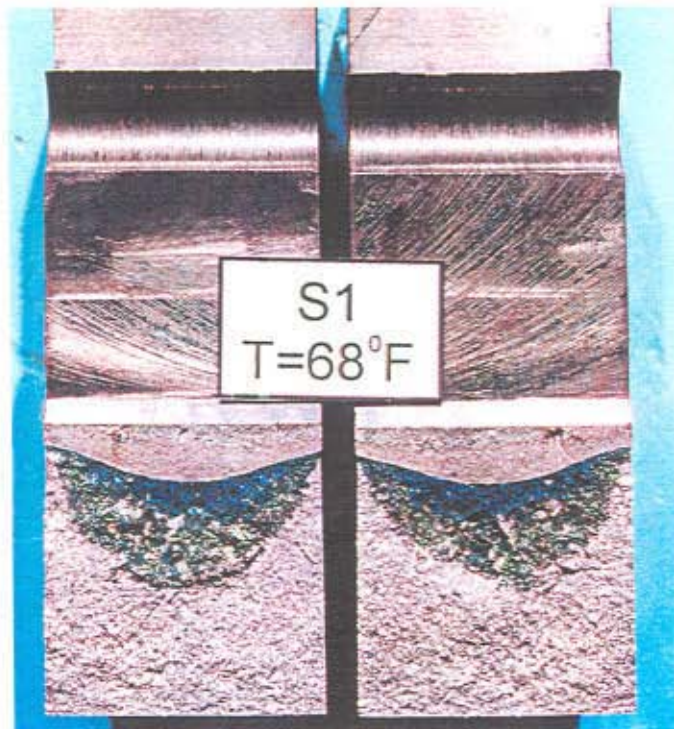
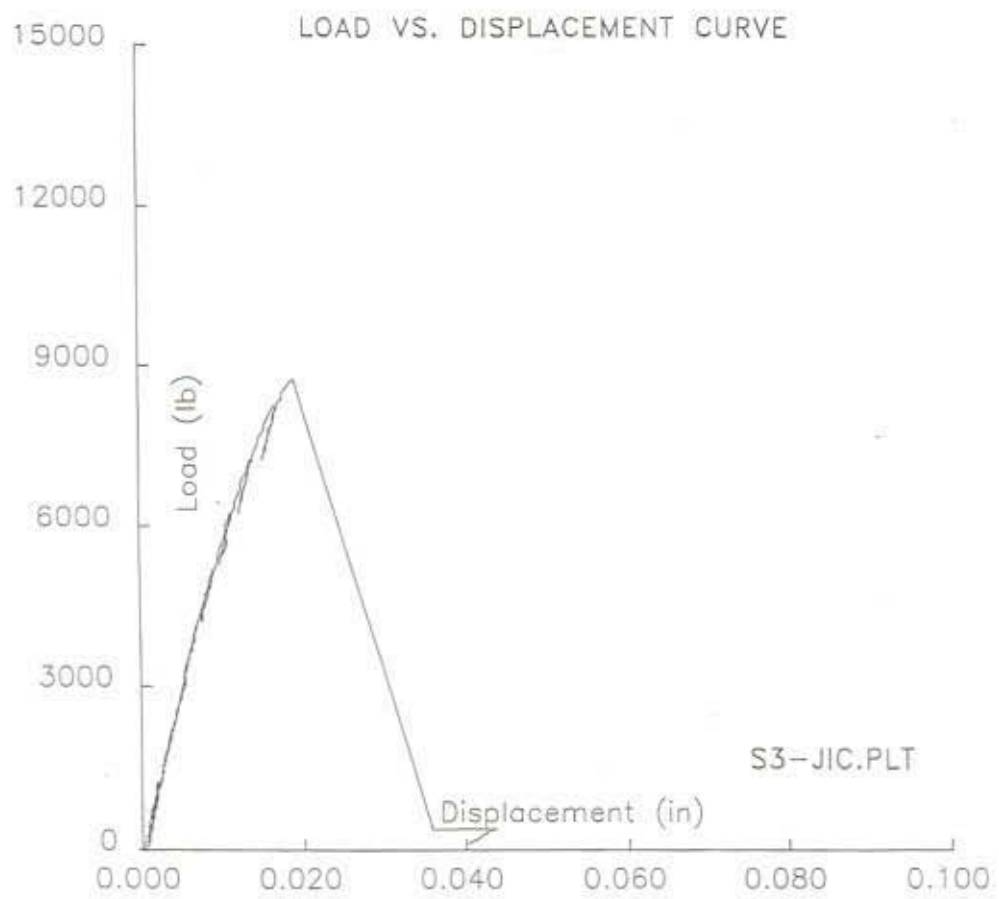
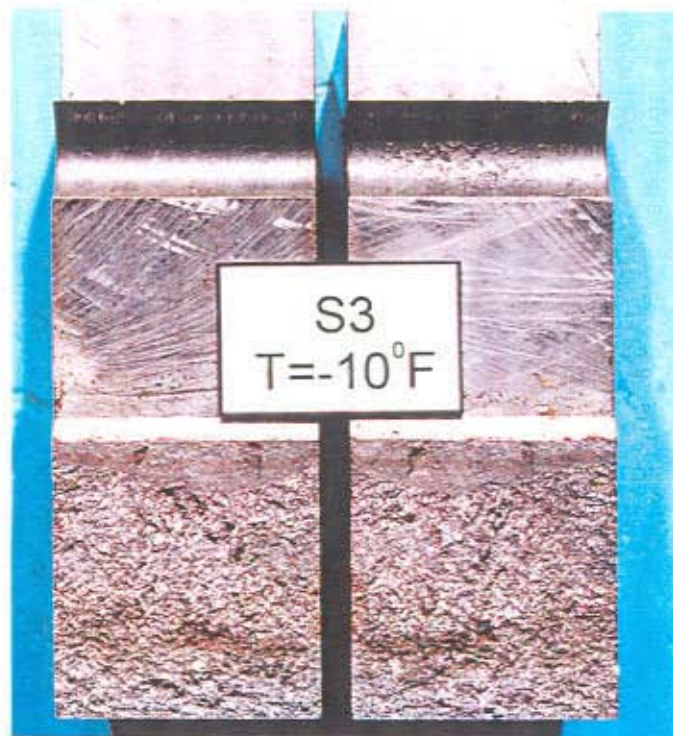
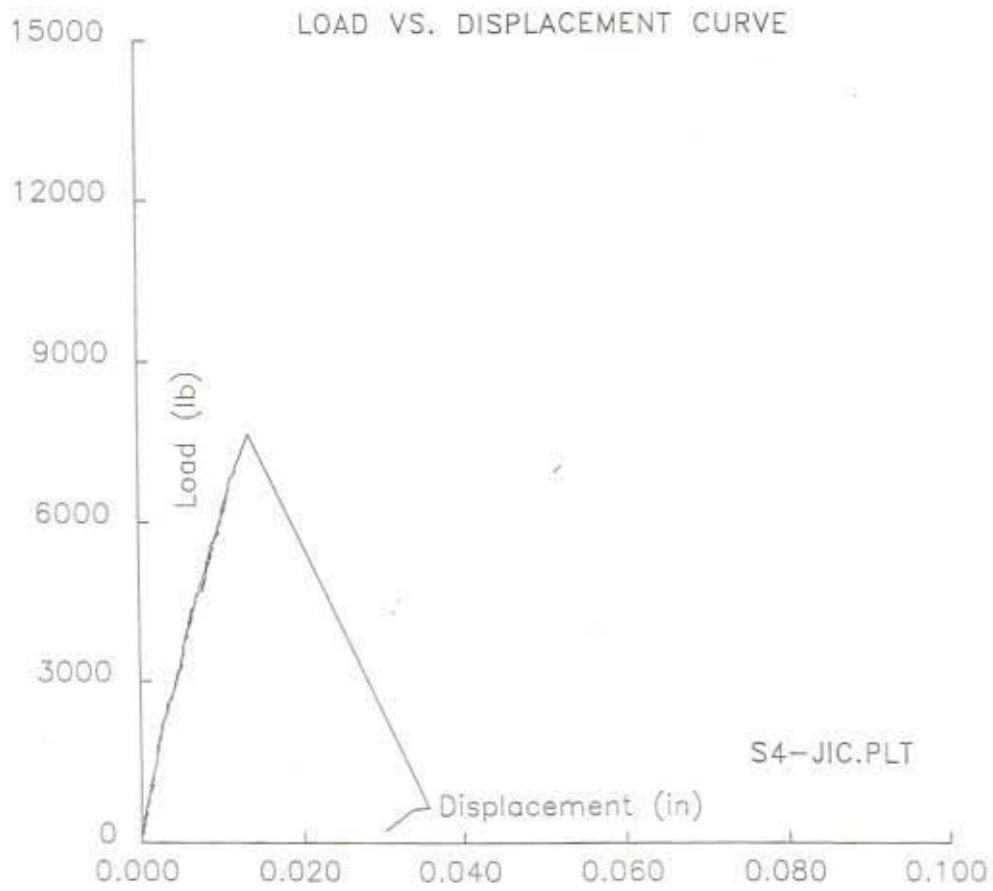
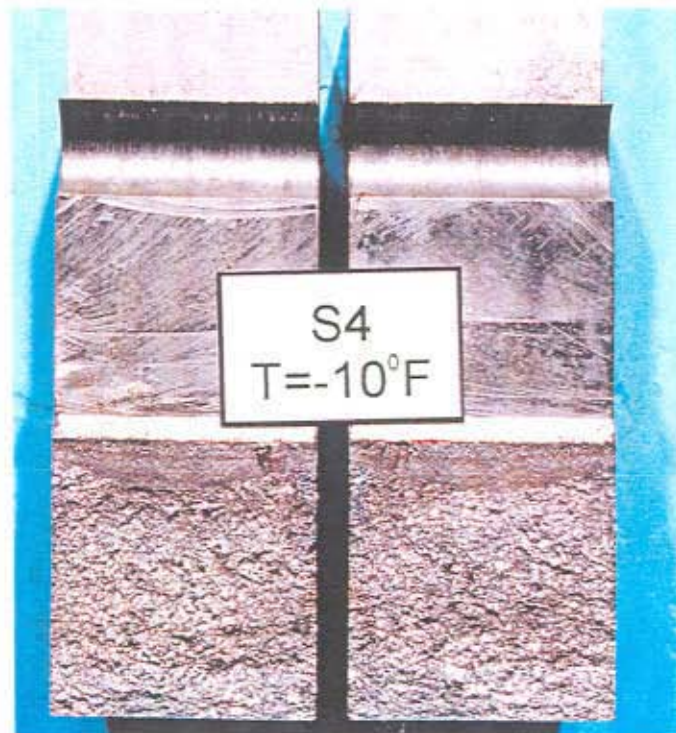
Figures 29 through 44 show load-clip gauge displacement traces for the eight specimens tested along with the appearance of the fractures. The behavior of both the trunnion and sheave specimens were surprisingly similarly considering their different metallurgical condition (ie. forged vs. cast). All of the specimens tested at the minimum service temperature fractured brittly with only a small amount of crack tip plasticity. All of the specimens tested at room temperature (68 F) showed increased plasticity, however, fracture also occurred by cleavage without any evidence of ductile stable crack extension prior to fracture. Multiple brittle crack extensions or "pop-ins" were observed in the sheave material tested at room temperature (Specimens S1 and S2, see Figures 37 and 39) prior to a large brittle crack extension. The final crack extension is seen on the fracture surfaces after heat tinting.

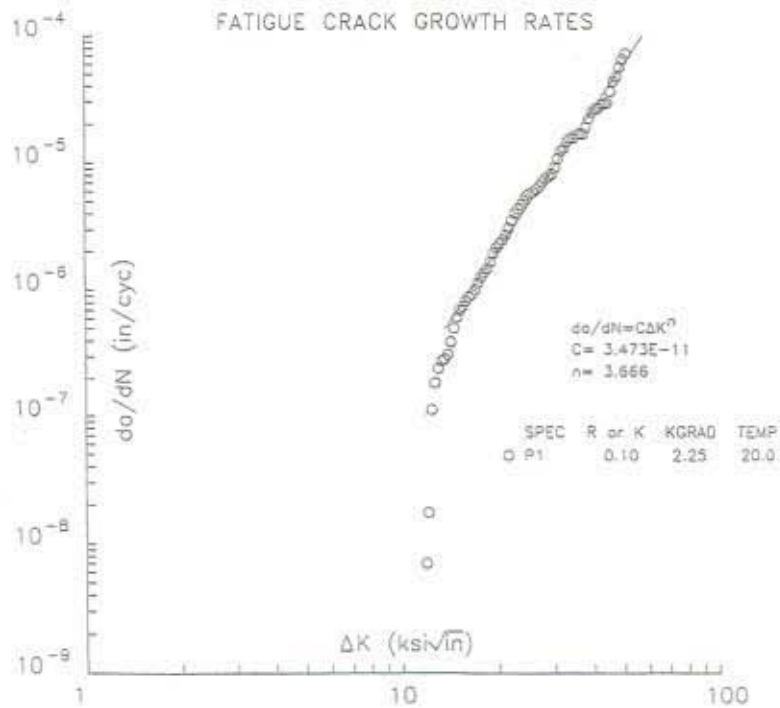
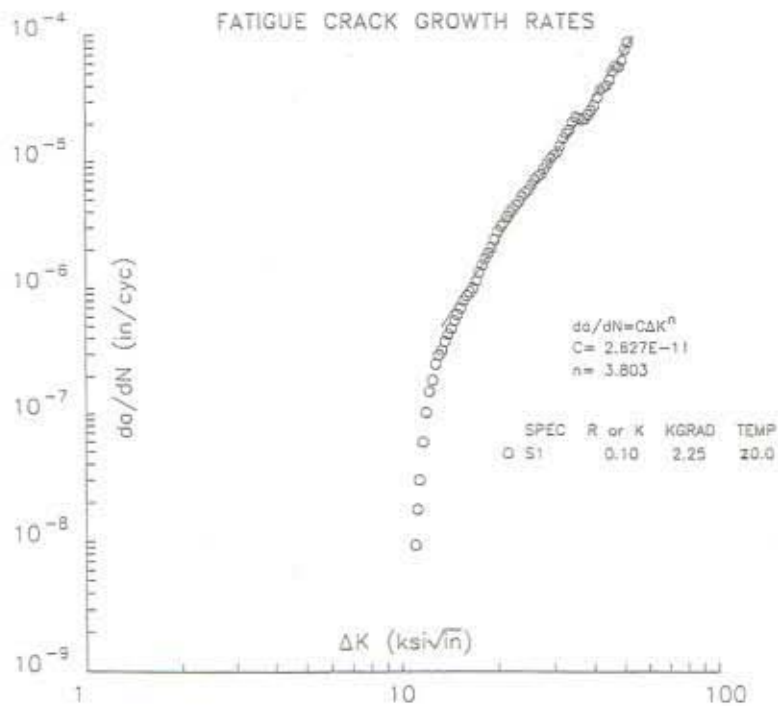
Figure 45a shows da/dN vs. ΔK plots for the trunnion and sheave material. Also shown are Paris law constants computed by regression analysis. Data for both materials suggested a slope of 3.6-3.8 which is greater than the value of 3 generally used for steels. Regression analysis of the data in the threshold region indicated $\Delta K_{th} \sim 10-11 \text{ ksi-in}^{1/2}$ (see Figure 45b), however, data at the lower growth rates were problematic due to crack closer effects. Actual thresholds are likely below this value.

Figure 45a - da/dN vs. ΔK plots for the trunnion (top) and sheave (bottom) material.

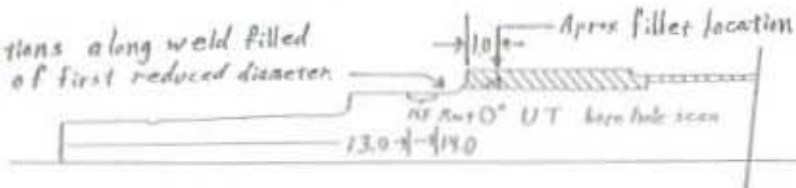
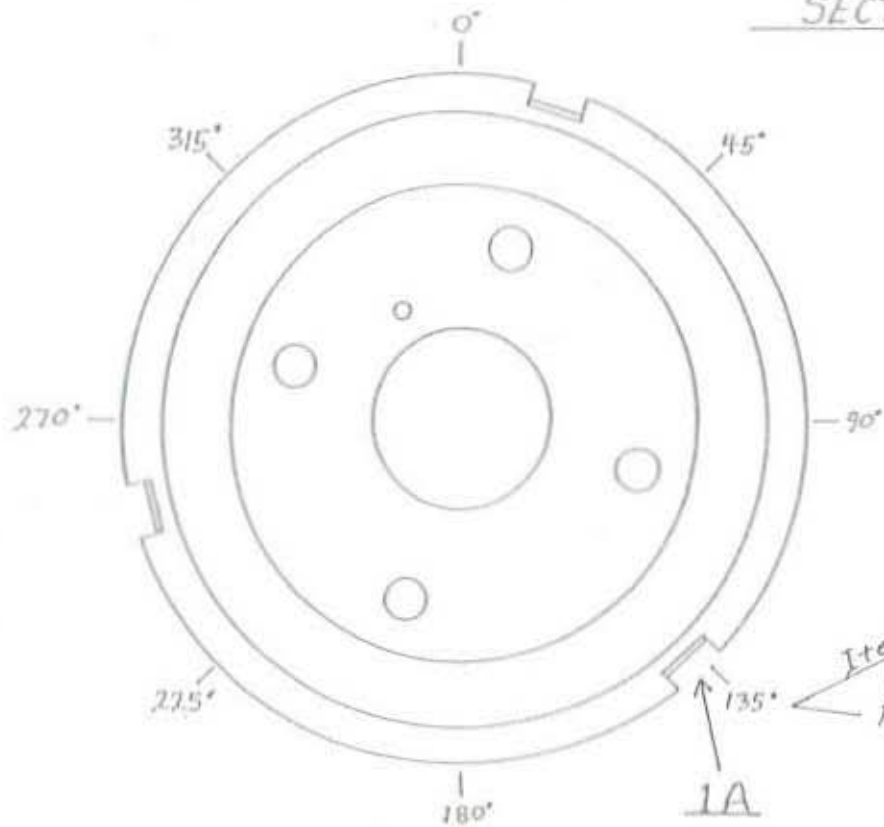
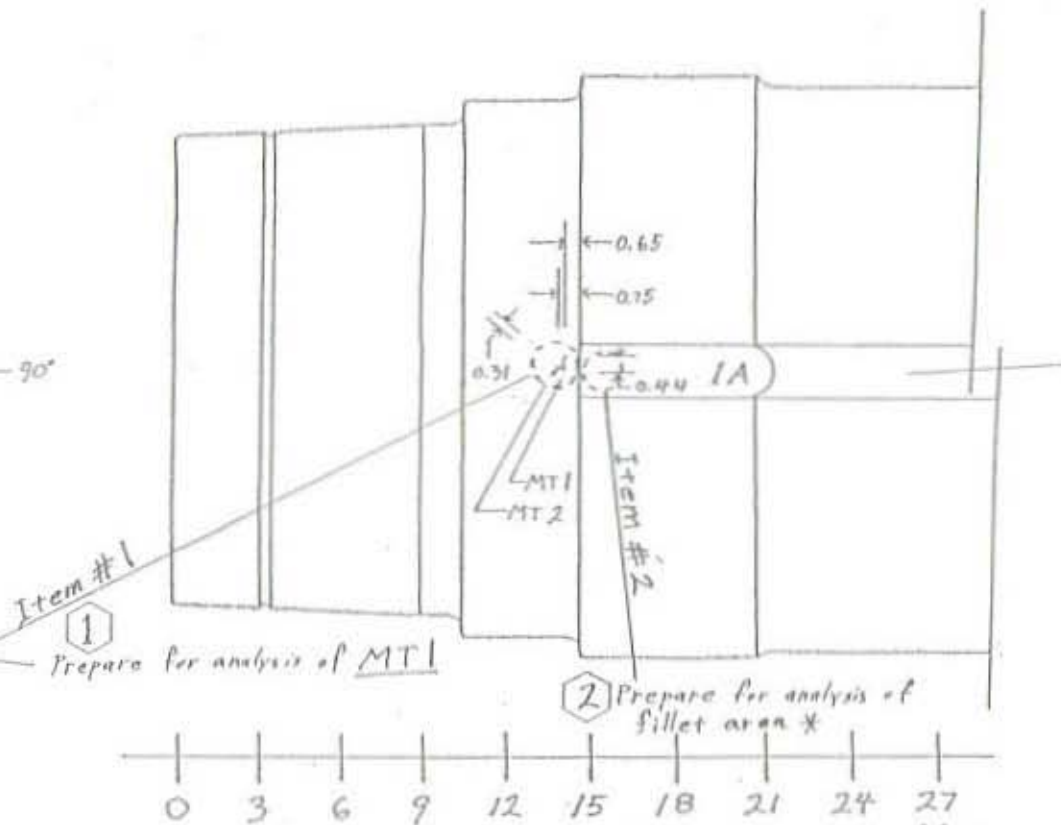
SECTION AT KEYWAY 1A

MT Indications along weld filled
oilway of first reduced diameter

Item #1
1 Prepare for analysis of MT1

Item #2
2 Prepare for analysis of fillet area *

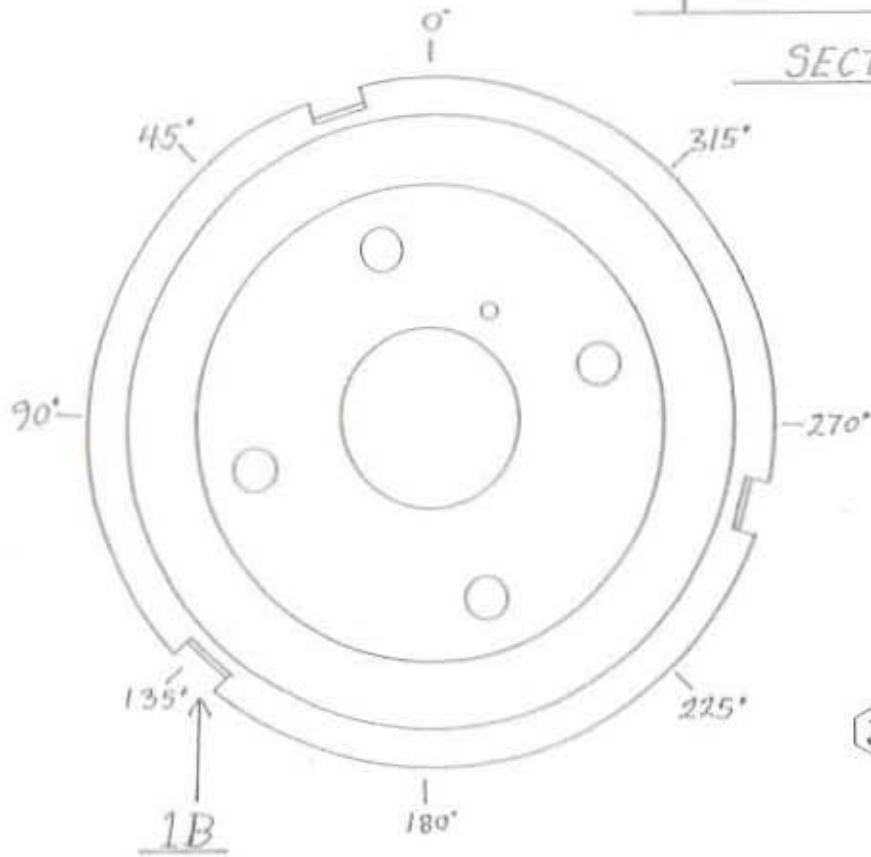
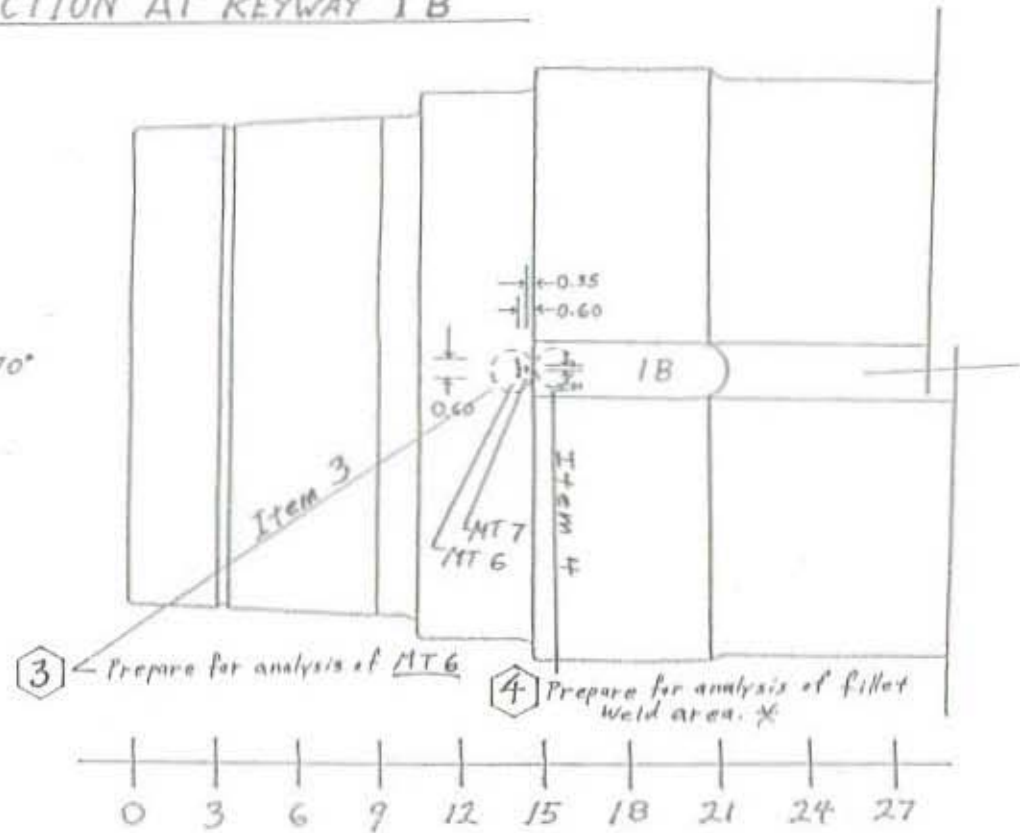
SECTION AT KEYWAY 1B

③ Prepare for analysis of MT 6

④ Prepare for analysis of fillet
weld area. *

* Fillet is intact as welded. Leg
fusing to Key was previously
fractured. See keyway section, above

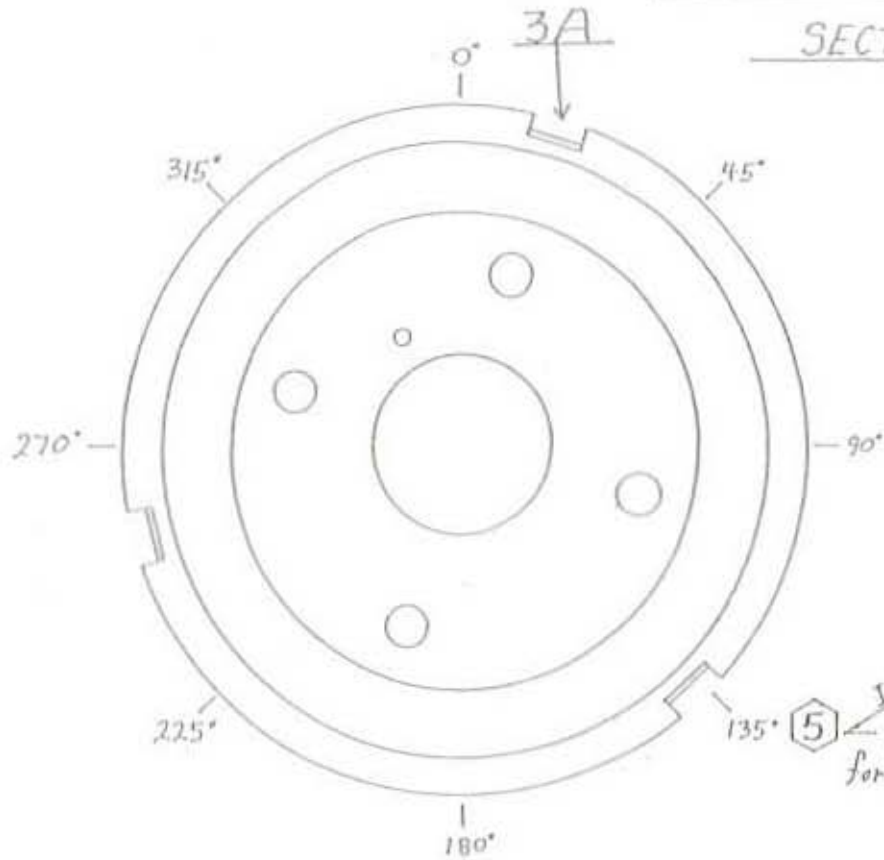
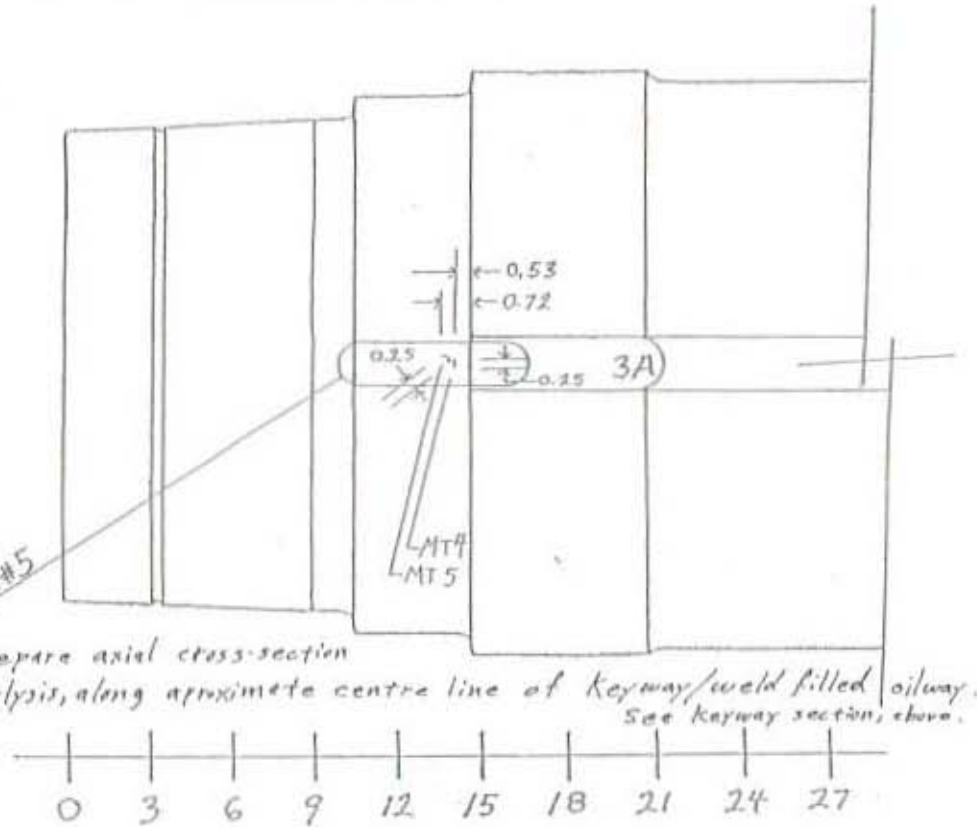
SECTION AT KEYWAY 3A

Prepare axial cross-section for analysis, along approximate centre line of keyway/weld filled oilway. See keyway section, above.

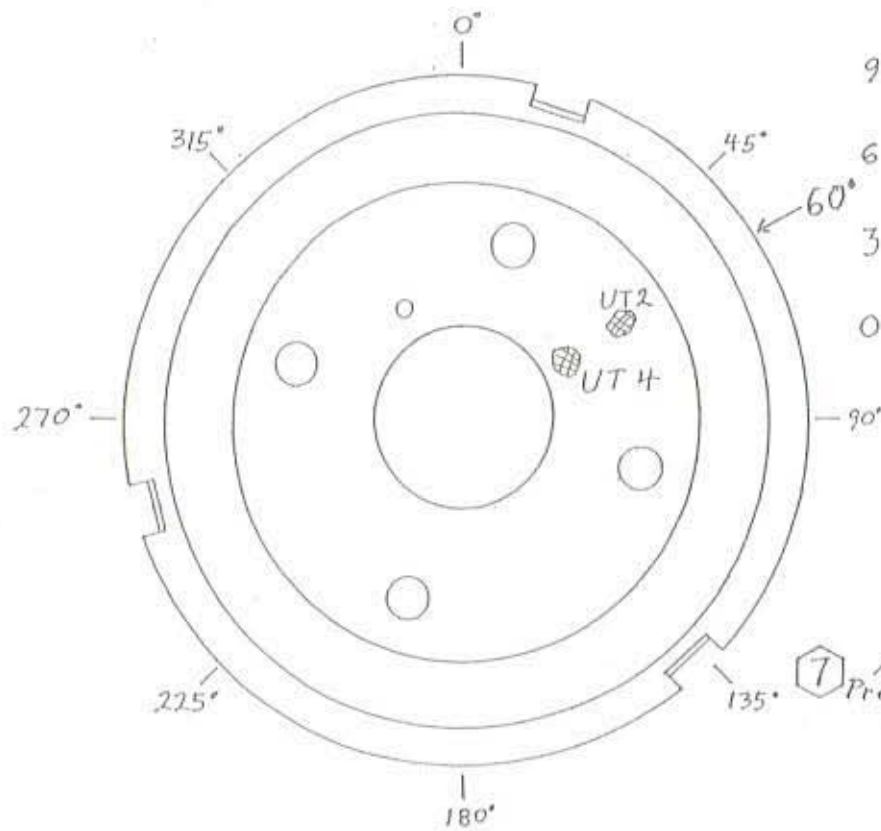
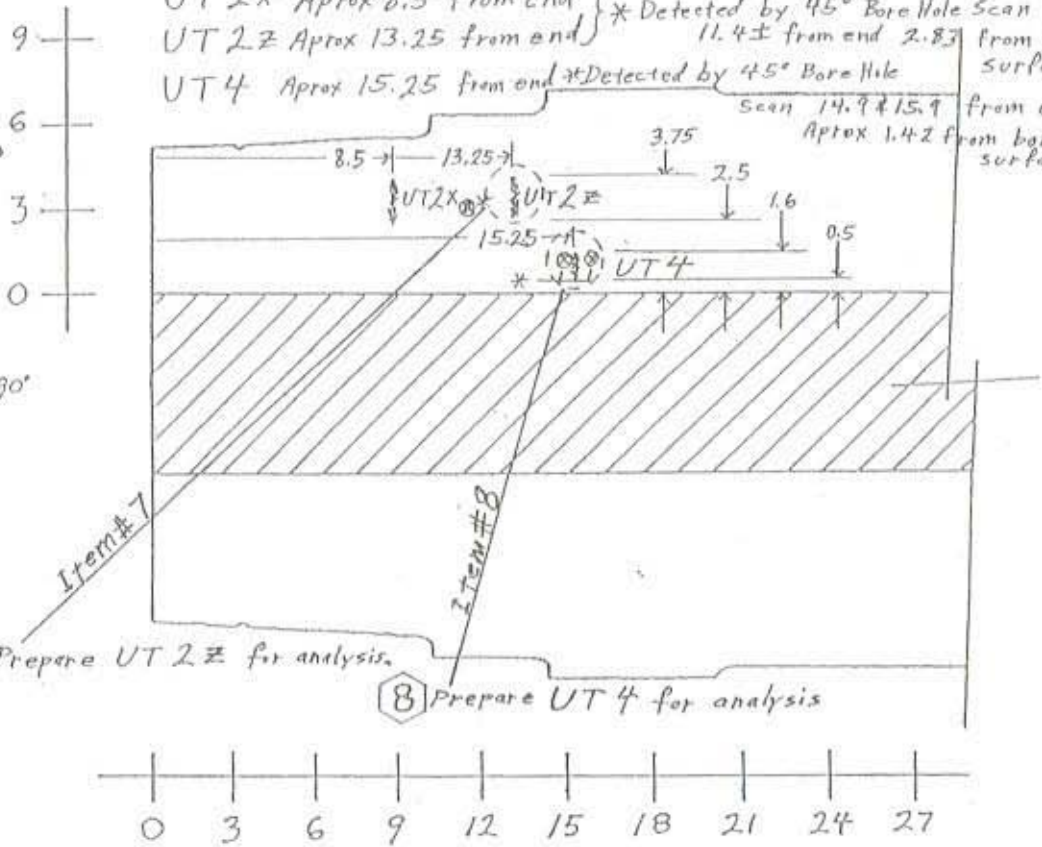
CROSS SECTION - EAST END (T.C. 15°)

Discontinuities located by UT Axial Scan

UT 2X Aprox 8.5 from end } * Detected by 45° Bore Hole Scan
 UT 2Z Aprox 13.25 from end } 11.4 ± from end 2.83 from bore surface
 UT 4 Aprox 15.25 from end * Detected by 45° Bore Hole Scan
 Scan 14.9 & 15.9 from end
 Aprox 1.42 from bore surface

7 Prepare UT 2Z for analysis.

8 Prepare UT 4 for analysis

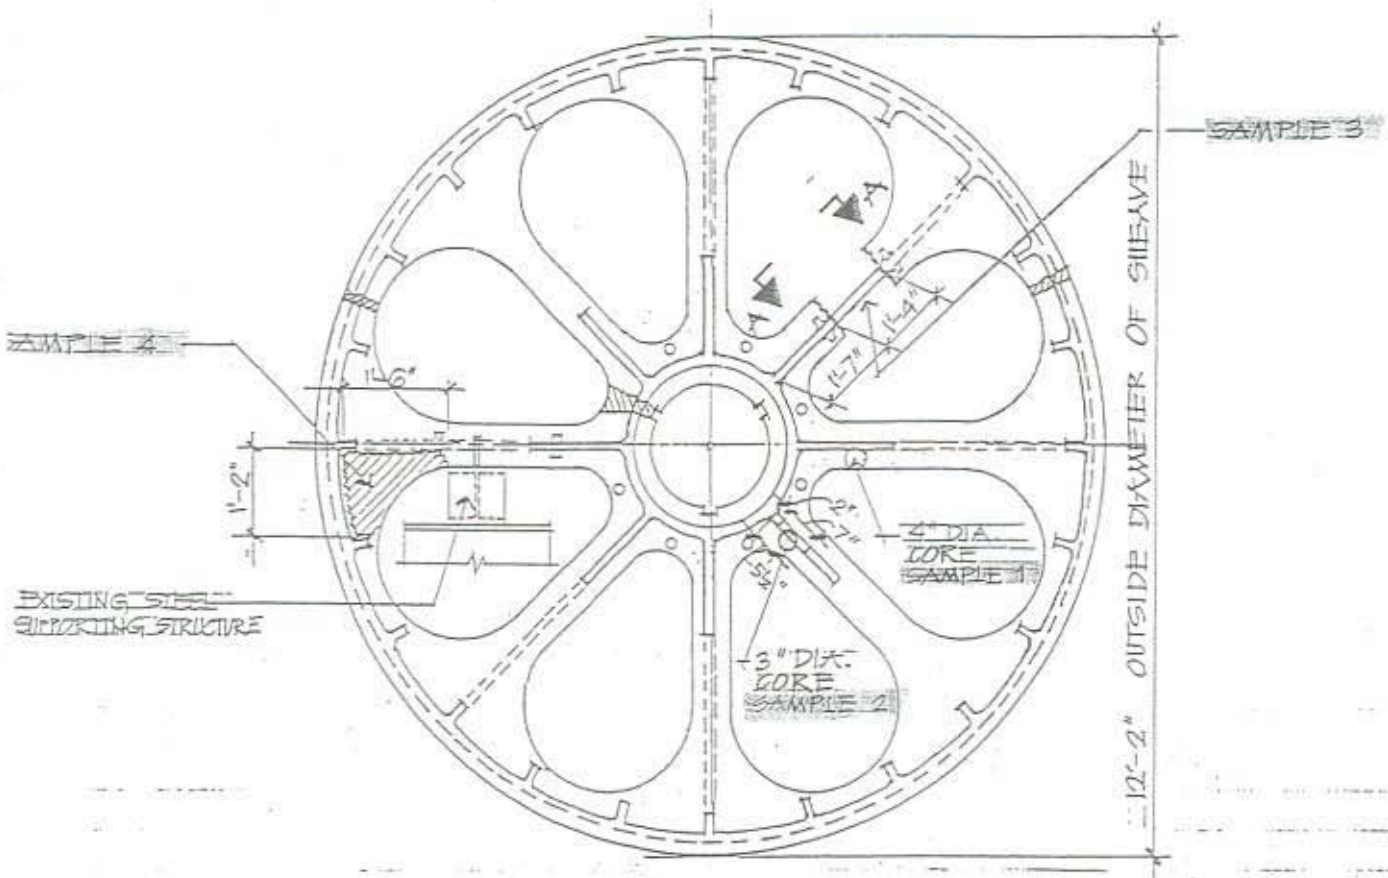
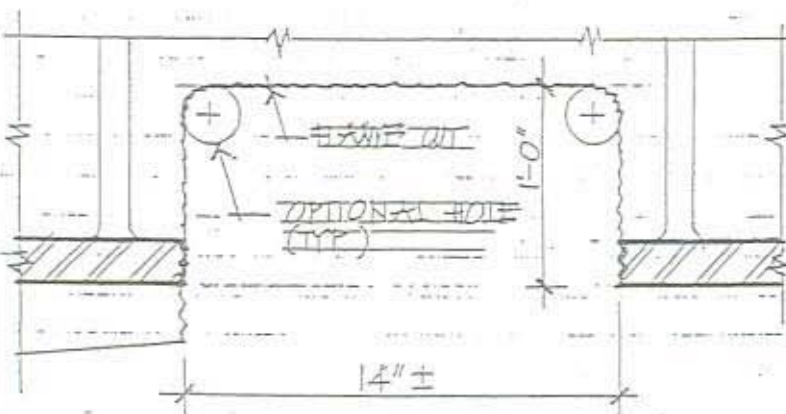
WHEEL SAMPLES FOR MATERIAL TESTING
AND SAMPLES CONTAINING CRACKS

SAMPLE NO.	DESCRIPTION
1	4" DIA. CORE CONTAINING CRACK
2	3" DIA. CORE WITH GROUND CRACK
3	SPOKE & WEB PLATE SAMPLE FOR MATERIAL TESTING
4	SPOKE / RIM SAMPLE FOR MATERIAL TESTING
